VERNACULAR BUILDING 12

Scottish Vernacular Buildings Working Group

1988

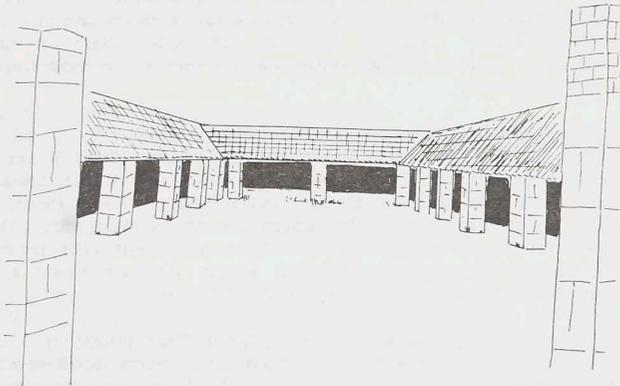
GLEDE KNOWE

At the foot of Huntly Cot Hill about 900m south-south-east of Huntly Cot farm is this sheep house which is still in use and has racks round the walls. Rectangular, 21.5m x 12.9m overall, the perimeter wall is 1.5m high except for the gable ends of the roof on either side of the south-east end which has a centrally placed entrance. Internally there are six square pillars equally spaced on each side and a single square pillar centrally placed at the inner end. The pillars, 1.5m high, are linked by timber lintels and resting on these and wall plate timbers are collared trusses supporting a pantile roof 3.5m wide of equal slope on either side.

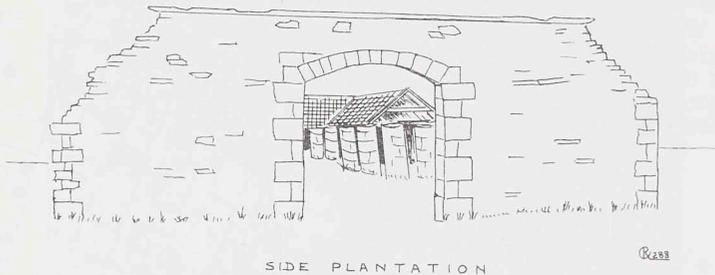
sheep house, now ruinous, its north end roofed, its south end tumbled, the roof trusses and pantiles lying on the ground. Rectangular, 20m x 11.2m overall, the perimeter wall is 1.8m high except for the south end where it rises to the gable ends of the roof on either side of the entrance which is arched over. Internally are five round pillars on each side, four free standing, the most southerly, on either side of the entrance, a half pillar built into the perimeter wall. The pillars, 1.8m high, are linked by timber lintels and resting on these and wall plate timbers are collared trusses supporting a pantile roof 3.5m wide and of equal slope on either side.

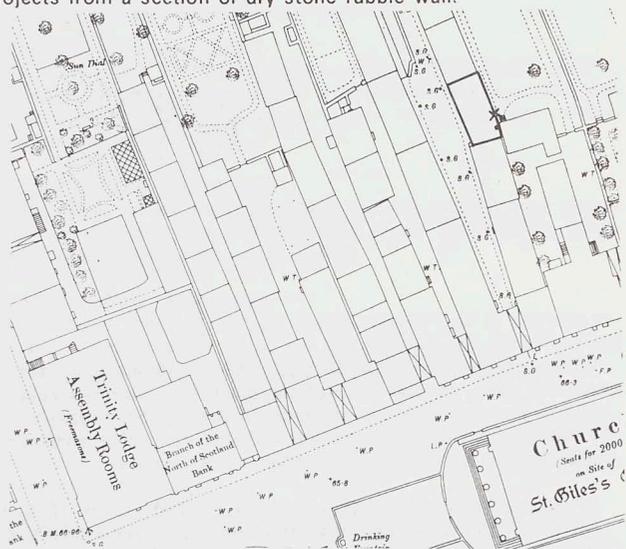
Elgin -
1st OS, 1871
Reduced from
1:500 scale

× Cruck Blade
• Cruck Slot

This length of walling formed the long east elevation of a single-storey cottage to the rear of 121 High Street, revealed on the 1st edition Ordnance Survey of 1871 as the fourth in a row of seven buildings stretching back from the principal street frontage. The cottage measured approximately 36' x 15' (10.98m x 4.56m) on plan, and 6' (1.83m) high to wallhead. There is a small blocked window with a re-used lintel with roll-moulding (quarter-round) similar to that found on windows of the 'Bishop's House' (dated 1557) close to the cathedral. The single cruck blade is roughly central, seated in the usual mural slot commencing 1' (30cm) above ground level; it measures 5'8" (1.73m) in length and projects about 1' (30cm) above the wallhead. The cruck blade was scarfed or jointed, lapped to an upper member at wallhead height, secured by at least two wooden pegs. At its head it is now cut away where the upper timber abutted, fastened with wooden pegs of which one

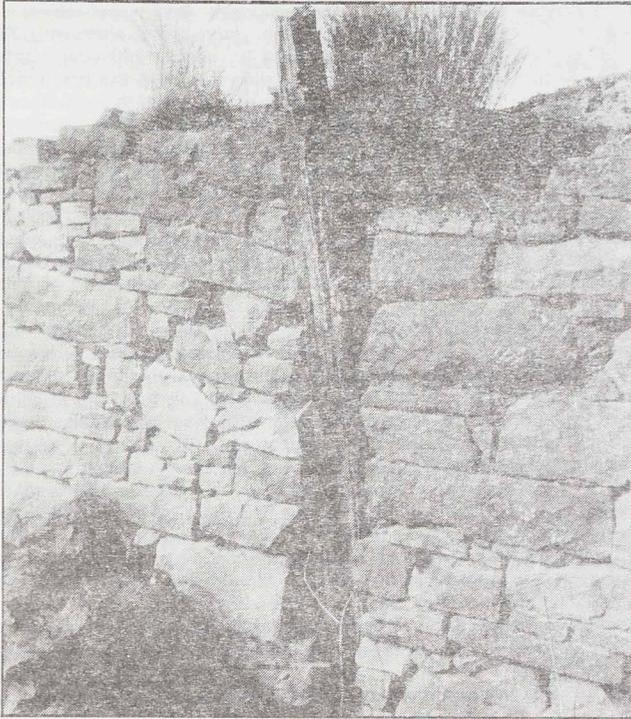
survives together with a second peg hole. It is formed from a single tree trunk or heavy branch, is crudely shaped for easement into the mural cavity where it remains firmly embedded, and is roughly adzed on the outer face.

However, the importance of this single, somewhat mutilated and stubborn section of timber is to reveal tangible evidence of a cruck building tradition in Moray. Thomas Dick Lauder shows cruck framing in his graphic illustrations of the 1829 Moray floods, a pair of cruck trusses standing amidst a scene of desolation at Broom of Moy on the west bank of the Findhorn River²². During the last four years cruck framed cottages and steadings have been identified on Dava Moor, in Inverallan, Cromdale and Advie Parish, Badenoch and Strathspey District, Highland Region²³. The solitary cruck blade in St Giles' Close, Elgin, places the tradition firmly in the urban heart of Moray district.

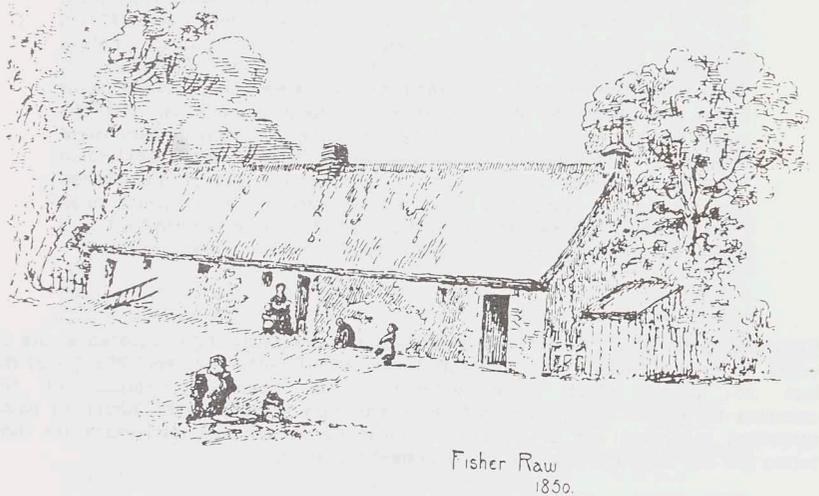
Fisher Row - from J S Fleming *Old Nooks of Stirling* (1898).

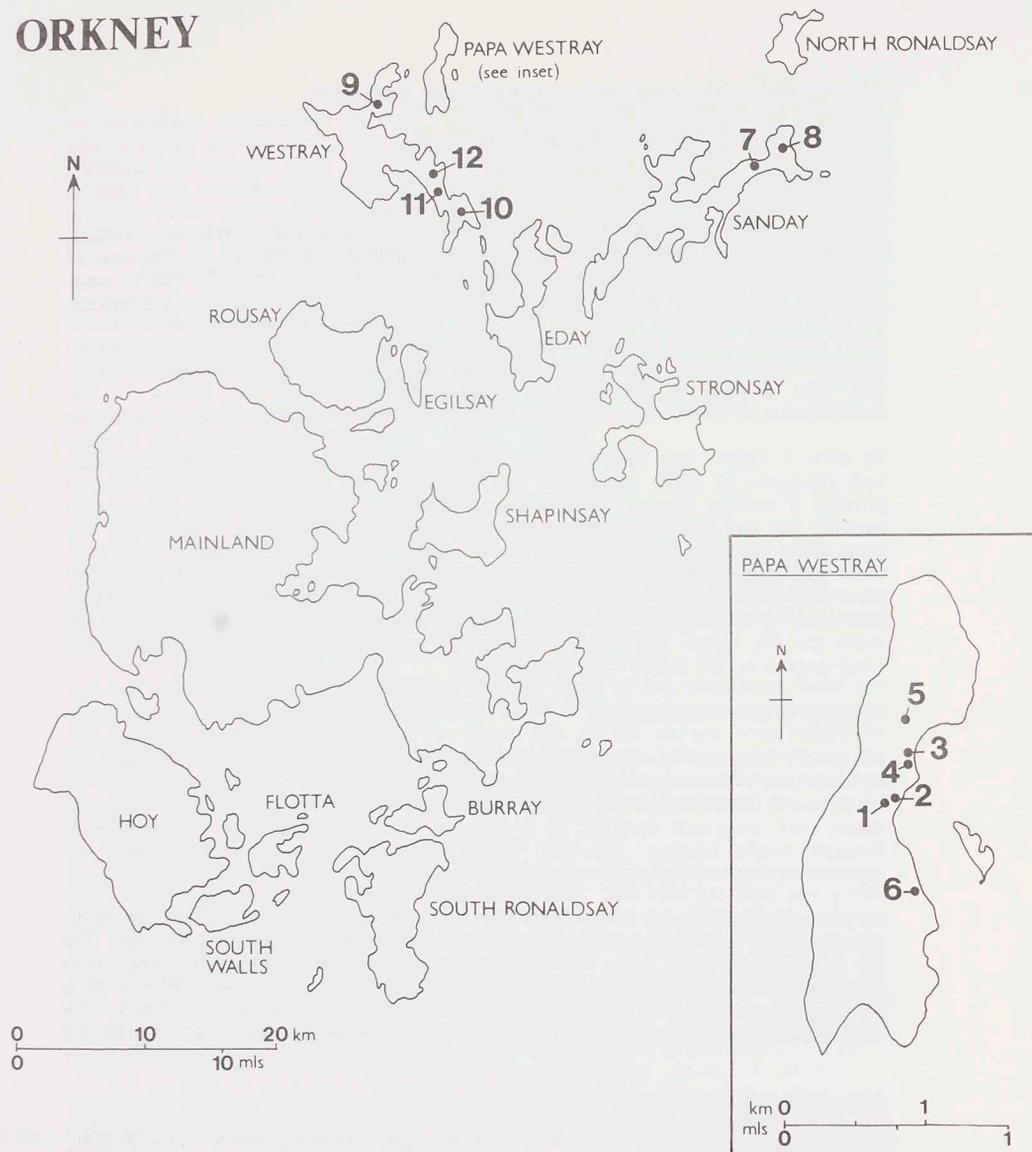
FIGURE ONE: Recorded Wind Powered Threshing Machine Sites in Orkney.

KEY TO ORKNEY WIND-ENGINE SITES:	<u>PAPA WESTRAY</u>	<u>SANDAY</u>	<u>WESTRAY</u>
(Discovered by December 1986) ●	1. Maeback	7. Rusness	9. The Links
	2. Roadside	8. Lettan	10. Sanquhar
	3. North Via		11. Swartaback
	4. South Via		12. Hillhouse
	5. Gowrie		
	6. Hookin

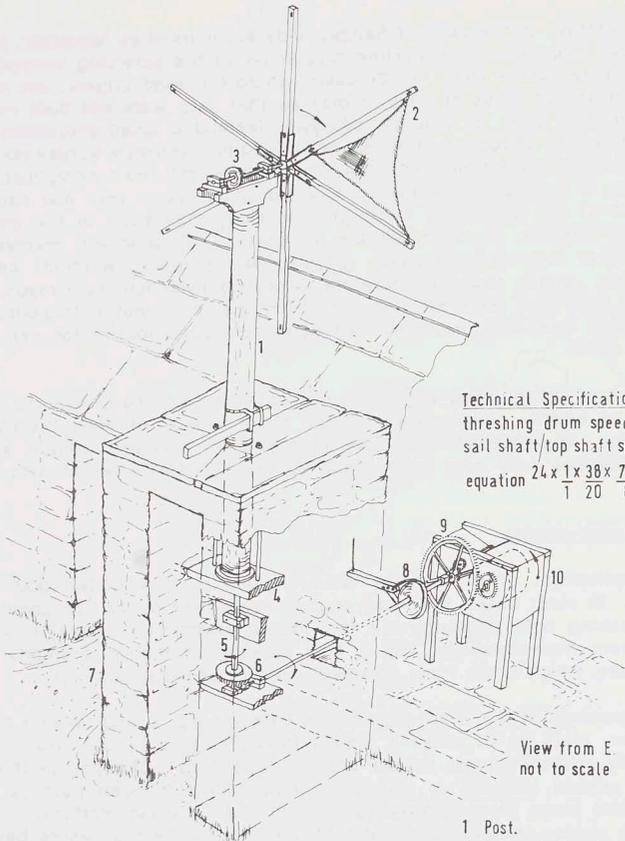
FIGURE TWO: Anatomy of an Orkney Wind Engine and Threshing Machine at Sanquhar, Westray.

The sails themselves were usually canvas, and were either triangular or rectangular (the former in the case of Sanquhar). They were fixed in position on sail arms,

Technical Specifications

threshing drum speed c. 430 r.p.m.

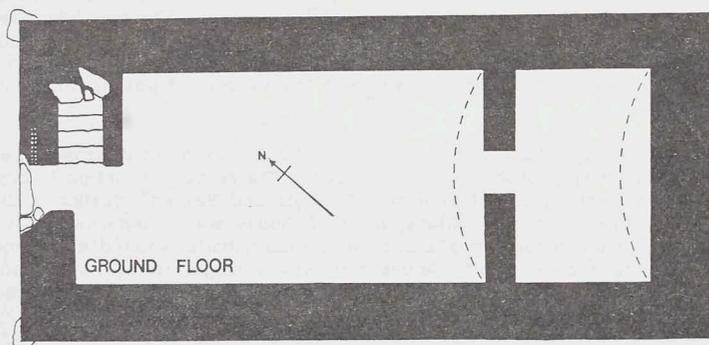
fig 1

WINDGATE HOUSE

The window openings were of dressed sandstone. Parts of sills and lintels were found with holes cut into them to accommodate iron bars, two in number, inserted vertically and approximately 0.15m apart. Measurements taken from the assembled pieces of a sill suggest the width of a window opening to be 0.6m. The roof was covered with slates typical of the Southern Upland variety, each slate having a hole 0.01m in diameter to take a wooden peg to fix it to the roof. In general the walls had a projecting plinth on the outside formed of large irregular stones. The surviving corner stones are battered in an attempt to round them off. Windgate House has the main characteristics of a bastle house as described in *Shielings and Bastles*. These include the elongate plan, the barrel vault, draw-bar tunnel, partitioned basement and barred windows. However, in Windgate House, the stair is located inside the building and is relatively wide. The windows are of typical size and had two iron bars built into them. The fact that fragments of the lintels and sill were found on both the east and west sides of the building indicates the position of at least two of them. The position of one may have been immediately above the deepest part of the midden, 5m from the south gable. As no window glass was found we may conclude that the windows were not glazed but simply shuttered. The basement may have been lit and ventilated by a couple of slit windows with internal splay through the vault. However, no evidence was found to support this

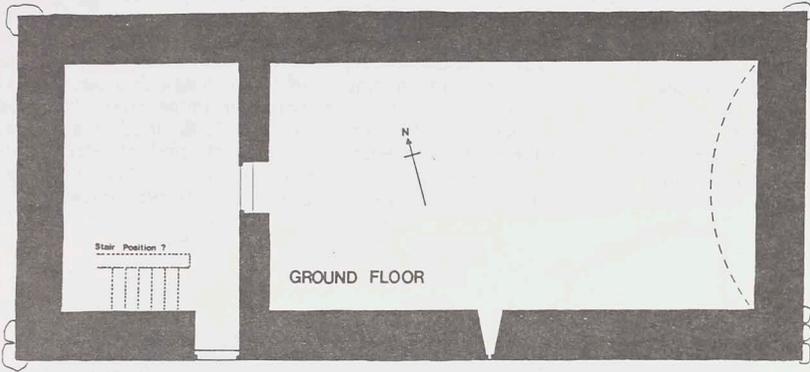
fig 3

GLENDORCH

GLENDORCH (NS 870188) fig. 3: This ruin was part excavated. Unfortunately (for our purpose) the site had been in continuous occupation until 1957. As a result of this the remains of the original house and the archaeological deposits have suffered. However enough has survived above and below ground to give a complete plan at ground level and this compares favourably with that at Windgate House. An original slit window (fig. 4) is still complete, the aperture measures 1.5m x 0.075m, the tiny window is splayed through the haunch of the surviving part of the vault on the south wall and would have given light and ventilation to the chamber. The maximum heights of the surviving wall and visible curve of the vault are 3.5m and 2.2m respectively. The positions of the doorways were found with door check stones and steps in situ. The lower pintle of the external door hinge is also in situ. On three external corners squared sandstone quoins are still in place and several other dressed stones were found in the excavation. Stones were also noted in the nearby nineteenth-century shepherd's cottage (now also a ruin) and in drystone dykes which had obviously been re-cycled from the older house. All these dressed stones were of good quality red sandstone and were worked to a high standard.

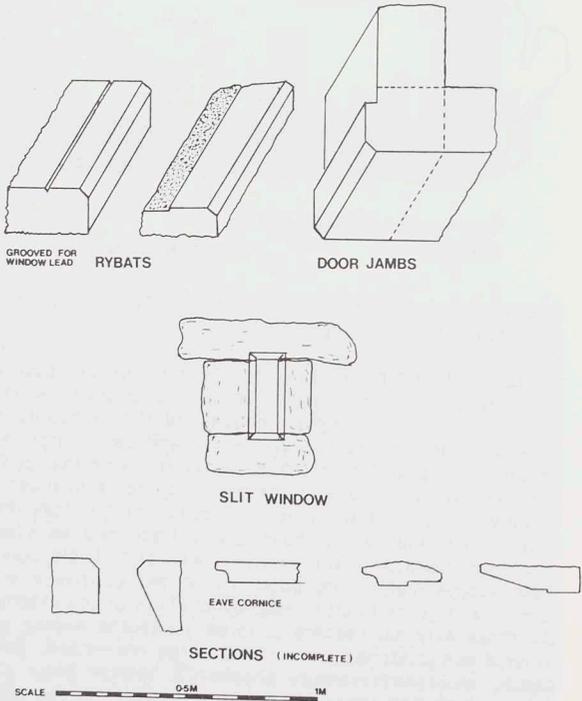
fig 4 GLENDORCH DRESSED STONWORK

plain chamfering of the corners being the only attempt at embellishment. Two particular shapes recognised were eaves cornice drip stones (fig. 4) and a stone with a V-groove cut into it to accommodate leaded glass (fig. 4). Window glass and its lead strip were also found. Neither ridge stones from the roof nor evidence for the style of skews were found. A peculiar arrangement of mortared stone-work beneath the floor level and which is bonded into the south-west corner of the smaller room cannot be explained satisfactorily. It is suggested that this may be the foundation of an internal stair. Many interesting objects dating throughout the seventeenth/eighteenth century were found. Perhaps the most interesting were three types of substances (possibly used as keel) which were found on the site. In the seventeenth century the occupants used red haematite (same as Windgate House) as a colouring agent, and in the eighteenth century an altered felsite had been ground to give a yellow powder, and two modern jam jars of bright red keel had been abandoned on the walls of the ruin - three substances presumably for the same purpose, a colouring agent, spanning almost four hundred years! Another parallel with Windgate House was the use of slates on the original roof. These also had a large hole which shows wooden pegs were used to fix them. Clearly however Glendorch was a 'cut above' Windgate House in architectural quality. This may be explained by the fact that the owner in the late sixteenth century was one Thomas Foulis, a wealthy Edinburgh goldsmith who had a licence from James VI to exploit the nearby lead deposits at Leadhills. Foulis died in 1628.

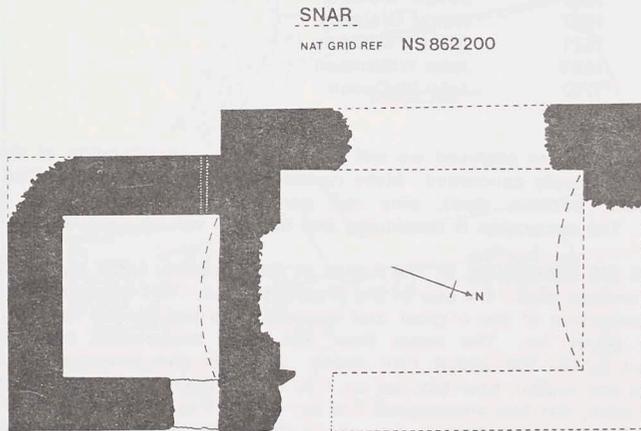
fig 5

SNAR (NS 862200) fig. 5): This site has also had continuous occupation. Modern farm buildings have encroached onto the site, a stream is undercutting one side, which may have been a factor in its final abandonment in the nineteenth century. A limited excavation was carried out here to establish the ground floor plan and this was to some extent achieved. No significant artefacts were retrieved, but from references it is known that both chambers of this building were vaulted. It is obviously two periods of construction - a small room has been added at the south end of a main chamber. There has been no connecting doorway between the rooms. Unfortunately not enough of the ruin survives to be conclusive about its architectural style.

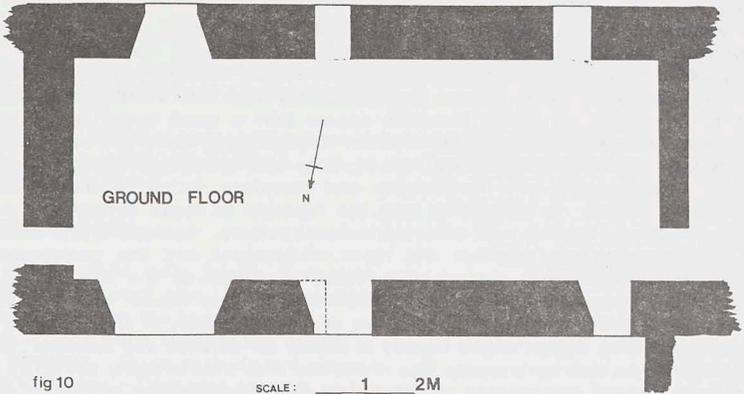
fig 10

COMPARATIVE GROUND FLOOR PLANS OF BASTLE HOUSES

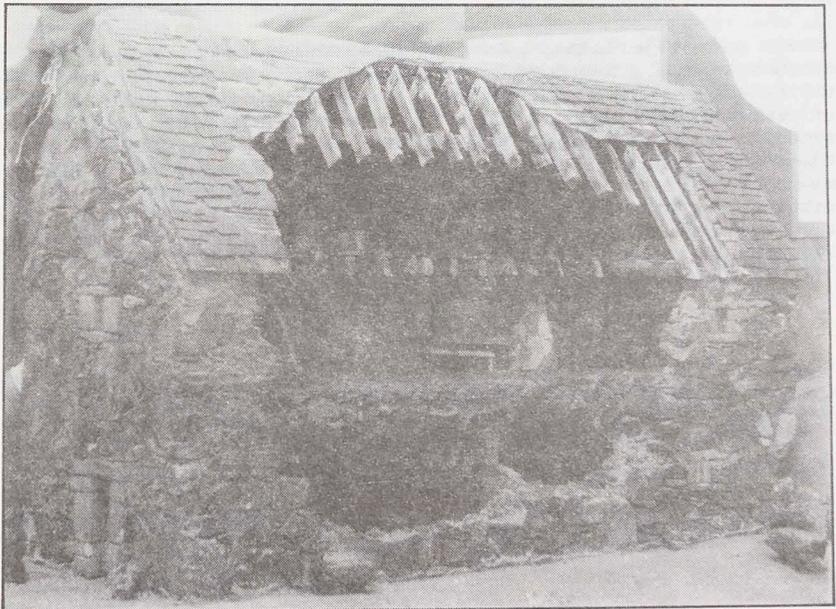
This paper model has now been converted into a 1:20 scale model in stone, slate and wood to demonstrate how substantial and grand these buildings were at a time when most people were living in turf and stone hovels which may have had difficulty keeping out the weather, let alone an intruder. This model can now be seen along with a permanent display of artefacts, photographs and information in the new Moat Park Heritage Centre in Biggar.

Model bastle house - on display at the Moat Park Heritage Centre, Biggar.

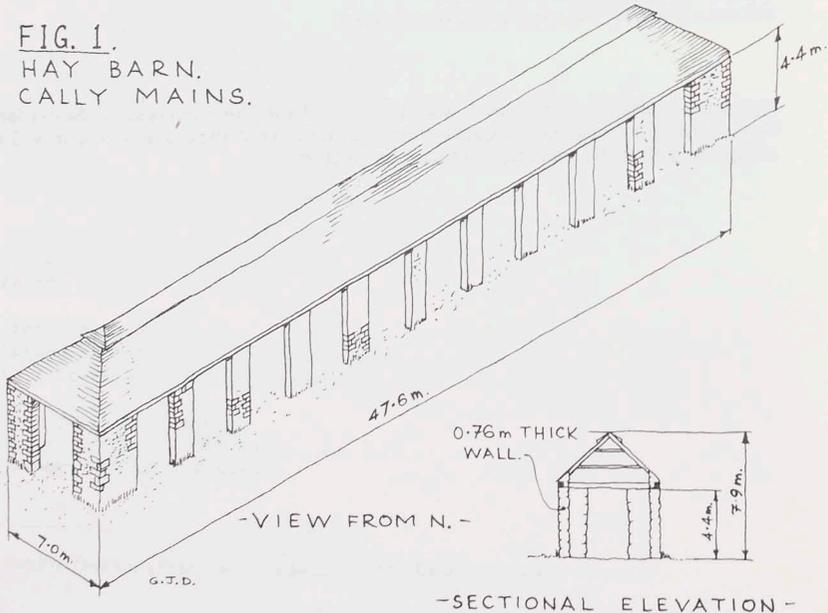
FIG. 1.
HAY BARN.
CALLY MAINS.

Granite quined piers of hammer-dressed rubble support timber lintels of up to 9m in length, from which rises a common rafter roof with a pair of collars to each rafter couple. It is a blue slate roof with a raised ventilator running the length of the ridge. The barn probably dates from the end of the nineteenth-century and thanks to the remarkably wide openings it continues in use today as a straw barn.

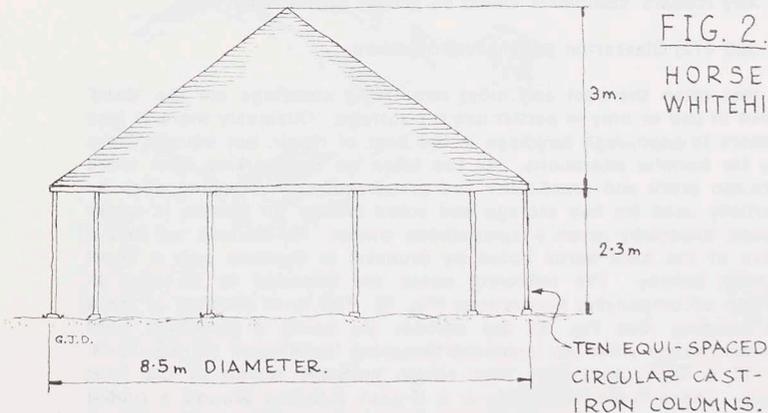
FIG. 2.
HORSE ENGINE HOUSE.
WHITEHILL OF BALMAGHIE.

The Balmaghie group are all of a similar nature and seem to be of altogether a different type to Tonderghie. Fig. 2 illustrates Whitehill of Balmaghie as an example. All three horse-engine houses have comparatively flimsy roof structures which would seem incapable of supporting anything so heavy or stress-laden as a horse-engine and its accompanying gearing. Ten cast-iron columns support laminated timber lintels from which rises a conical slate roof supported by light-weight timber rafters. The absence of any substantial timber roof truss, or indications of its removal, would seem to rule out an overhead drive of the Tonderghie type and point to a sweep-drive underfoot gearing. If so the provision of a covered walk, especially in cast iron is unusual and noteworthy. Alas, as is often the case, there remains no visible trace of machinery in any of the Balmaghie horse-engine houses, nor in the accompanying threshing barns. Though the three horse-engine houses are very similar, the cast-iron columns used for each are slightly different in profile, some having rudimentary capitals, some with fillet moulding.

In Balmaghie parish, Stewartry, there is a group of three unusual horse-engine houses, all shown on the first edition OS map of 1853. The standard Stewartry horse-engine house has substantial rubble piers supporting a conical slate roof (polygonal roofs are rare) and overhead harness-shaft and gearing. One recently visited at Tonderghie is a good exemplar of the type; here the roof structure supports a substantial polygonal timber drive shaft and formerly the harness-shafts (the latter alas not extant). In the adjoining barn is a complete threshing machine of roller-feed type, probably dating from the 1840s.

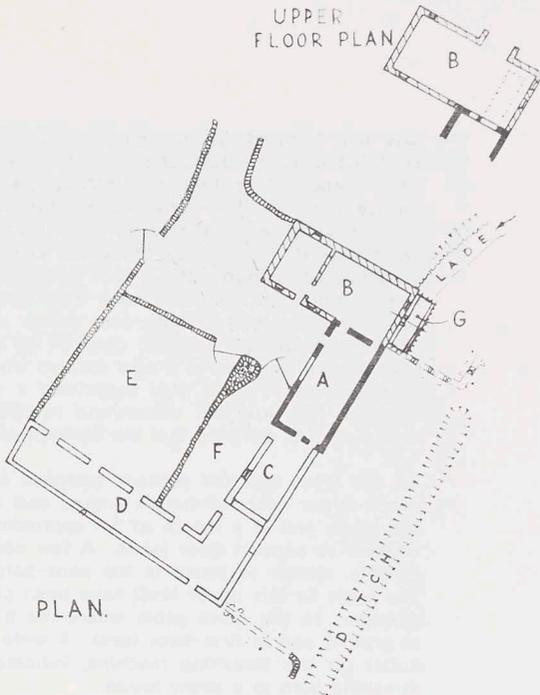
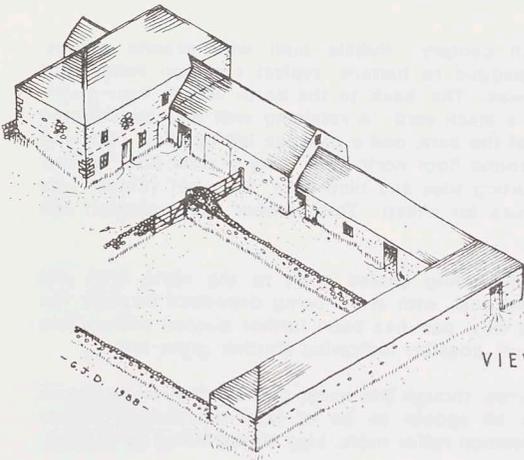
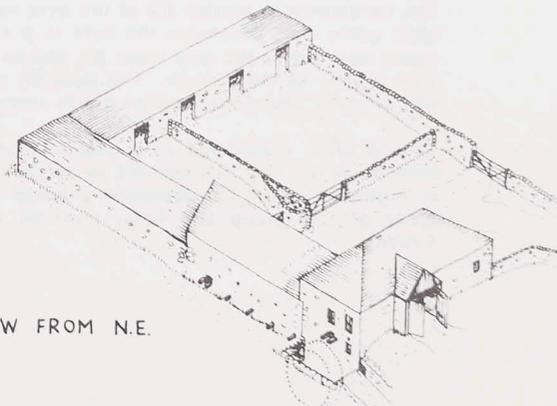
PLAN.

VIEW FROM S.W.

VIEW FROM N.E.

way this building adjoins the bank-barn, and its unusual and early roof structure confirms it as the earliest part of the steading. The roof has principal rafters with collars and side purlins, the graded slates are pegged to battens and plastered underneath. At each rafter couple there are indications of a further lower collar beam having been checked in, these were probably removed when the floor levels were altered. At intervals along the exterior east wall are several projecting stone cantilevered supports, these bear no signs of fixings or wear marks. Their purpose is thus uncertain, but they must have functioned in conjunction with the threshing machine sited in the south-east corner of the 'straw-house', the opening for the drive shaft, though blocked, can still be identified. There are two alternatives: a) they carried the lade to a now defunct wheel, though there is now no trace of it or of a wheelpit. or b) they supported a drive shaft from a wheel in the current wheelpit (G); it is not uncommon to find wheelpits detached from the threshing barn, and it is possible that the Stellock wheelpit was always in its present position.
