# VERNACULAR BUILDING 15

## Scottish Vernacular Buildings

Preface		2
Souness	<i>Heather Thatching in Scotland - Further Observations</i>	3
Paul and Alison Newman	<i>Simmens and Strae: Thatched Roofs in Orkney</i>	27
Sam Seabrook and Brian Wilson	<i>Rebuilding Jeannie MacAlpine's Inn</i>	41
Harry Gordon Slade	<i>Artamford and Greenware: Designs for Two Improved Farm Courts: 1760 and 1822</i>	45
Graham J Douglas	<i>Closet, Gill Pier, Westray, Orkney</i>	50
	<i>Ardnamurchan Field Trip</i>	51
Elizabeth Beaton	<i>The Glasite Meeting House, 33, Barony Street, Edinburgh</i>	52
Contributors		54
SVBWG - How to join		55

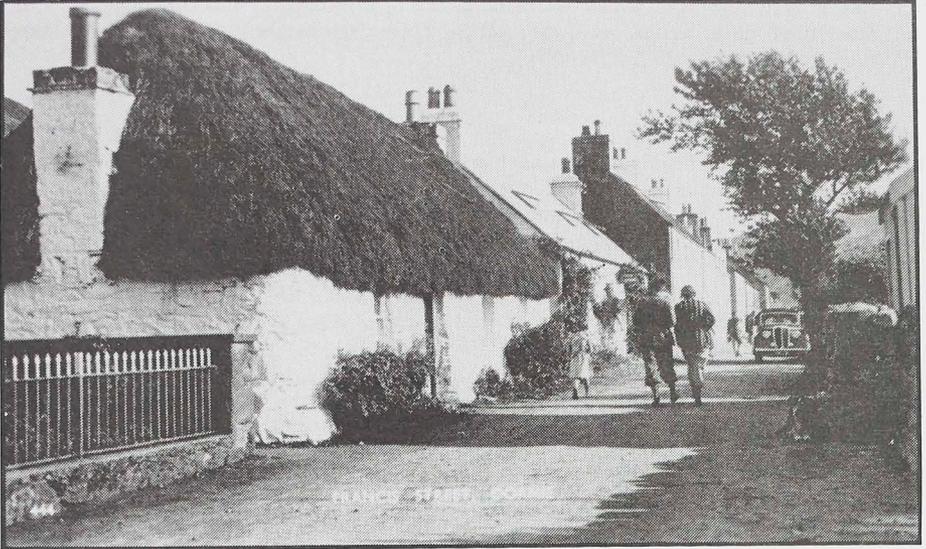
**Heather thatched house, Dornie c.1930s**

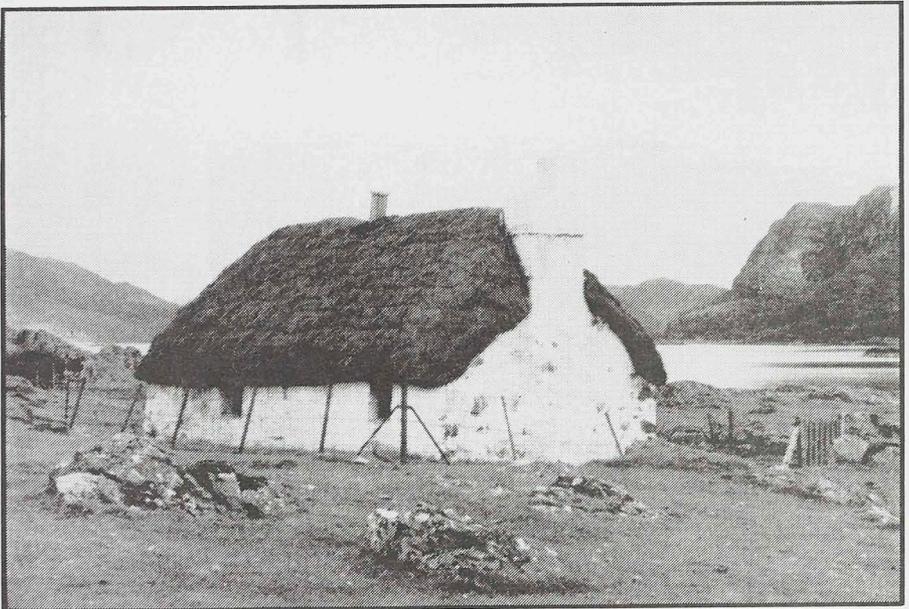
**Heather thatched house, Plockton, 1936**  
(note fixing with *lathisean* - hazel laths)

Securing might be done in various ways. Preferably, this would be done as the job progressed. In the past, it would be done either with hazel laths (**lathuisean**) and pegs (**dromanaich; sgolban**) driven into the underlying divots or old thatch, or by tying to the roof timbers with lengths of split young willow (**gad sheileach**) which made a tough and durable twine. As wire became available, its durability and ease of use made it popular and, for the recent work, tying with a thin, plastic-coated wire answered the purpose admirably. The wire was attached to iron pegs fixed into the stones of the upper gable and, on the completion of a horizontal course, was stretched tightly over the middle of the uppermost heather stalks to the other gable and fixed there. Then, shorter lengths of wire were pushed through the roof with a thatching needle, looping over the horizontal wire at intervals of about one yard, and were tied tightly round secure timbers by a man inside with a twisting tool. Incomplete horizontal courses could be secured in a similar fashion. Even with this tying method, an external line or two of laths and pegs is desirable on each side of the ridge and perhaps also at the eaves.

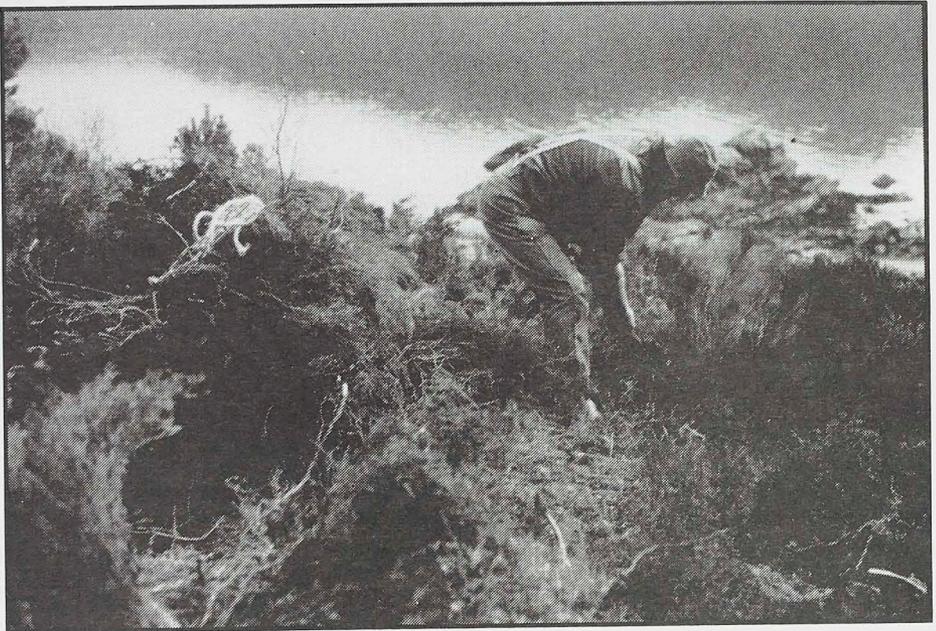
**Duncan Matheson pulling heather**  
(note cual tied on left)

The plant is pulled out by the roots one piece at a time with both hands (protective gloves are wise), and most of any soil or moss attached should be shaken or wiped off. It is best to work uphill along a short 'face' as this continually loosens the heather above and eases the work. Once a suitable area has been found, 'the best heather is where you are standing!' - it pays to pull an area in its entirety rather than to jump from place to place in understandable frustration at variable heather quality!

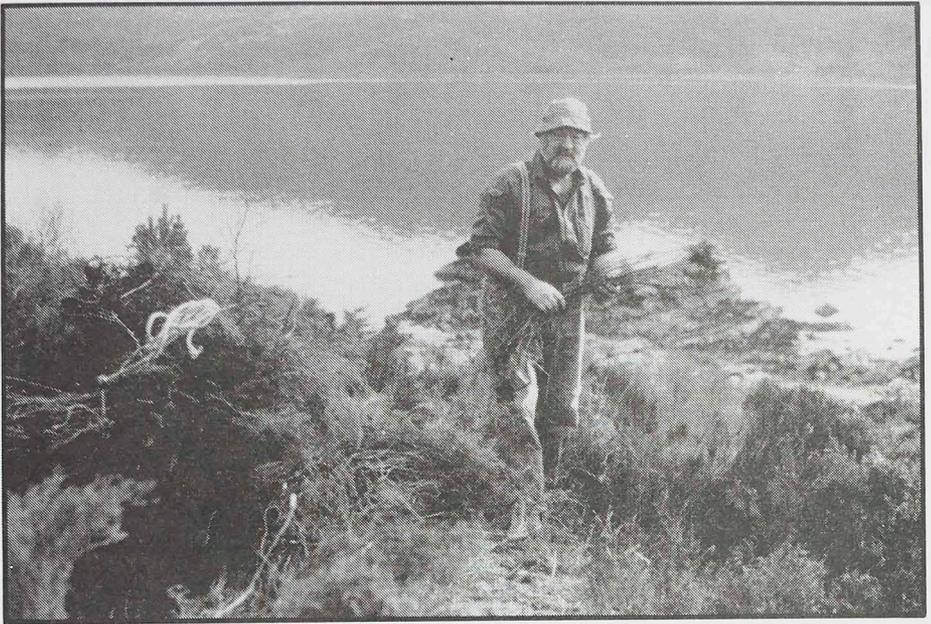
**Duncan Matheson pulling heather**  
(note length of heather)

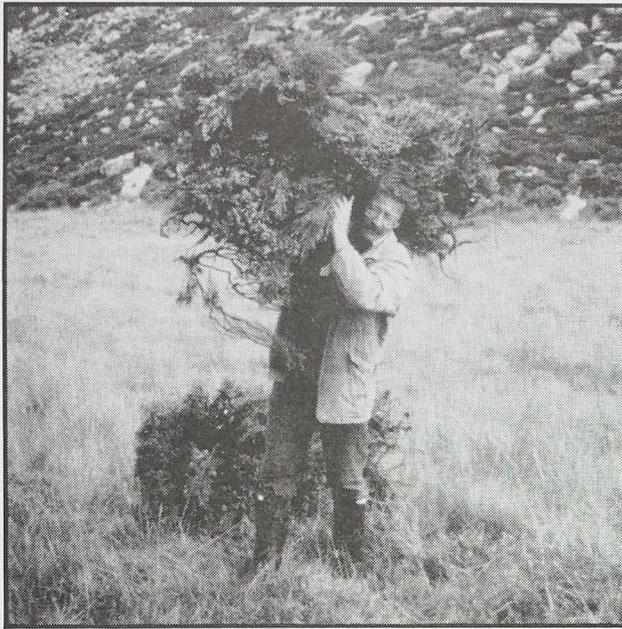
**James Souness with heather cual**

As it is pulled, the heather should be laid in neat rows or small piles behind the puller as he advances. At the end of the day, these are gathered up into large bundles (**cuail**). These will comprise perhaps four good armfuls laid in opposite directions (**cas-mu-sheach**) and tied together. The tying is best done by two men - a thick rope looped through a ring at one end will be pulled as tight as possible and held that way by one man while the other secures twine near the two ends of the **cuail**, whereupon the thick rope may be released. As the **cuail** will receive much rough handling, the twine bands should be very tight although this can be overdone - **Mar is teann a' bhann air a' chuail, 's ann as dualaich' i air bristeadh** (the tighter the band, the more likely it is to break) is a proverb with application to more than heather **cuails**! Each **cuail** is as large as can be carried and these will be rolled, sledged, carted or carried off the hill, whatever is practical. The pulling and gathering of about eight **cuails** was considered a decent day's work for a man. The gabled house recently thatched in Applecross (approx. 11 x 5 yards externally) took one hundred and thirty **cuails** while the little Plockton house with one hip-end took one hundred and fifty **cuails**, or perhaps twenty man-days of gathering.

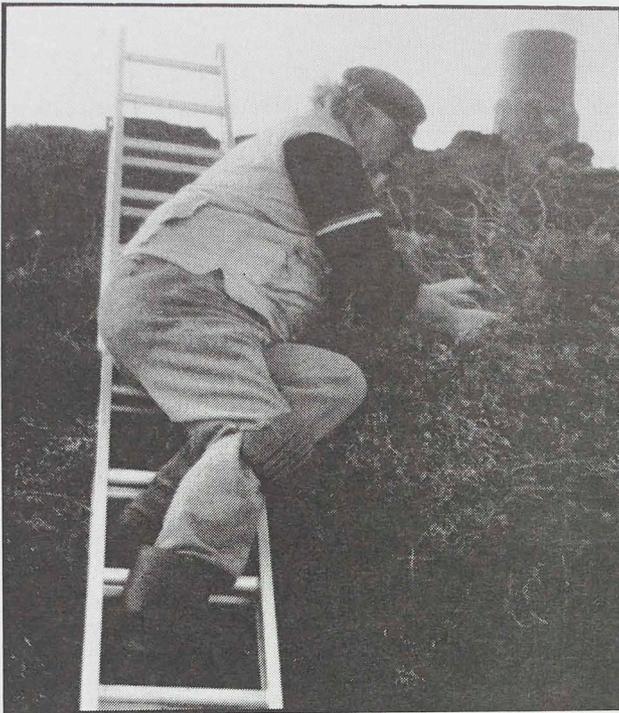
**Duncan Matheson thatching**

Vertical junctions in heather thatch are less easily merged than with other thatches, and are likely to become a source of leakage, so the heather is applied in long horizontal courses, preferably stretching the length of the roof. A single section about two feet wide and one foot high is applied at a time, whereupon the ladder is moved two feet to the side, another section thatched, and so on. Thatching is continued up each side of the roof in turn, until the approach of the ridge (*cìrean*) which is done last. Other than at the eaves and ridge, heather of the same average length should be used over the whole roof. The ridge, like the eaves, is of special importance and the thatch will be especially thick here, the idea being to get as sharp a ridge profile as is feasible. Ideally, two men will thatch the ridge together, one from each side. A few courses of increasingly shorter heather are applied, intertwining at the apex. Then a row of heather stems may be laid on parallel with the ridge to give it an extra sharpness prior to the final 'cap' of long, fine heather being bent over the ridge in alternating directions (*cas-mu-sheach*) and secured.

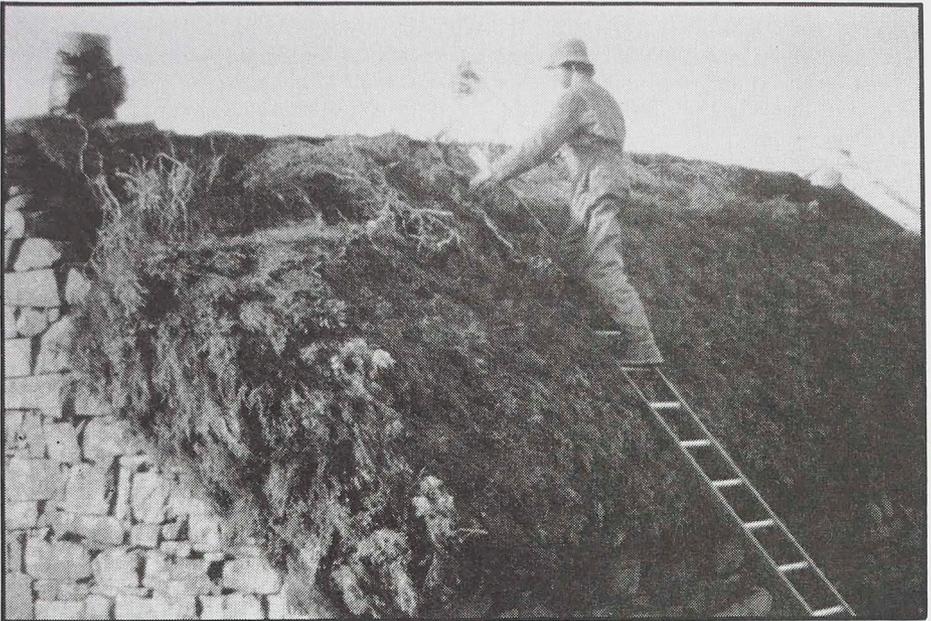
**D. Matheson Jr., thatching at Loubain**

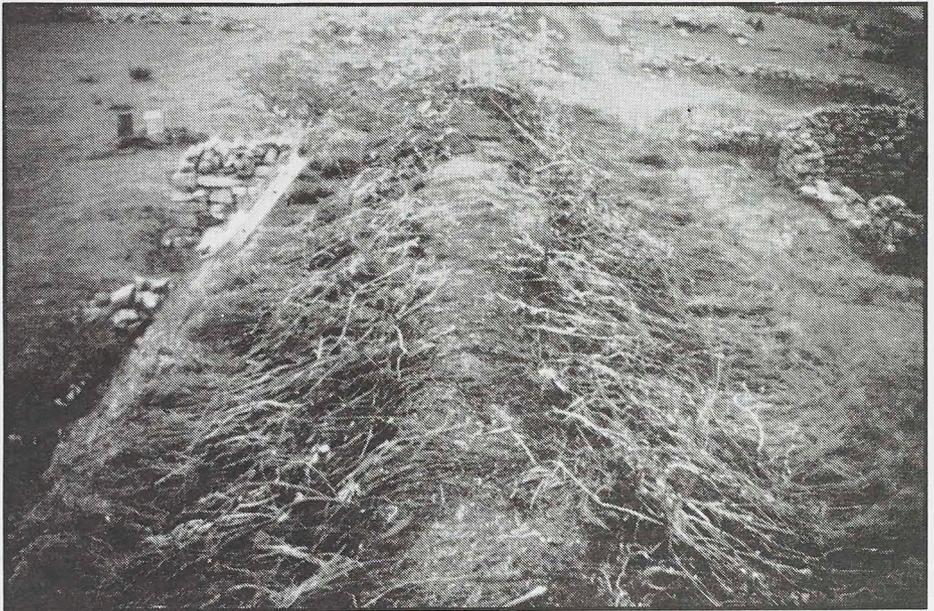
**Approaching the ridge - viewed from ridge**  
(note thickness and angles)

If the roof has gables, the endmost section of thatch can be splayed out to overhang the wall slightly at the gable, thus protecting this junction. At hip ends, the heather will be splayed carefully and tightly around the hip in courses diminishing upwards.

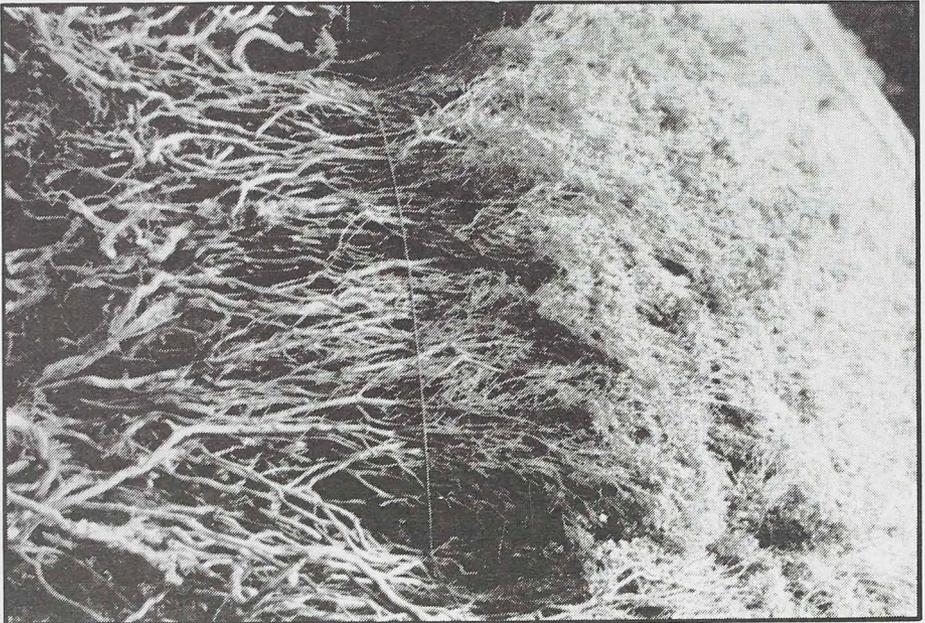
Heather thatch tied to roof with wire

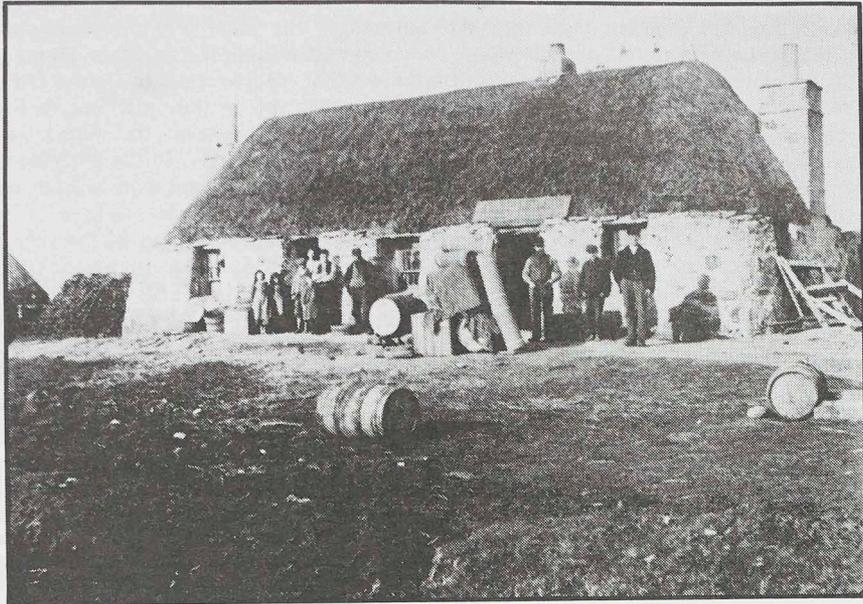
Shop at Locheport, North Uist, c.1900 - heather thatched

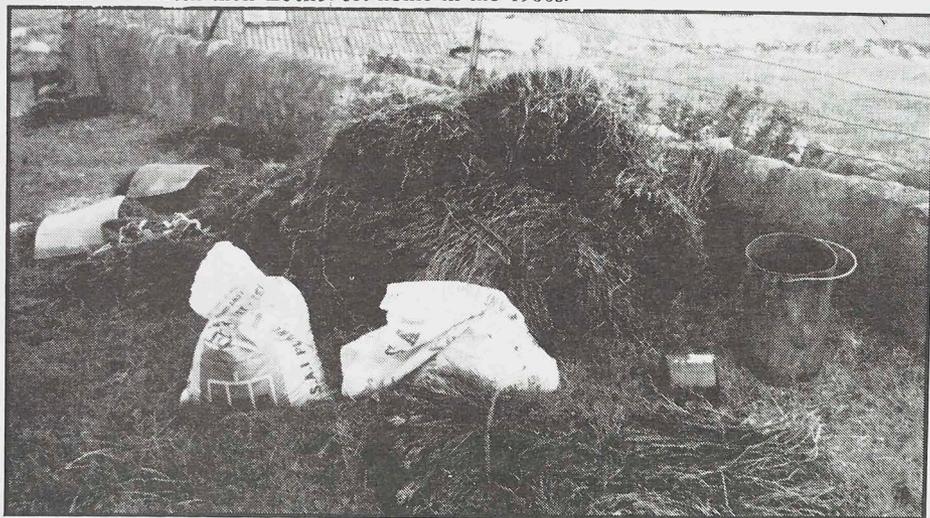
Bundles of thatching heather, North Uist

The heather sought for thatching was thin and straight - not too old, long and rank, but preferably plants with about ten years growth since a burning. A length of eighteen to twenty four inches was thought best in Uist. Shorter thin heather would be utilised for twisting into rope but, in contrast with Wester Ross, it seems that older longer heather was considered useful only for the likes of fuel, besom-making or road-bottoming in boggy ground. The pulled heather would be gathered into bundles (**eallach**) of no more than two feet diameter and transported to the thatching site where it would be weighted with planks and boulders and left for several weeks to 'mature', straighten and improve its binding qualities. Contrary to most of the evidence gleaned elsewhere in Scotland, Uist sources point to a favoured gathering season of August and September - the peak of the flowering season! This at least would tie in with the popular thatching season during calm weather of early winter, but circumstances might dictate differently and one **Uibhisteach** complained to the writer of his family's winter-long toil to gather sufficient heather to thatch their Locheport home in the 1960s.<sup>38</sup>

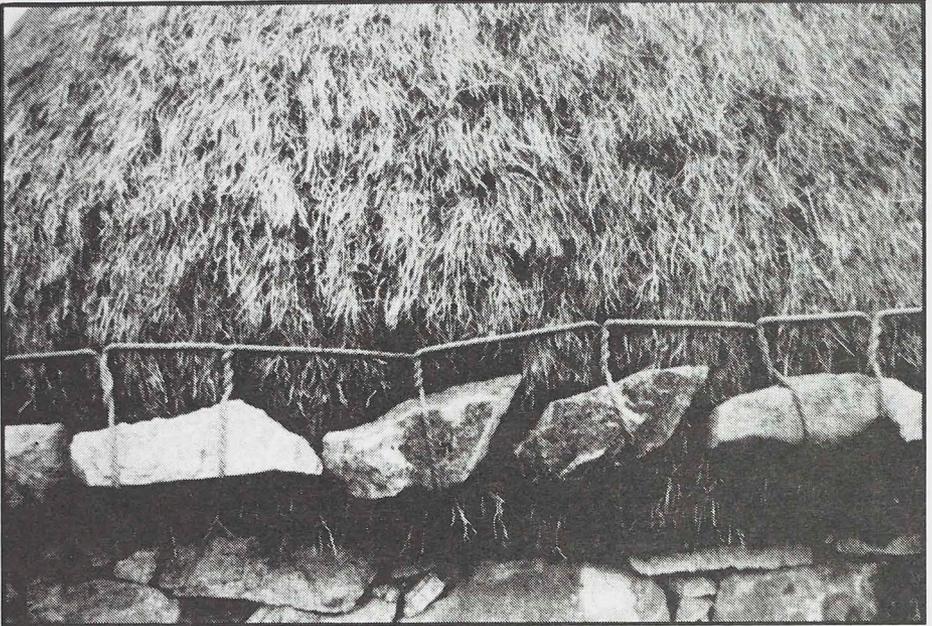
**Heather secured with netting and stone weights, South Uist**

No more than rough weighting was used to secure the thatch while it was applied - the work was done relatively quickly in quiet weather. Other than weight and friction, securing of the finished job relied entirely on external roping (*siomanachadh*) or, latterly, wire-netting, both weighted with a 'necklace' of anchor stones (*acraichean*) just above the wallhead. Heather rope (*sioman-fraoich*) had a long life and would soon merge into the thatch. It was more effective than the wire-netting which would always tend to form small loose bulges, where hollows in the thatch could form. The wire's heating in sunshine and slight movement against the thatch in high winds also contribute to decay. But wire-netting is much less work!

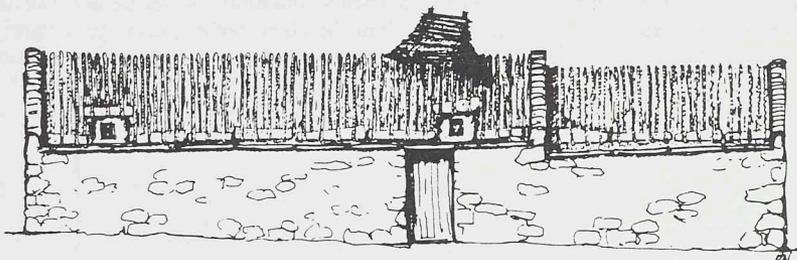
*GIMPS : as it may have been around 1830's*

Even with written archive material it is very difficult to date these rural buildings with any certainty. With the soot staining and the smoke hole we suggest the earlier parts of the building date to before about 1830-1840 (after which time one might expect new buildings to be built with flued gables rather than open hearths and smoke holes). We conclude that this building has been substantially modified at least twice without rebuilding the roof over the original core. This suggests the original roof structure is unlikely to be less than one hundred and fifty years old. The needled simmens may be original; or if not original, at least one hundred years old.
