VERNACULAR BUILDING 20

Scottish Vernacular Buildings Working Group

Cover: West elevation, Haa of Sand, West Mainland, Shetland. Drawing by Mike Finnie.

CRAIBSTONE LIMEKILNS, DESKFORD

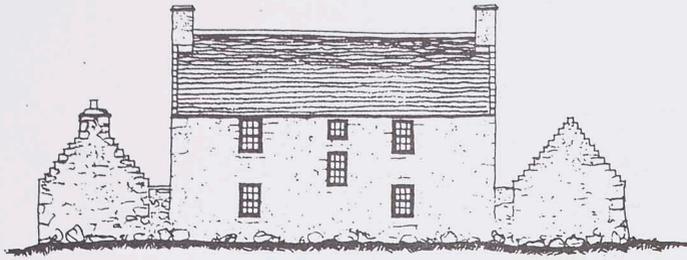
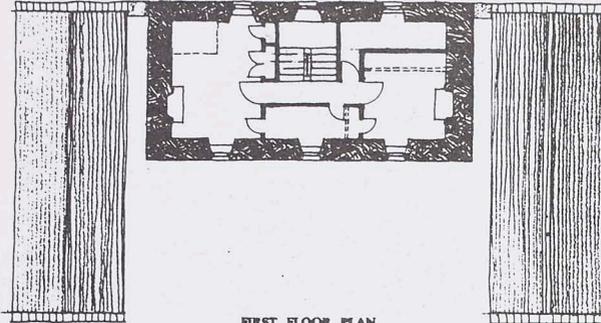
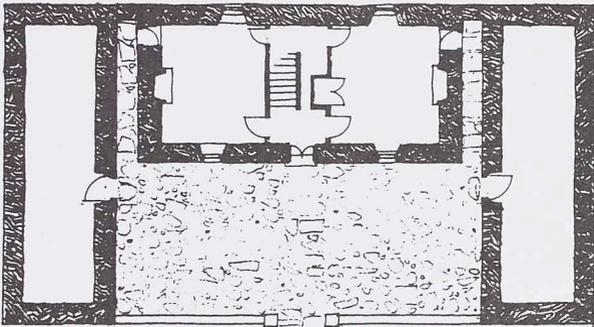
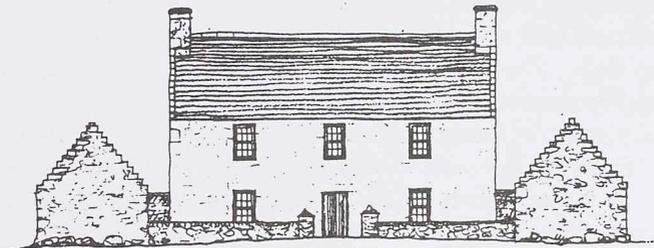
figure 1 South elevation, first floor plan, ground floor plan, north elevation.
Conjectural reconstruction c.1750. (Simpson and Brown Architects)

By this time the family styled themselves 'of Gruinard', though they resided at Udrigle in a dwelling whose masonry was found during the restoration of Udrigle House in 1992-4. George was succeeded by his son John, who in turn was succeeded by his son William, fourth of Gruinard, who in 1745, with his wife Lilia (daughter of John MacKenzie, first of Lochend) built Udrigle House (figure 1).

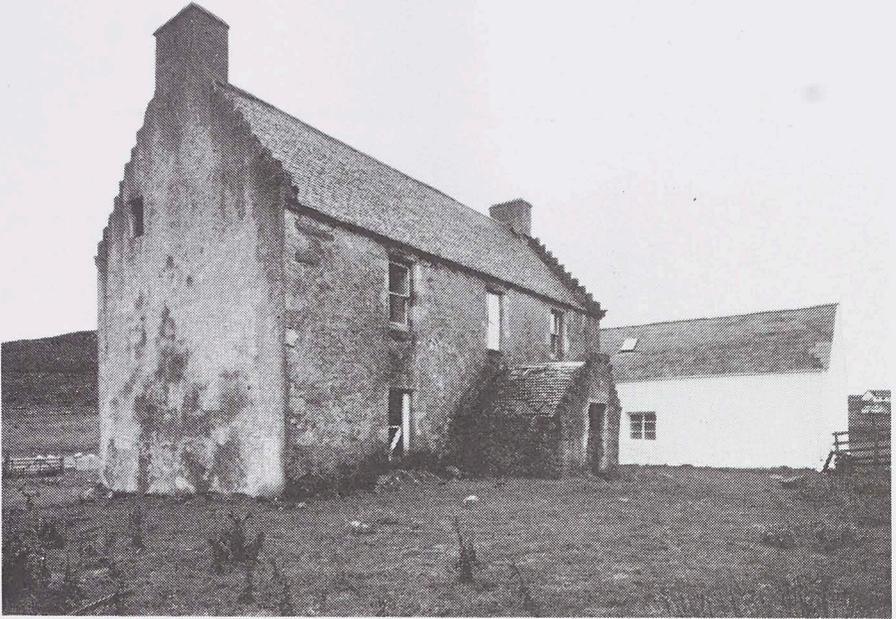
figure 2 View from north-east, before restoration (Crown Copyright: RCAHMS)

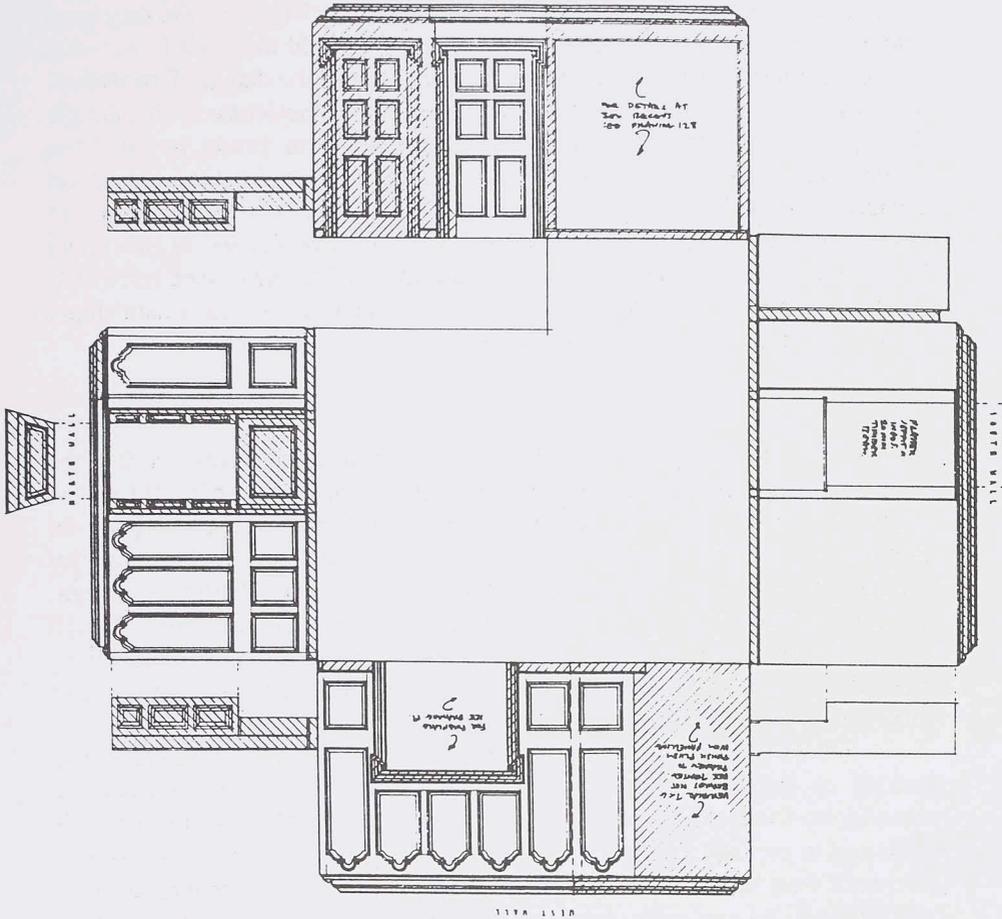
figure 3 First floor, west room - internal elevations. (Simpson and Brown Architects)
 Joinery repaired or restored in 1994 is shown hatched

Udrigle House is most remarkable for the survival of its mid-eighteenth century joinery. The illustrations show this in two panelled rooms on the first floor, and also on the stair, which retains its original moulded timbers (figures 3, 4, 5 and 6). The areas shown with cross hatching indicate where missing joinery was reinstated or severely damaged parts replaced.

The west bedroom has been altered at various times. There may always have been two rooms here with a bedroom to the north and a smaller room to the south reached from the door on the landing to the west of the stair. The extent of the south room is suggested by the boarded area to the south of the panelling on the west wall. It must have been a small room, possibly a closet. By the twentieth century the original partition had been replaced by a new one placed slightly further north. This is indicated on the room elevation drawing by a dotted line on the west wall (figure 3). The later partition was removed in 1993. The door from the landing has been retained in position but has been fixed shut. The door in the north-east corner now leads into a cupboard. The design of this door and the architrave around it is of 1994, based on the adjacent door.

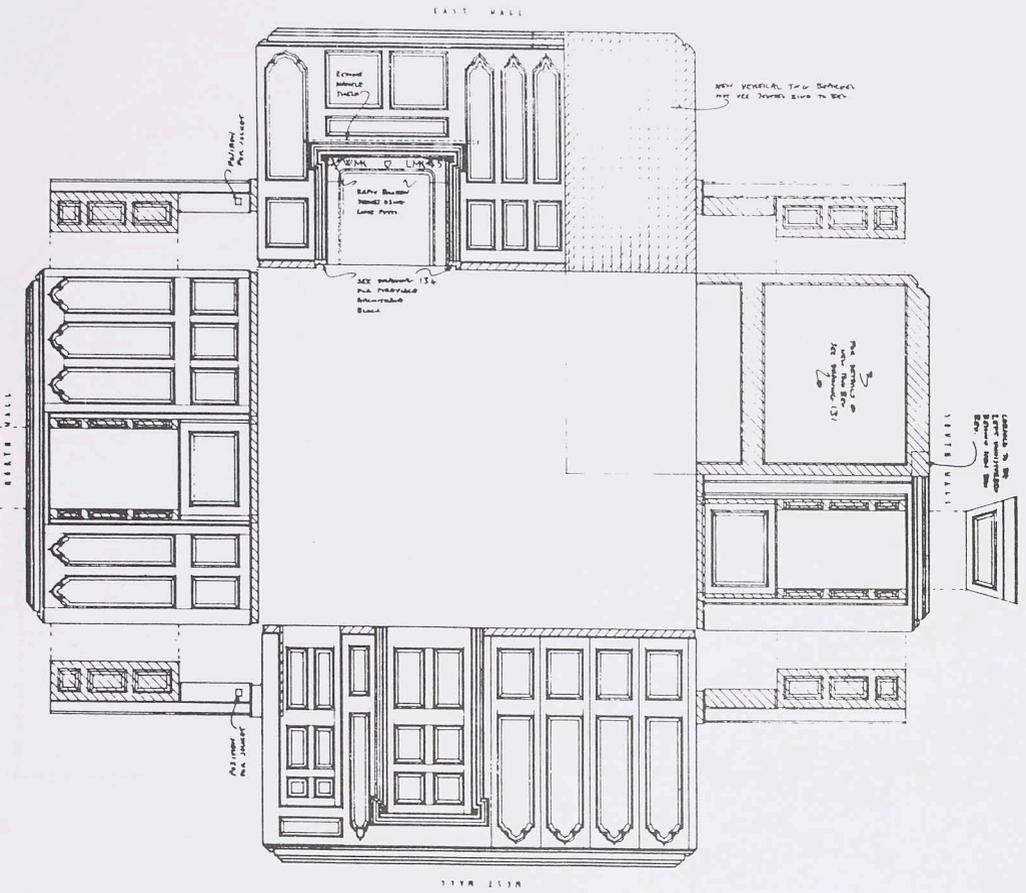
figure 4 First floor, east room - internal elevations. (Simpson and Brown Architects)
 Joinery repaired or restored in 1994 is shown hatched

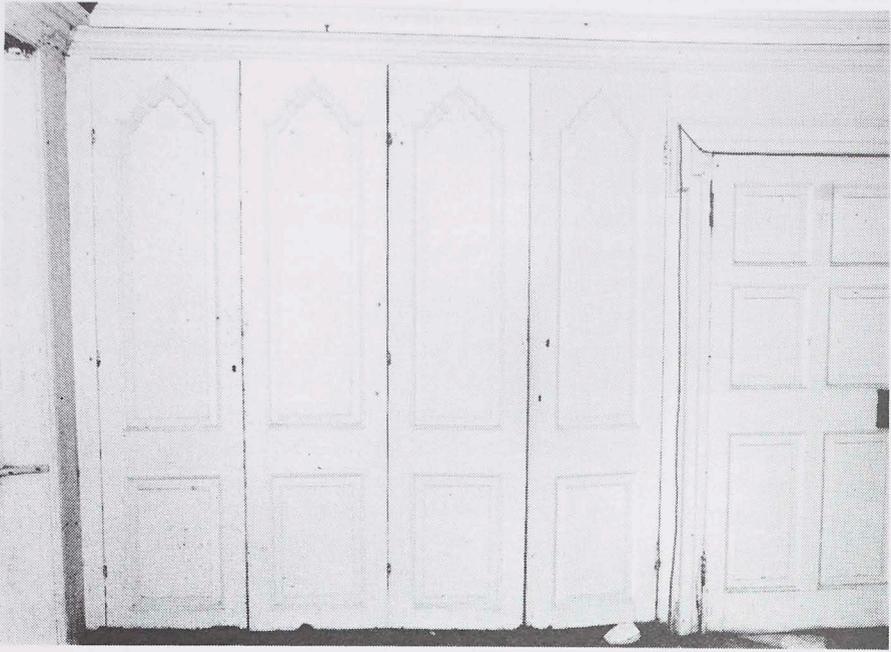
figure 6 View of panelling in first floor east room, before restoration (Crown Copyright: RCAHMS)

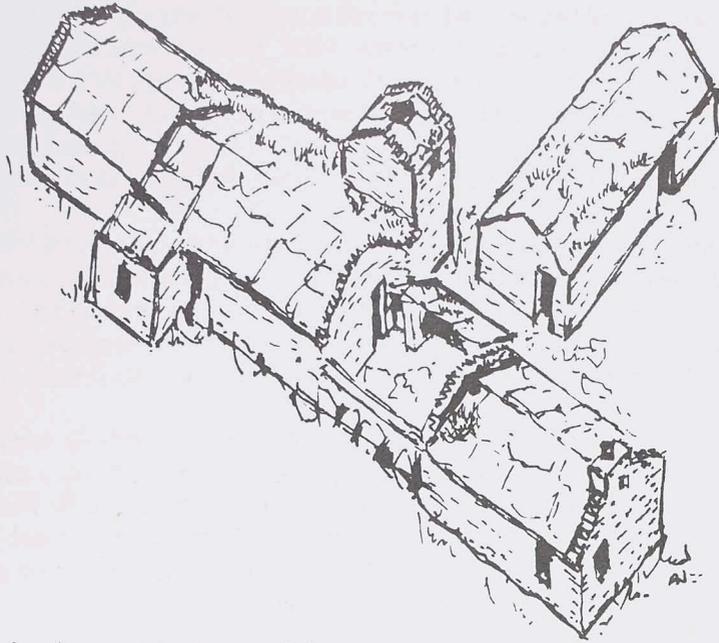
figure 2 Axonometric view, as existing

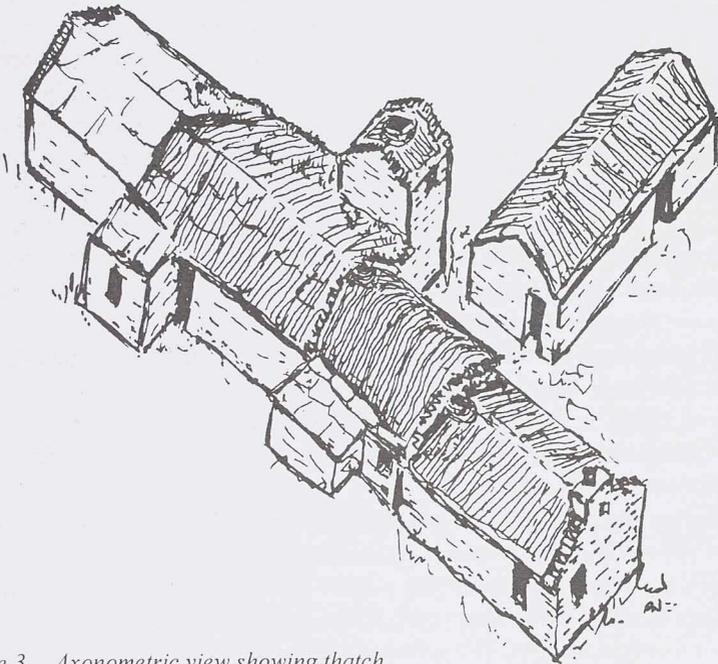
figure 3 Axonometric view showing thatch

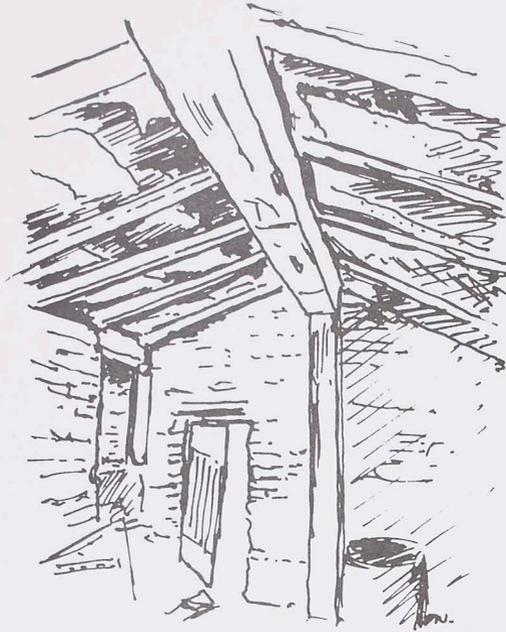
figure 7 Interior of Verracott barn showing maintree and kiln opening on left

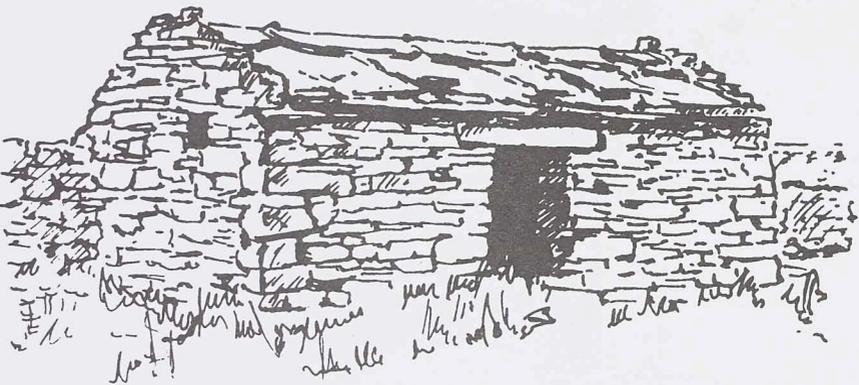
Drawing by Paul Newman based on a photograph by Jocelyn Rendall

In 1995, on another visit to North Ronaldsay, some of the sites were revisited. On this occasion a second wooden lum of the same basic type was found in the derelict dwelling at Verracott (HY758544); we had not been able to see the interior of this dwelling previously. The fireplace is against the gable wall and contained at the sides with flagstone cheeks. As at Viggay, the wooden lum rises from floor to roof.

As can be seen in the illustration, two vertical wooden planks rise from floor to roof, the wood being protected from the fire by two vertical flagstones. The fuel would have been dried cow dung ('scones' in North Ronaldsay) or imported peat. Horizontal boards are nailed to the vertical members to make a flue, which is contained at the back by the stone gable. It will be noted that the horizontal boards do not extend all the way to the roof. It would seem reasonable to assume that the flue would have been enclosed at the top, in which case some of the horizontal boards are missing. It can be seen that the flue is somewhat off the centre of the gable.

It will be noted that there is a substantial ridge beam at the apex of the roof. This dwelling is one of those Ronaldsay buildings with a maintree and rafter roof rather than the typical Orcadian coupled roof². The smoke hole is to one side of the maintree.

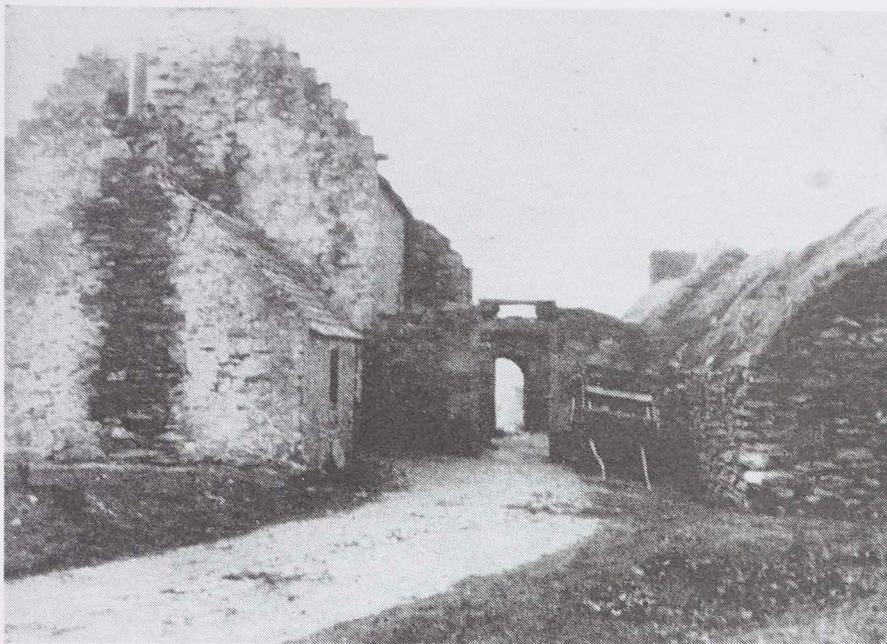
figure 1 Old Haa of Brough, Burravoe, Yell. An early Haa, from 1672, of two rather low storeys, with crow-stepped gables. Built for Robert Tyrie, his initials and 1782 are on the armorial panel above the round headed arched gateway, the only remains of the former courtyard. (Photograph - Barbara Garriock)

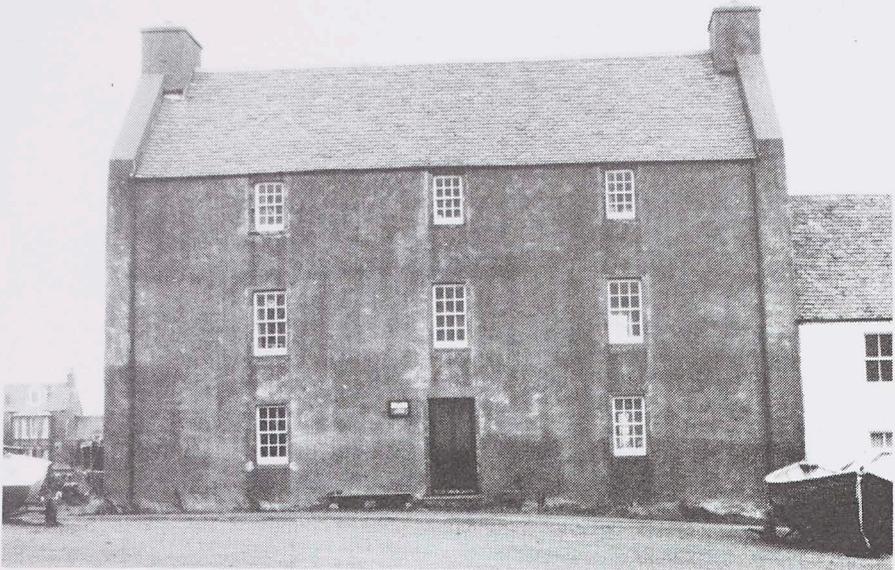
figure 5 Bayhall, Walls, West Mainland. Built c.1750, this tall three storey Haa, three bays wide, was rescued from decay, and converted into flats in 1978. Note the larger windows to the first floor principal rooms. A fine Haa from the period when the Haa reached its most developed form. Residence of the Henrys of Bayhall.

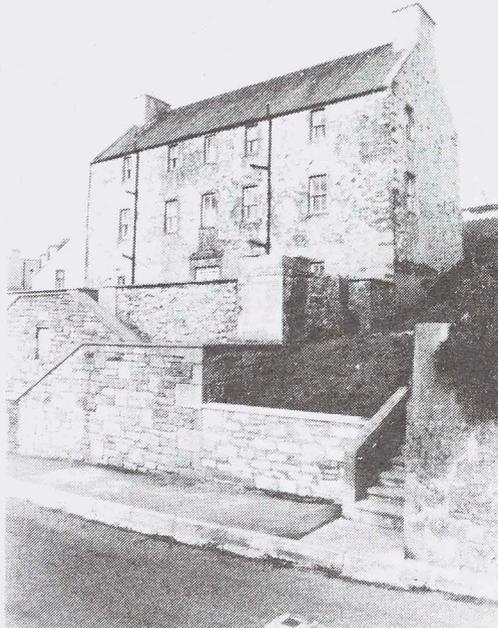
figure 6 Old Haa of Scalloway. One of Shetland's most impressive Haas, almost identical to the contemporary Haa of Sand (West Mainland) (figure 7). Three storey, five bay grouped 1/3/1. Stairs to the front not contemporary, but include dressed stone from a former gateway. Armorial panel commemorating the 1750 marriage of James Scott to Katherine Sinclair, heiress of estates in Scalloway and Burra (Houss), over entrance doorway with shouldered architrave. Converted to flats and in poor condition.

The decay of many of Shetland's Haas started last century. The changing fortunes of the owners contributed to their downfall. The fishing industry changed from open boats sailing from remote beaches to larger boats concentrated at larger, fewer harbours. Lairds' fortunes changed from rural trade dependant on their tenants, to commerce increasingly centralised in Lerwick. The harsh treatment of tenants, their labour exchanged for goods in advance (the notorious truck system) is ingrained into the memories of the Shetlander, and there has in many cases been little fondness for the Haas of the former lairds. The last fifteen years has seen some saved as museums - the Böd of Gremista (Lerwick), eighteenth century; Tangwick Haa (North Mainland) seventeenth or eighteenth century; The Old Haa of Brough (Burravoe, Yell) 1672 (figure 2). Bayhall (Walls, West Mainland), c.1750, survives, converted to flats (figure 5). Some continue their lives as hotels - Burrastow House, (Walls, West Mainland), 1759 (figure 10), while the fortunes of others have reduced them to agricultural stores - Midbrake (Yell), c.1735, and a number remain as private houses. Most of the decayed Haas are past saving, as either dereliction is too far advanced, or because their location excludes them from having an economic future. A few examples are in danger of continuing decay, including the prominent and important example of the Old Haa of Scalloway, c.1750 (figure 6).

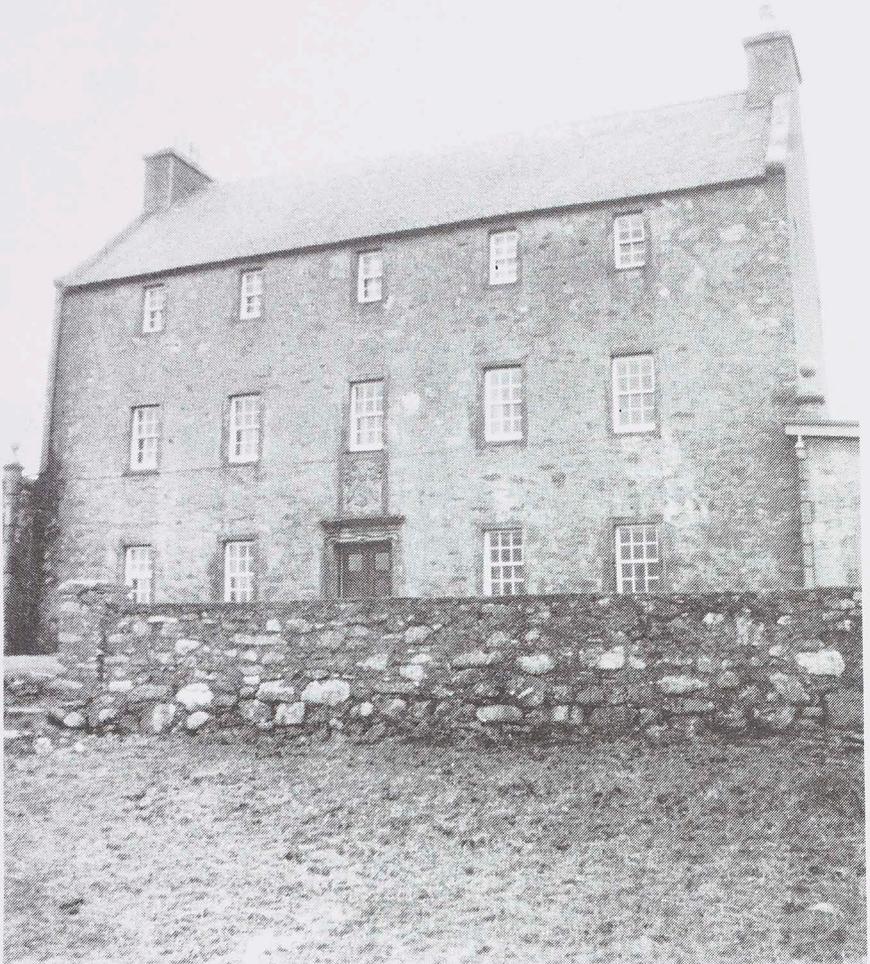
figure 7 *The Haa of Sand, West Mainland. Perhaps the ultimate development of the Shetland Haa, dating from 1754. A tall three storey, five bay wide Haa. The entrance door has a shouldered architrave with an armorial panel above it. Symmetrical single storey wings at either side of the Haa (now altered) each have a ball capped apex. The principal rooms on the first floor are indicated by their large windows; smaller windows serve the second floor bedrooms. All first and second floor rooms retain their fielded panelling with arcaded panelling in the drawing room. Almost unaltered internally other than the ground floor where the staircase has been turned and the entrance hall enlarged. The Haa was built as a summerhouse by Sir Andrew Mitchell of Westshore (Scalloway) who was given leave by the Earl of Morton to remove from Scalloway Castle 'dressed freestones torn from their place to supply door and window jambs and lintels, and cornerstones for this mansion'³. Two complete doorways from the castle lead into the walled policies.*

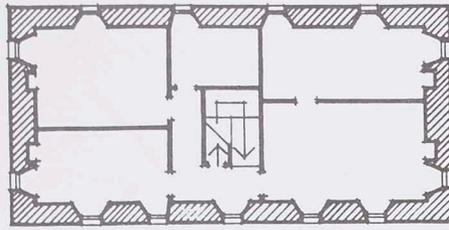
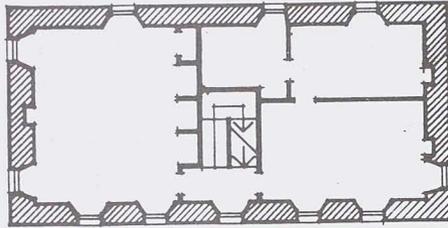
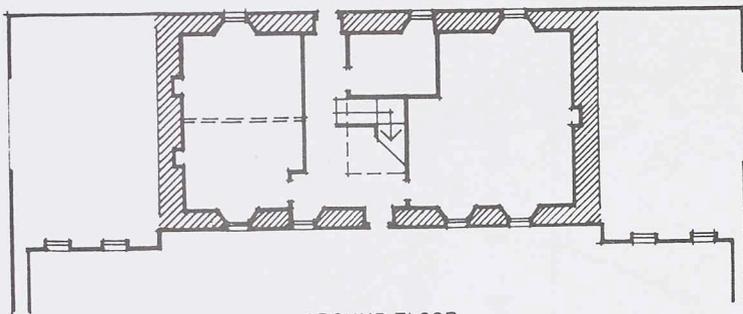
figure 8 The Haa of Sand, West Mainland. The drawings reproduced here show the thick walls, thin timber internal partitions and the formality of the east elevation with its flanking wings. This Haa is a remarkable survivor, having seen few alterations over the years. These plans are indicative only and not wholly accurate.

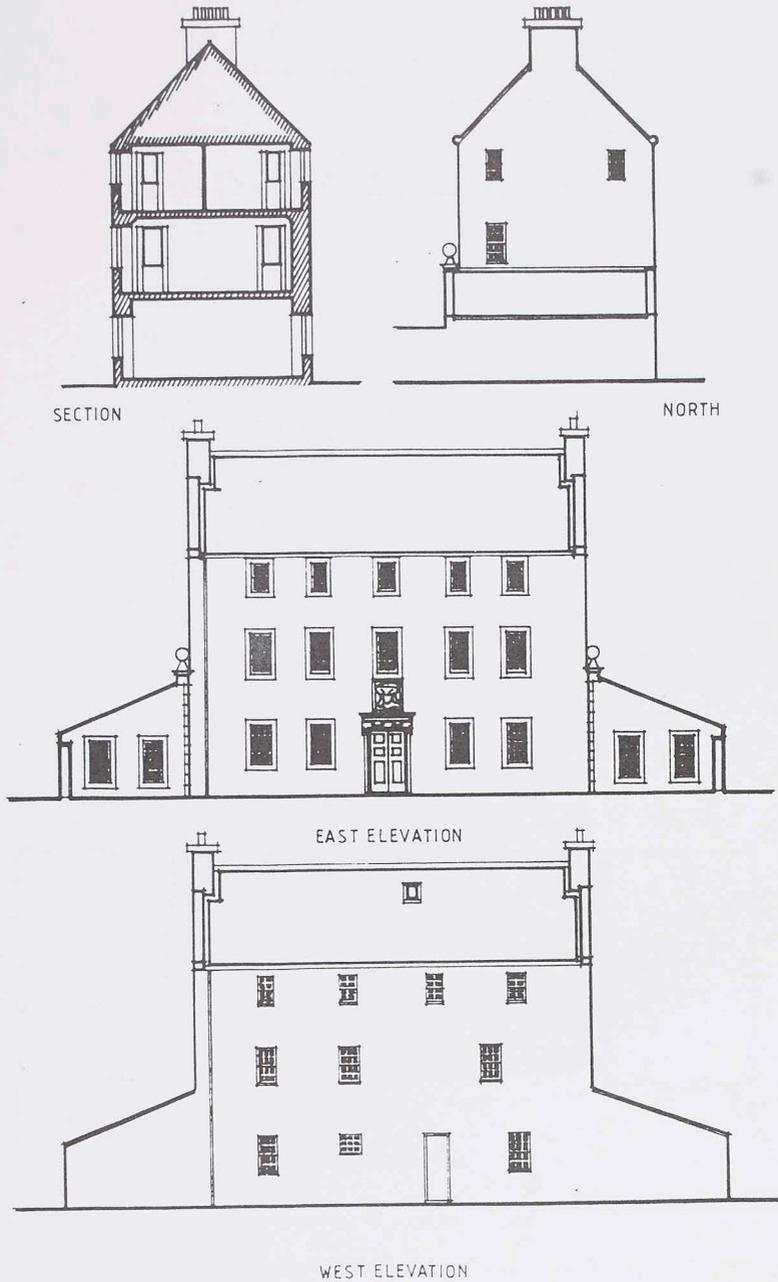
figure 9 The Haa of Sand, West Mainland (as figure 8)

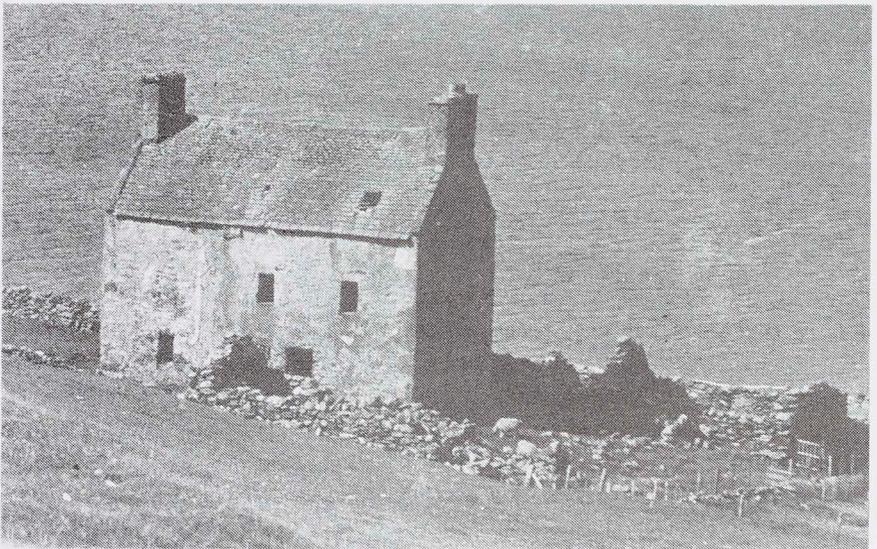
figure 13 The Haa, Grobsness, West Mainland. Two storey and garret, three bay. A typical merchant's Haa, c. 1800, on an elevated site overlooking a former fishing station. The beach is stony and has a flat area above high water indicating its use as a fish drying beach. There are other ruinous buildings around the Haa and on the beach. The walls remain, but the roof which had stone slates, held in place by large iron nails, has collapsed. (Photograph - Shetland Museum)

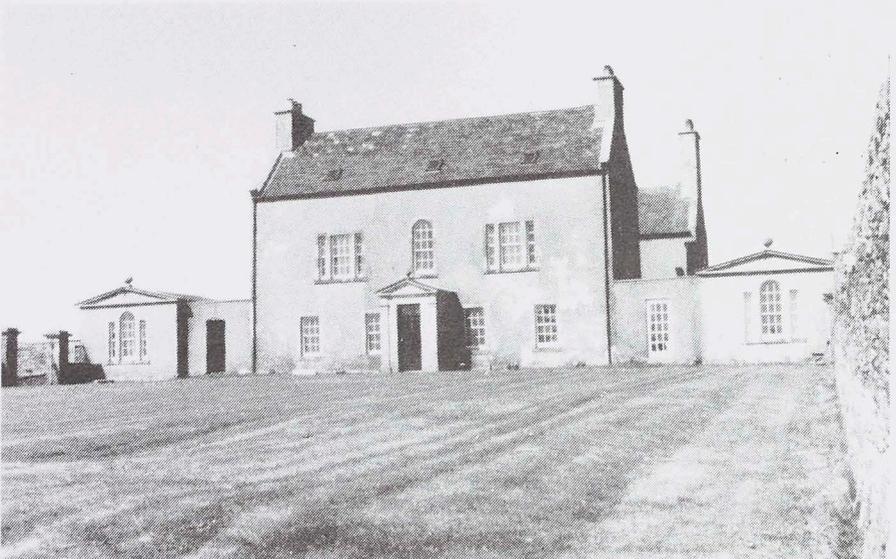
figure 15 North Haa, West Sandwick, Yell. The classical features on the frontage of this large double pile Haa date from a remodelling in 1829. The Haa itself is said to date from the seventeenth century with the front block added c.1770. The four smaller windows on the ground floor indicate that this was probably a five bay wide Haa before the remodelling.

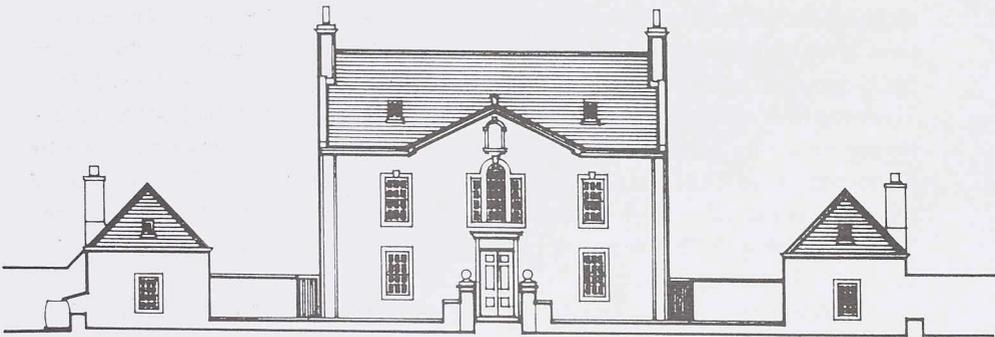
figure 1 Drawing of proposed front elevation of Belmont House

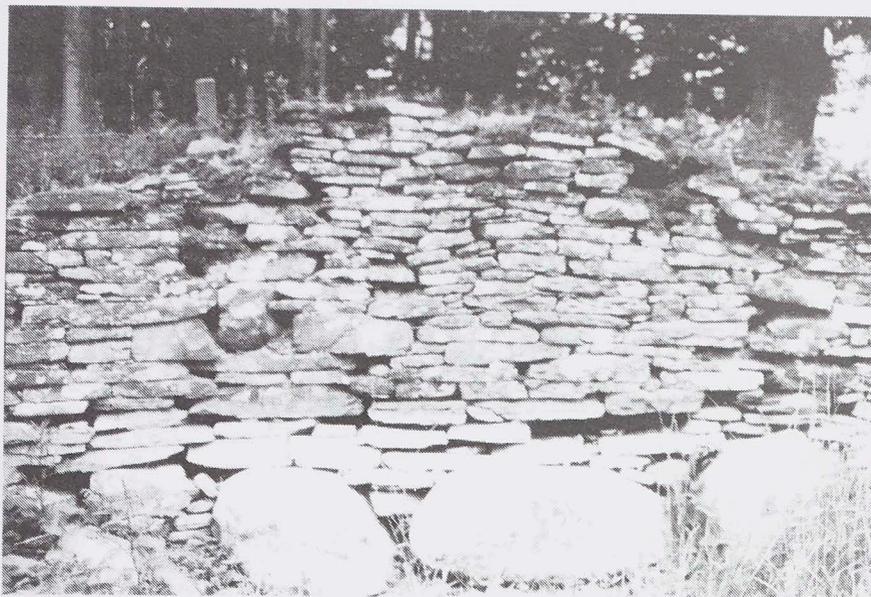
Mudstone slaits in a field dyke at Gallowhill, Lecropt (NS783984).

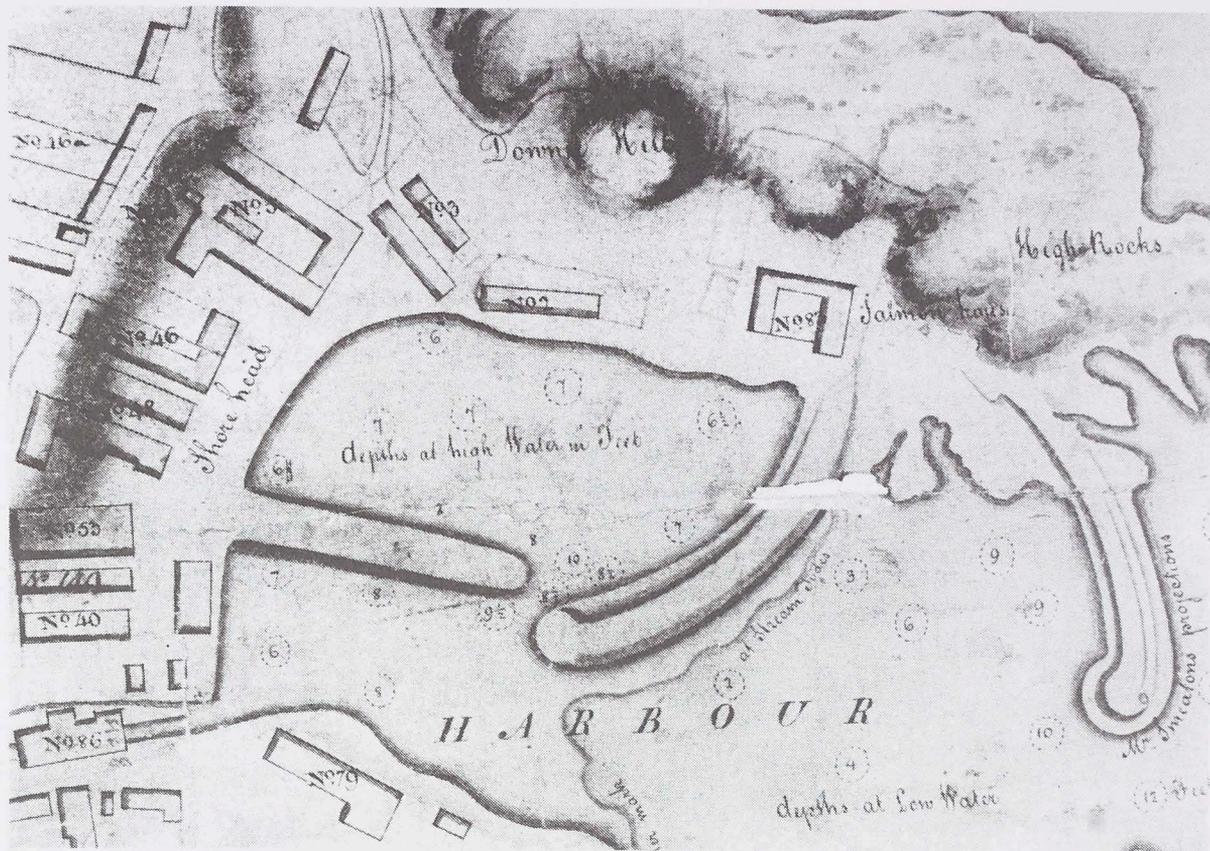
figure 3 Feuing plan of Portsoy by Robert Johnston, Land Surveyor, 1802. SRO RHP12889. Reproduced by permission of Scottish Record Office.

The 1802 feuing plan reveals ground plans of long rectangular or L-shaped buildings crowded by the quayside, some of which are known to be warehouses; others can be assumed to have served that role. There is a post-1802 pencilled rectangle probably indicating another storehouse; subsequent conversion to, or replacement by, housing may disguise others. In 1996, four warehouses survive, forming a most remarkable group - perhaps the most remarkable group of eighteenth century harbourside storehouses in Scotland¹⁰. The salmon house (figure 3, feu no. 83) has gone, superseded in 1834 by a new building east of the

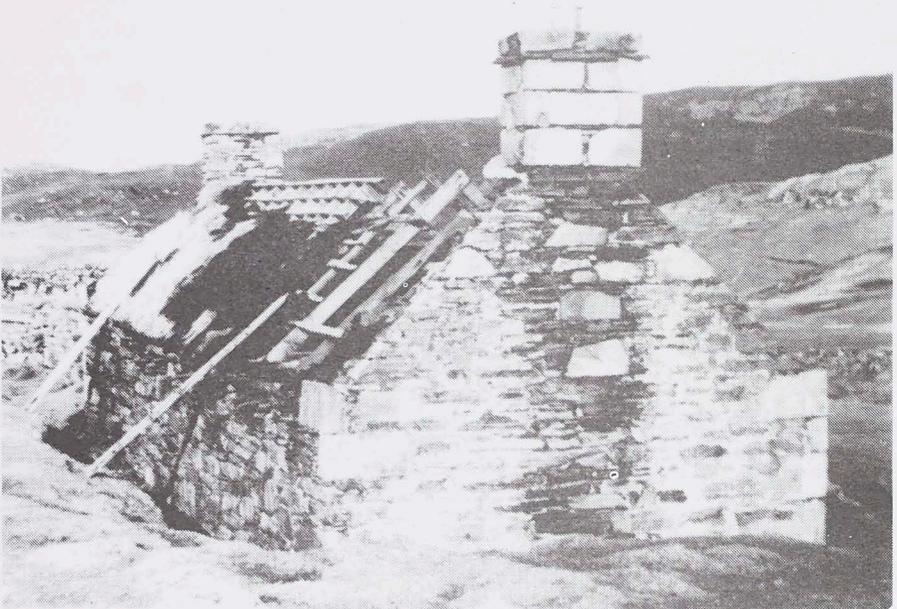
figure 2 Slettill house, showing modern roof trussing and skylight introduced above granary

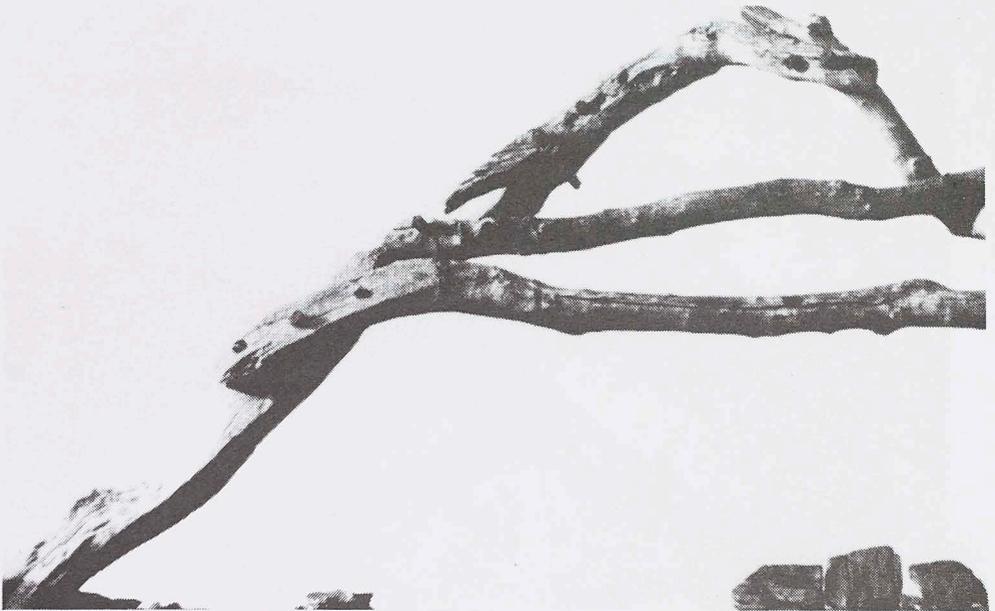
figure 3 Slettil, a house in an advanced state of decay, last standing couple

CONSTRUCTION - The sloping members of the cruck were formed from suitable timbers approximately 6 inches in diameter, and of a length to permit

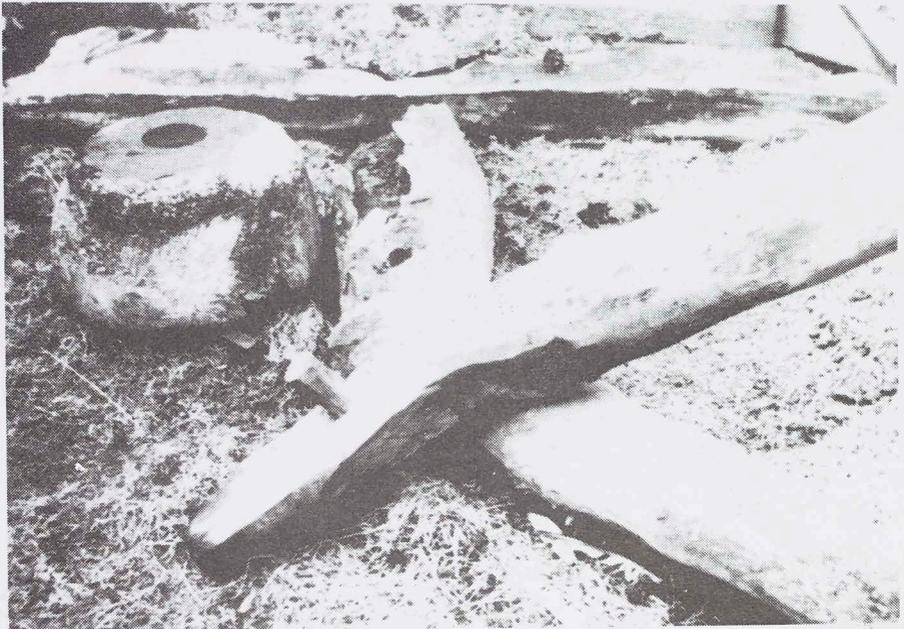
figure 4 Slettil house, byre, with collapsed couple showing tapered peg

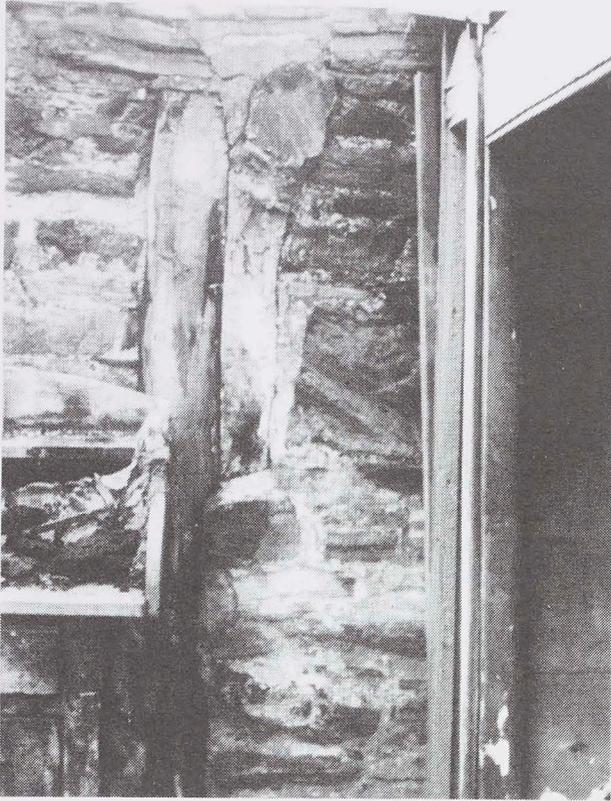
figure 5 Slettil house, original cruck leg and jointing seen to right of dresser. The doorway to the granary is just visible adjoining the boxbed end

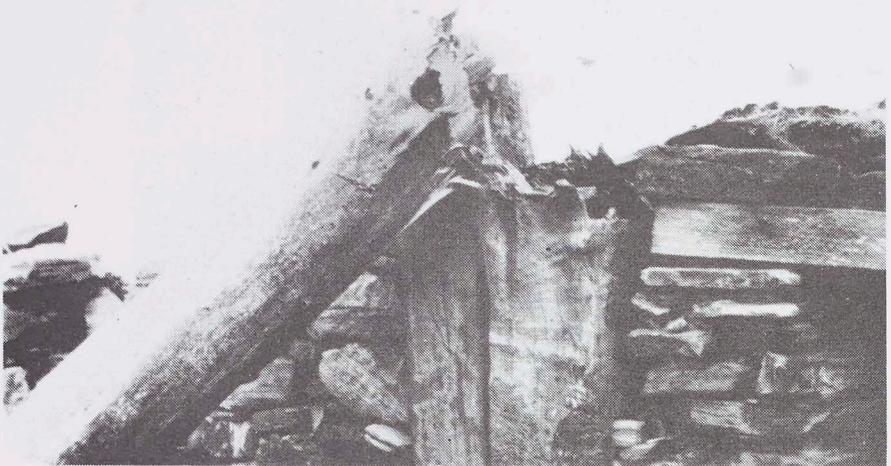
figure 6 Slettil house, cruck frame smashed by gale, and timber window lintel

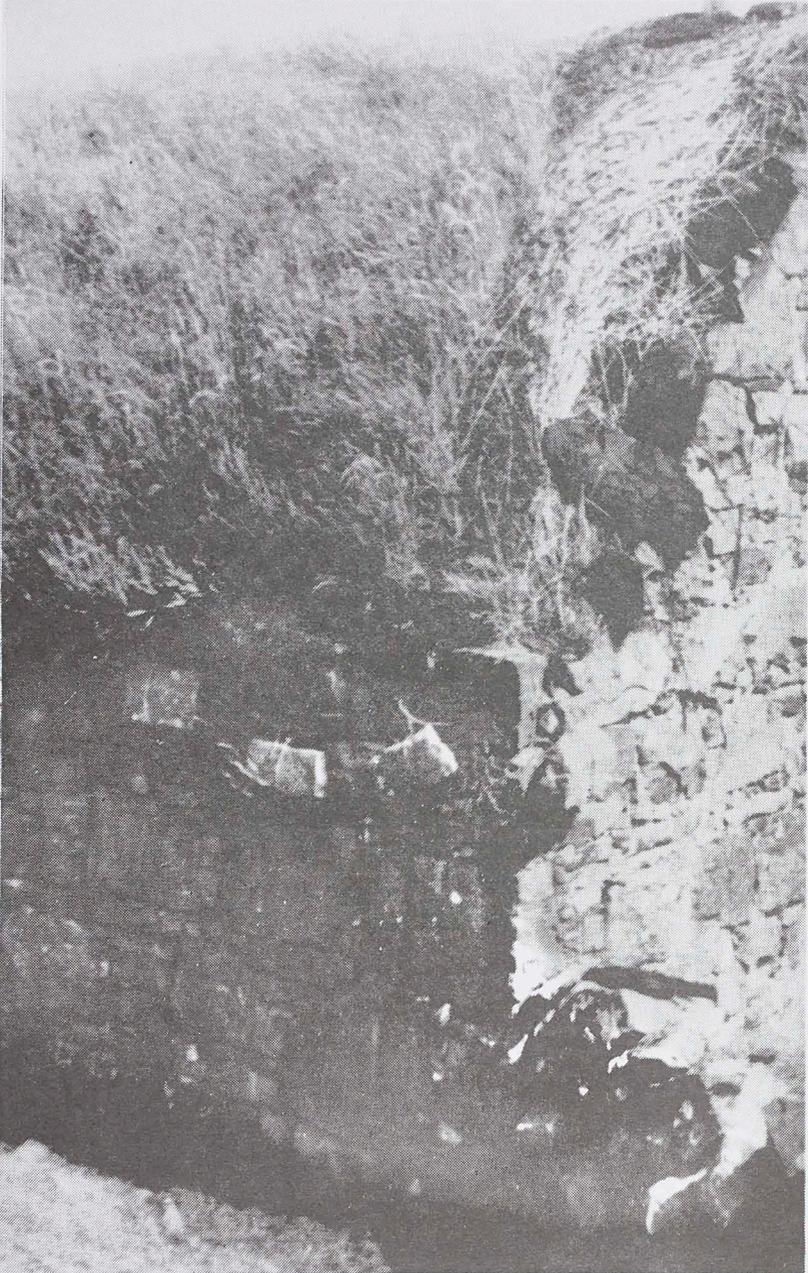
figure 7 Stoer house, showing weighted ropes across roof and thatching pegs

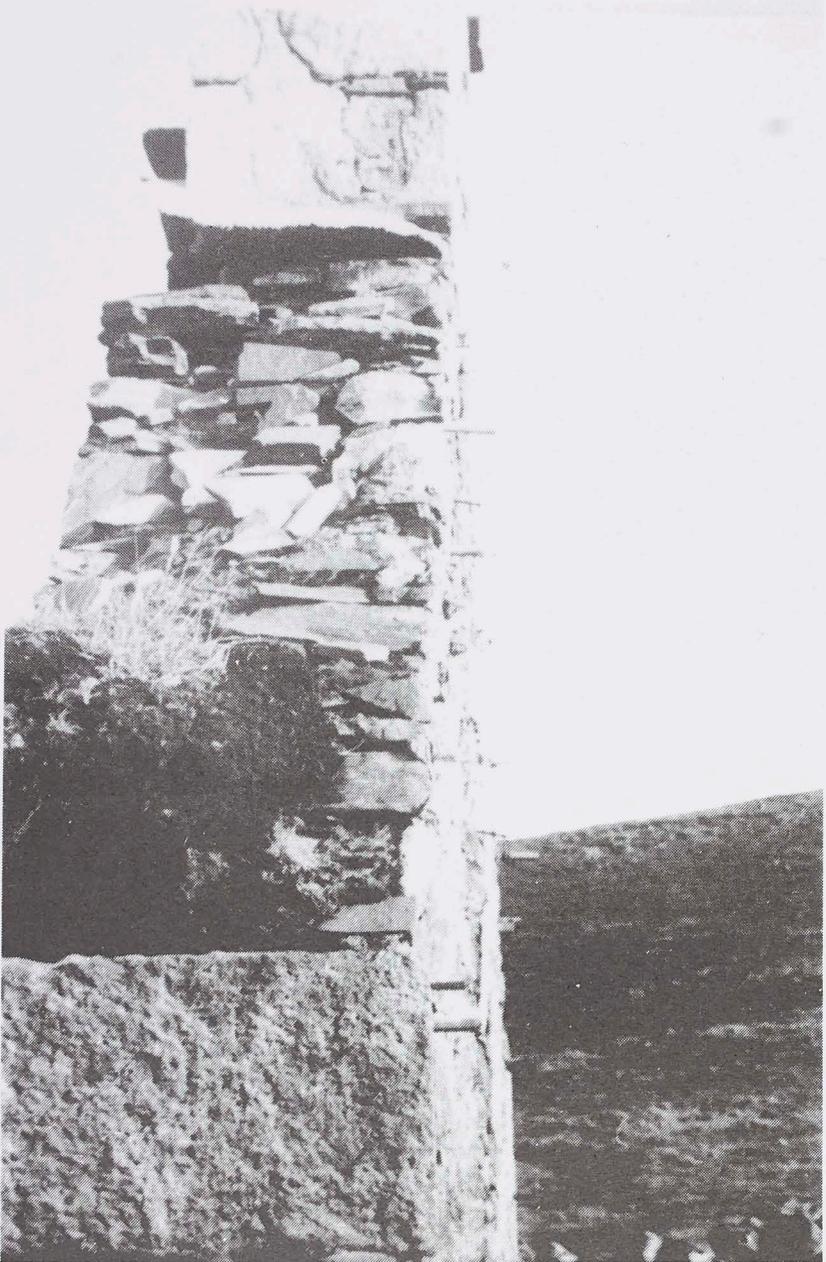
figure 8 Slettil house, showing thatching pegs set into gable to secure horizontal ropes

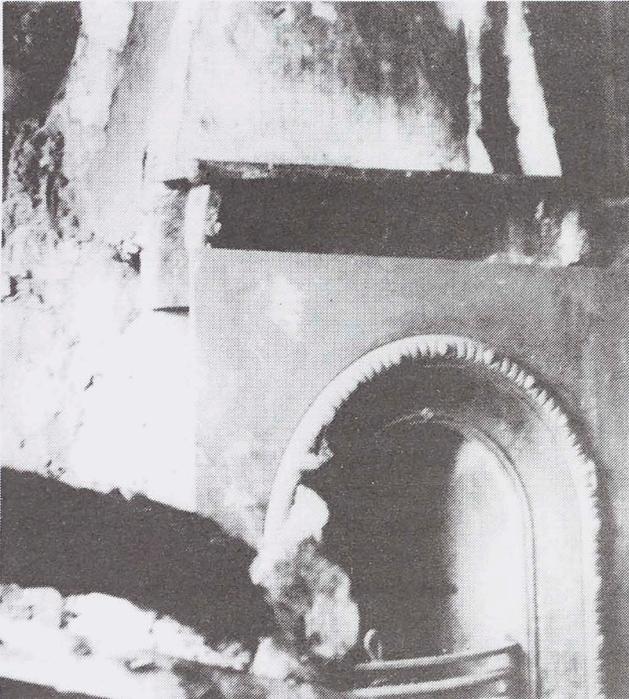
figure 10 Stoer house, interior with hinging lum and grate

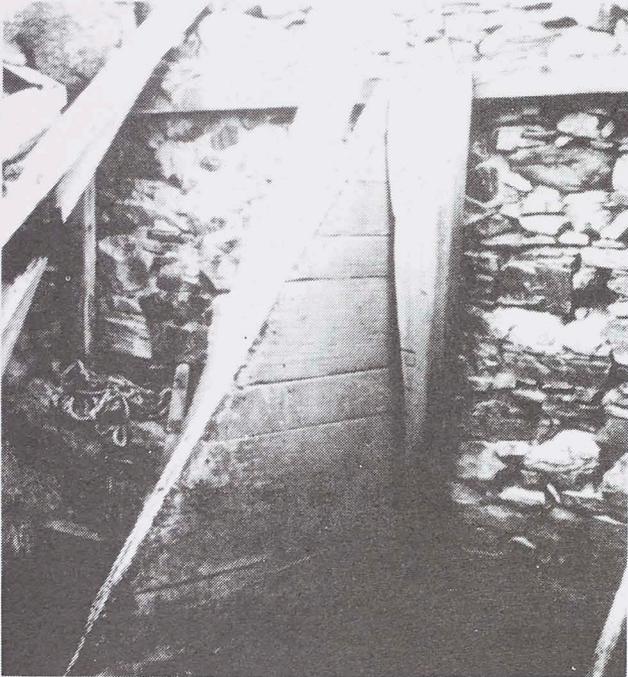
figure 12 Slettil house, byre, with livestock trevises, showing drystone construction

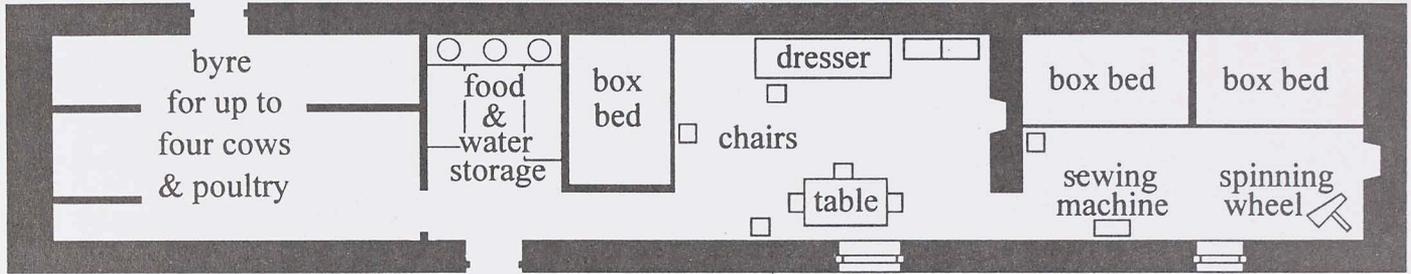
figure 2 Plan based on one by Iain MacRae, not to scale

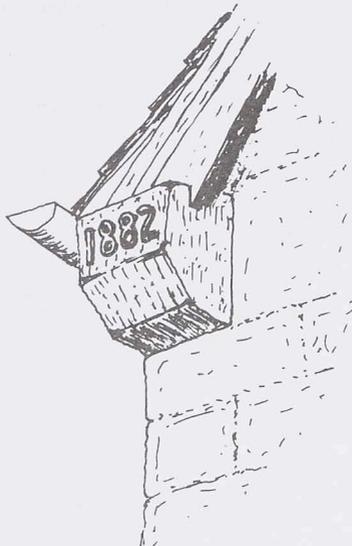
The illustration shows the corbel clasping pageboard with date on the stable leg of the steading at West Shinnes, Lairg, Sutherland.
