VERNACULAR BUILDING 26

**Scottish Vernacular Buildings
Working Group**

THATCH TRADITIONS IN ORKNEY FARM BUILDINGS

Elizabeth Beaton

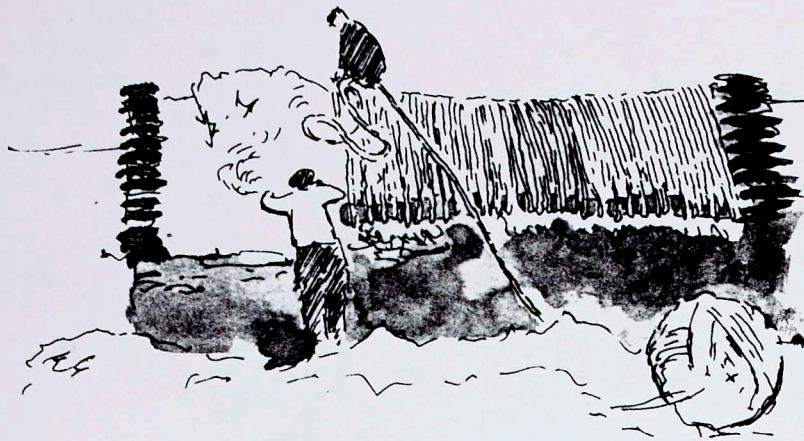
Sketch taken from a photograph in the Royal Scottish Museum Ethnographic Archive showing a roof being rethatched with simmens at Verracott in North Ronaldsay by Willie and Robert Swanney in 1965/6.

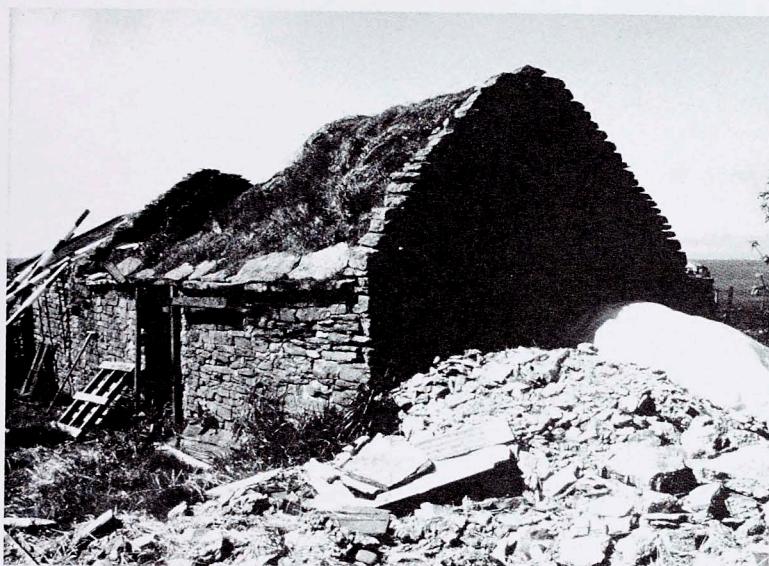
Thatched roof with curved skews and divot base layer at Greens in Toab.

There may have been a tendency for the middle layer of loose thatch to be thickest midway up the slope. Evidence for this are the occasional thatched buildings where the skews are not straight but have a convex curve. In this respect there are some similarities to the rounded thatch profile of traditional buildings in the Western Isles and the west of Eire.

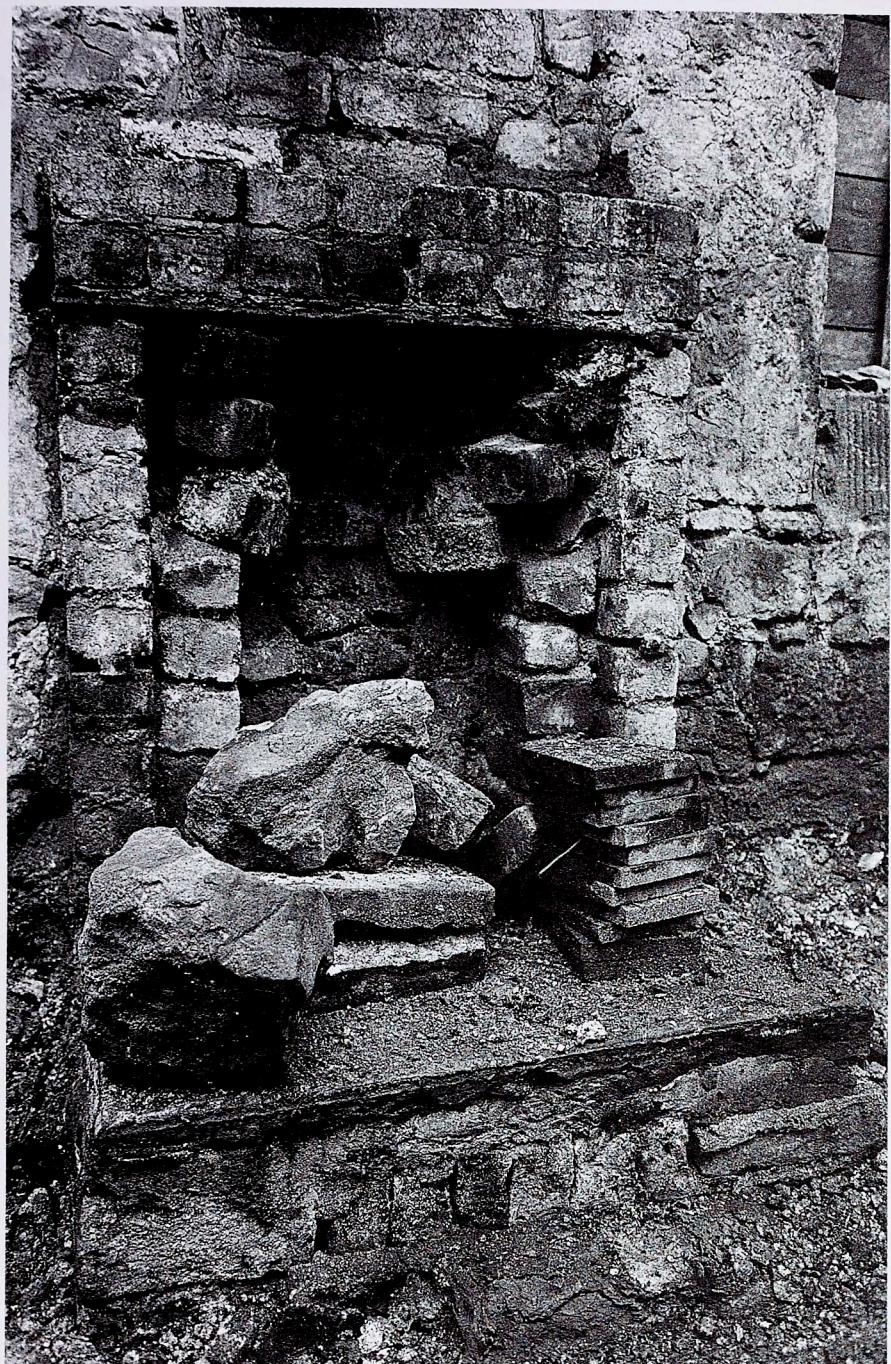
Figure 6 Interior of No. 11, close-up of east wall fireplace at supposed gable.

The need for stonework for the internal gable at the west side of the fireplace was avoided by the installation of presses or cupboards which served both No. 11 and No. 9 (Fig. 17). According to the ceiling scars in No. 11, there was a separate room at the back, with a fireplace (Figs. 6, 7, 25)

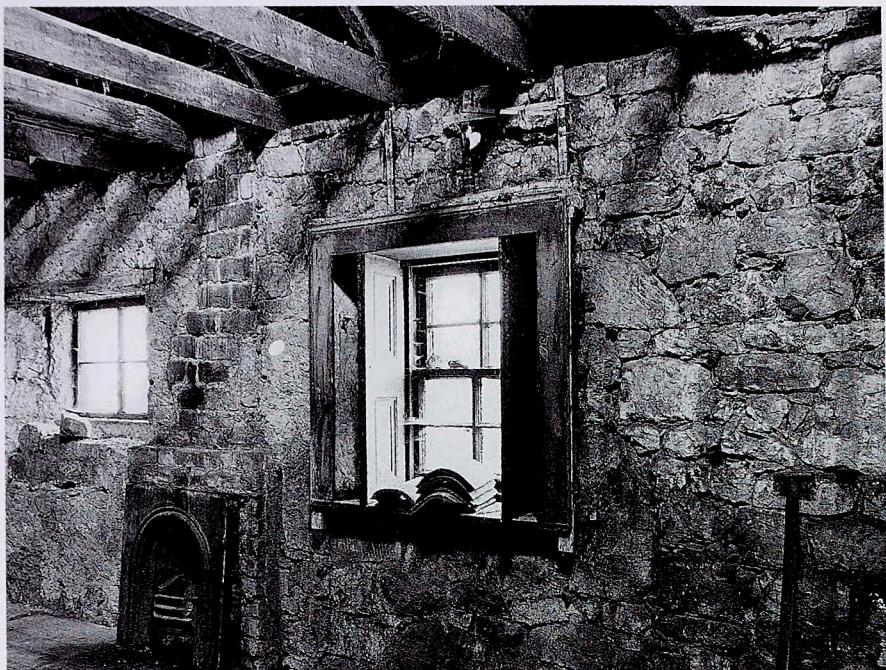
Figure 7 *Interior of No. 11, showing general view of the east wall fireplace.*

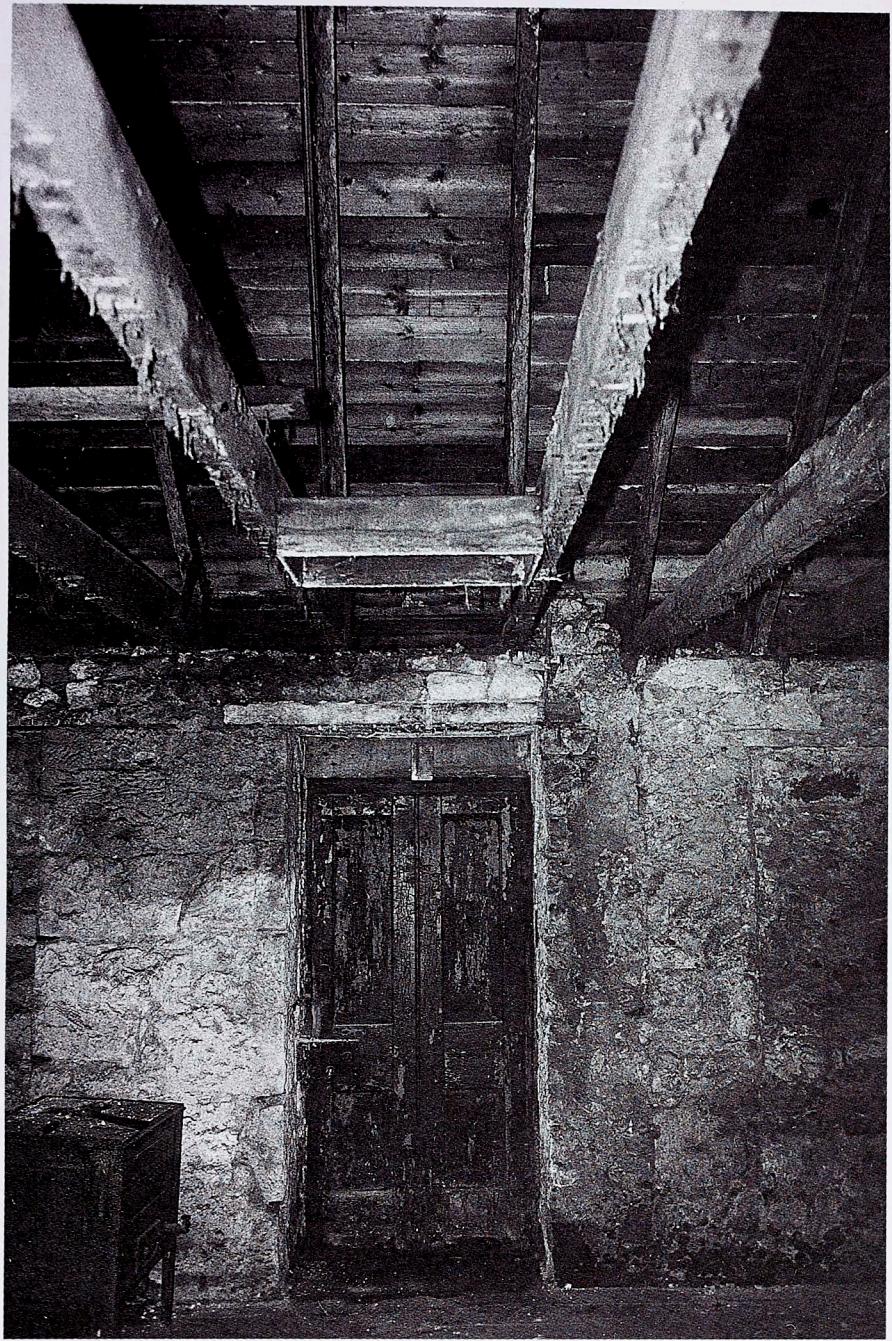
Figure 8 Interior of No. 11, west wall and door, with (to the right) evidence of gable material between the rafters, and vertical line suggesting some sort of change in the west wall.

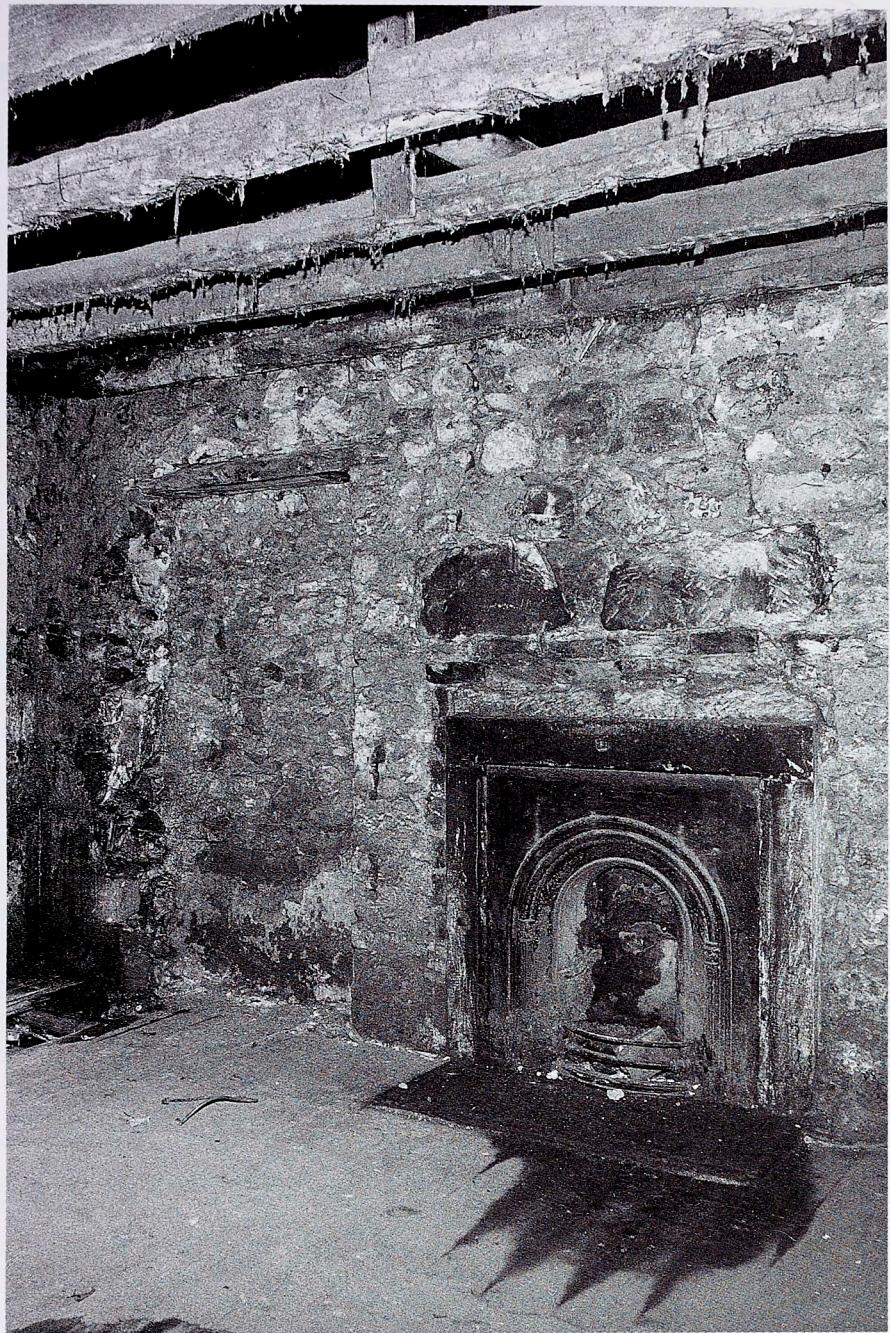
Figure 11 Interior of No. 11, showing north gable fireplace; note the larger space filled-in with bricks and the keystone arrangement above the Victorian fireplace lintel.

The fireplace in the north gable (Fig. 11) was probably once larger than the 'Victorian' one in the photograph. It could well have been an open hole with a swee above a floor-level hearth. Note the bricks down the left-hand side and the two courses above the late-Victorian lintel. Above this, two large stones are held in place by a key-stone in the middle. The original fireplace might have had a heavy beam in place of the courses of brick underneath the key-stone arrangement. There is evidence on the lower parts of the walls that the plaster was put straight onto the walls in this earlier building, with no lathes being used.

Further study of Figure 11 shows a distinct location of the chimney vent from its hearth to the chimney brace. Could this indicate that the builders of the extension who ragged out the space for a chimney vent in the east wall

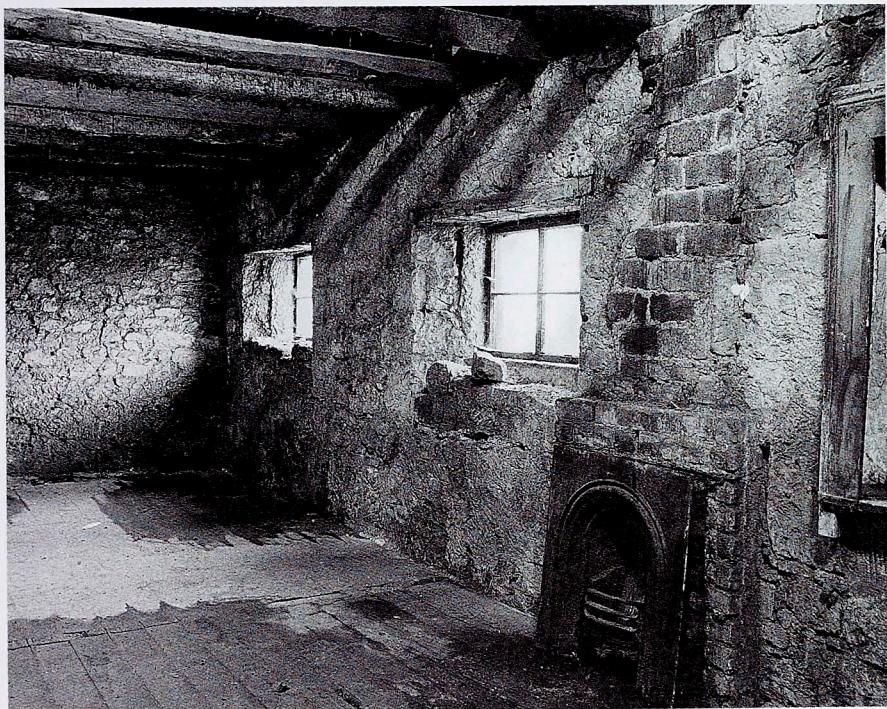
Figure 12 Interior of No. 11, showing back (east)-facing windows before loose material and stonework was removed from the sills.

Probably the most fascinating aspect of No. 11 is the pattern of the interior windowsills. When the building was taken over, the back (east) windows were intact as far as the view from outside was concerned. Inside, they had been obliterated by being boarded up with lathe and plaster to create an unbroken surface (probably at the time of the extension of the building; see below). When this covering was removed, the four-pane lights had, as expected, the usual windowsill (Fig. 12). However, these sills were made up of very loose material, which it was decided should be removed. Beneath, in each case, was a stepped-up window ledge with the plaster still in place.

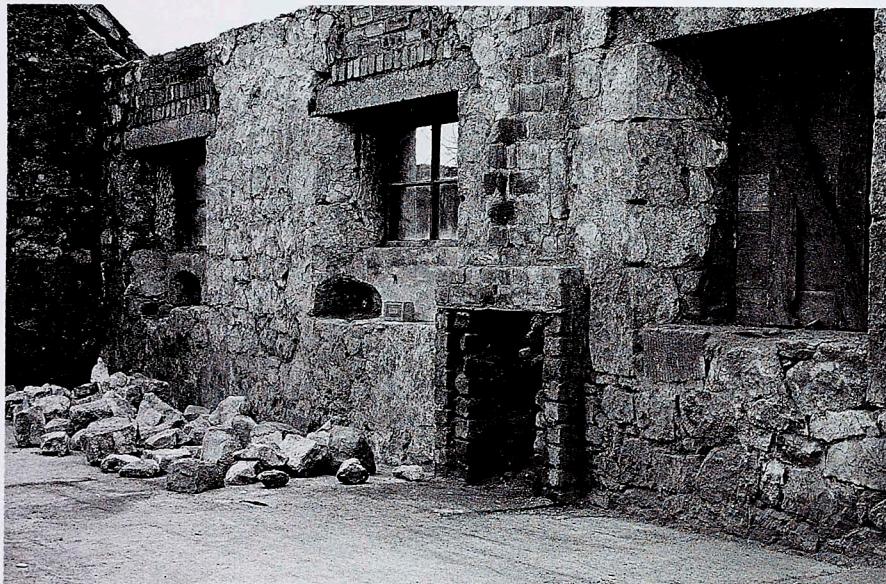
Figure 13 Interior of No. 11, showing sills of east-facing windows now cleared of loose material, revealing original stepped sills with niches.

More intriguingly, there was a niche at the left-hand corner of the lower part of each sill with plaster following the contours (Fig. 13). Similarly, the four-paned light in the front (west) wall (which had been blocked up; see

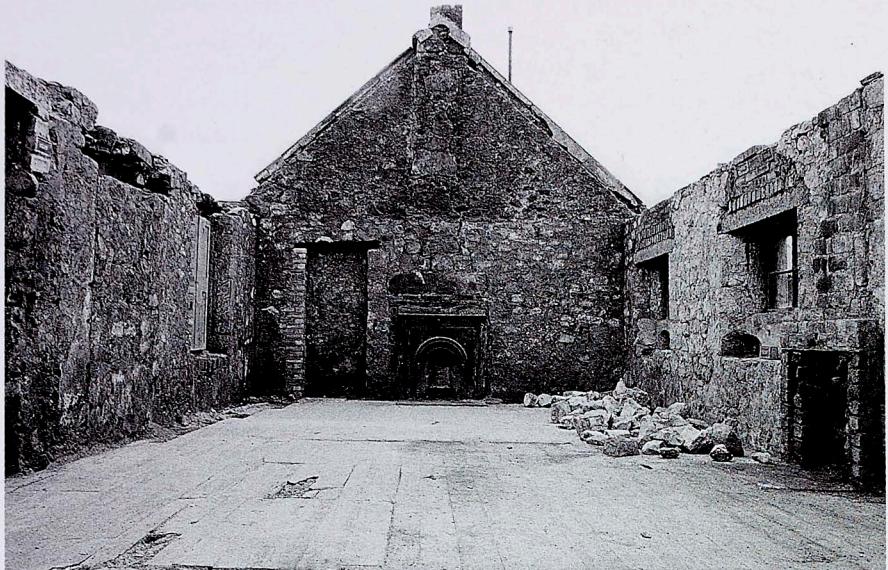
Figure 14 *Interior of No. 11, looking toward north gable, showing rough masonry and a blocked up window in the western wall (left).*

Fig. 14) when cleaned out was also found to have a stepped sill with niche and plaster work intact. No doubt the fourth window, at the front, also had all these characteristics. In the restoration, this stepped design and niche were retained as a feature of the three remaining original windows.

As the front was to have sash and case windows, the two small, square lights in the original building were blocked up. However, one sash and case was positioned partially where one of the four-pane lights had been, and there is telltale evidence of what was formerly there (Figs 14, 20).

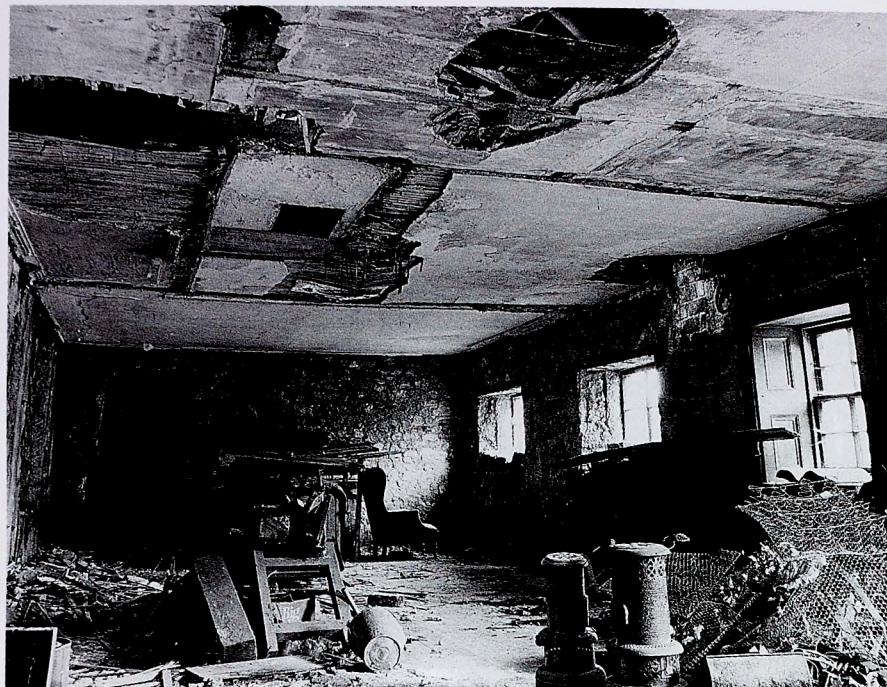
Figure 15 Interior pre-restoration, looking north; note ceiling scars delineating the lobby and room arrangement after the enlargement of the building.
