VERNACULAR BUILDING 27

Scottish Vernacular Buildings Working Group

2003

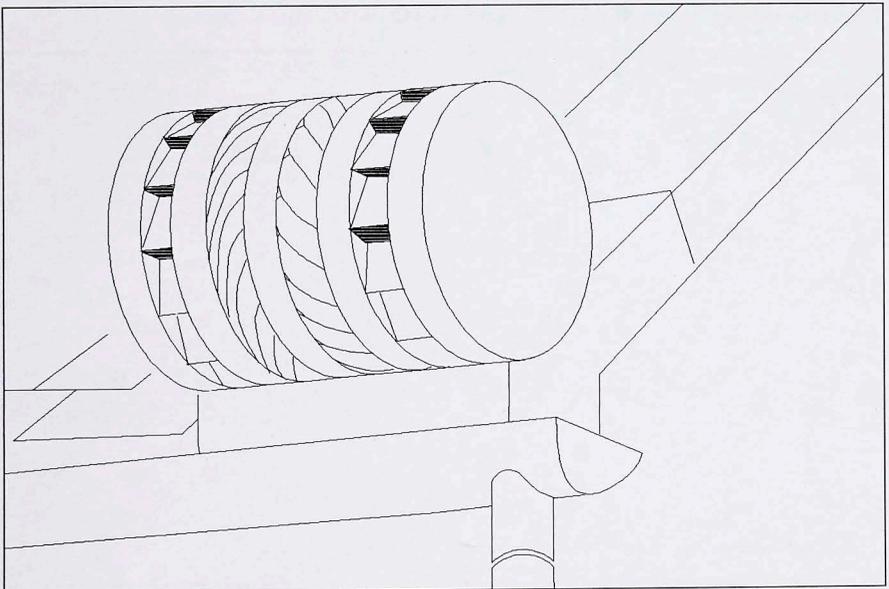
Cromarty Town is very rich in scroll skewputts, many of which appear to illustrate pairs of ropes in pulley grooves combined with one or two ratchet wheels. The one I have selected to sketch is at Cromarty Antiques in Church Street and has two ratchet wheels at the ends and two ropes inboard, the most common arrangement. On Stornoway House in Shore Street the ropes are outboard with a single ratchet wheel at the centre. Elsewhere is a pulley block with four ropes but no ratchet. The flat ends of the skewputts are sometimes plain and sometimes decorated with a scroll.

The ropes and ratchets may be pure ornamentation but I suspect that they represent components from the local 1772 rope works that also made sacking, or possibly some ship's equipment. I have failed to find confirmation of either supposition.

Skewputt at Cromarty Antiques

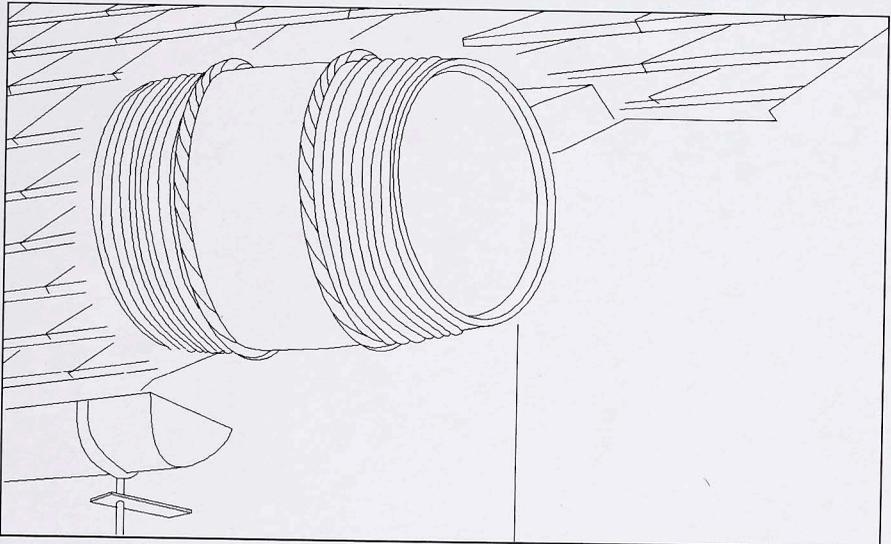
The ends of the barrel are shown bound with strips of wood called 'wattle' instead of the iron hoops that later became universal. Examples of both types are displayed by Wick Heritage. The two large diameter ropes may represent the ropes used to control barrels being lowered down an incline (for example beer barrels being rolled down into a pub cellar).

Parts of the house complex date from mid-18th century but an older two-storey house is now abandoned, and the barrel skewputt decorates what appears to be a later house. A still later wing overlaps the corner where a matching skewputt would be expected, and may entomb that skewputt. It is probable also that the gable was topped by a skew above the skewputt and that the skew has since been replaced by the present verge.

Skewputt at Lybster Mains

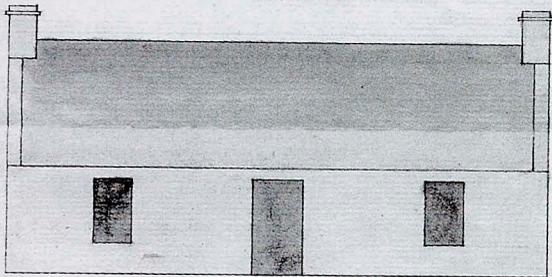
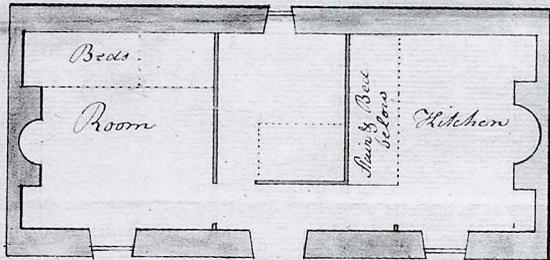
*Plan of the Millers House
Designed at Mountcoffer
1808*

The 'Plan of the Millers House Designed at Mountcoffer (*sic*), 1808' illustrates a conventional single-storey cottage of three bays, with centre entrance flanked by single windows, tiled roof (coloured red on drawing) and end chimney stacks. The cottage measures 38ft x 19ft (11.58m x 5.79m), the accommodation consisting of the usual (for the time) two rooms separated by a small room (sometimes called a *press room*) lit by a little

Extends 30 ft

Scale 1/8 of an Inch to the Foot

window in the centre of the rear elevation together with attic space reached by an internal stair. The kitchen is to the right of the entrance and the 'Room' to the left, each with hearth and both with built-in 'box' beds, in the 'Room' two built-in beds against the rear wall, one longer than the other, the shorter probably for a child or children. In the kitchen there is a mural stair against the small middle room wall leading to the attic indicated as 'Stair and Bed below'. There is yet another bed in the middle room, making four in all, 4 feet wide in the centre room and slightly narrower in Kitchen and Room. Access to the attic indicates it provided storage or even additional sleeping quarters. By the standards of the time, the house had generous accommodation for a family.

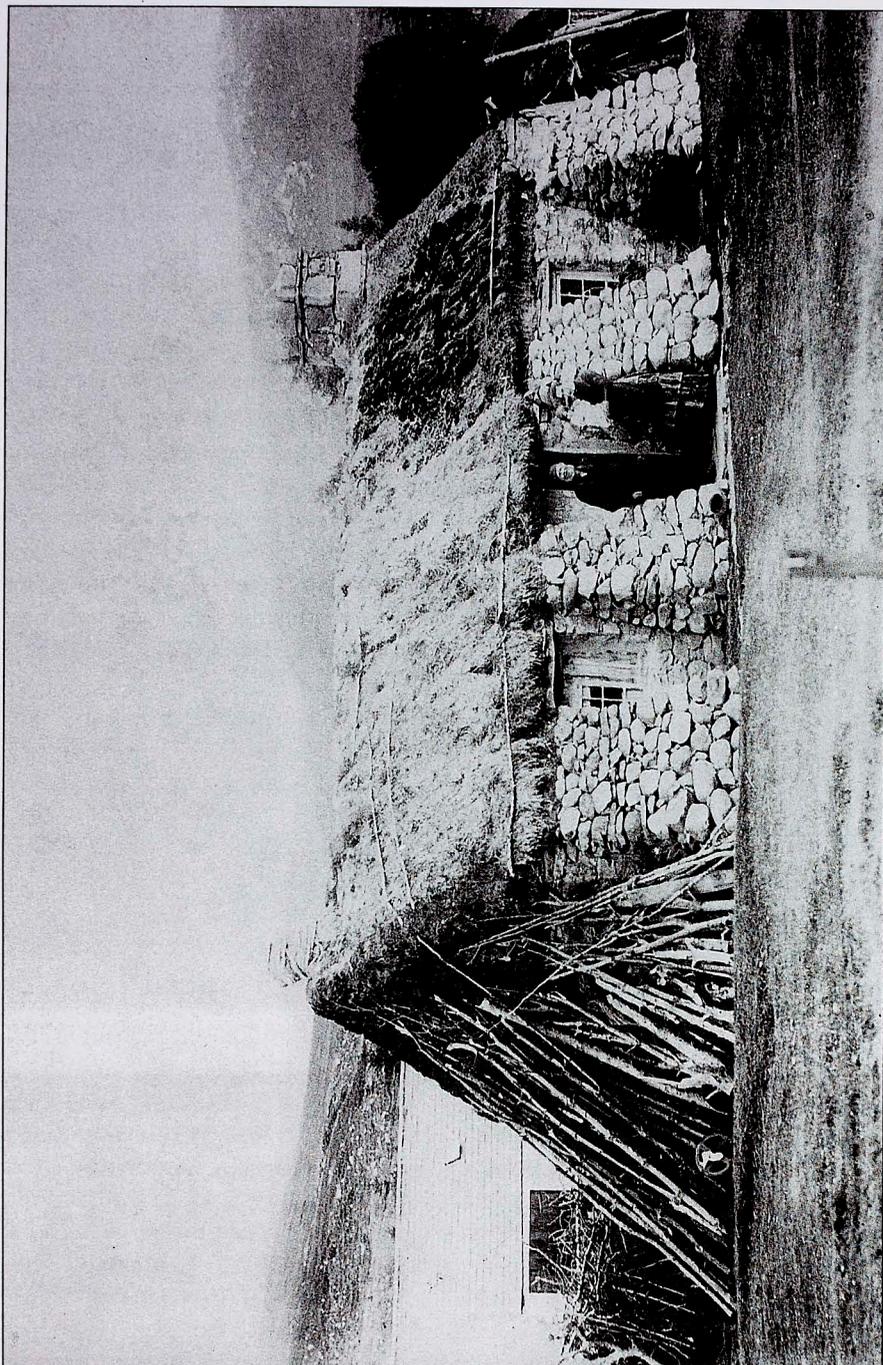
The single-storey, 3-bay cottage has a centre door closed by double-leaf plank doors, serviceable in rough weather for one person can slip in without opening both doors but sufficiently wide when fully open for visitors, a basket of peat to fuel the fire, the meal girnel or to let in sunshine and light during good weather. Four massive dry stone buttresses support the front wall—and maybe at the rear as well. I suspect the need to buttress the splaying walls was caused by various factors such as weak timber tie beams, heavy thatch and damp (the walls are not lime-washed as in Cottage B). The walls are of field boulders with little mortar, almost a drystone technique: the gathering of boulders for construction also helped clear land for cultivation. The wallhead is just higher than the man in the doorway, so nearly 2 metres high (the Imperial 6 foot is likely). These walls are masonry

Farm and cottage A

to wallhead height throughout but the return gables, completed in turf to the apex, are carried up and over the top of the gable wall as turfed skewes to merge with the thatch. The use of turf for gable walling was not unusual in this type of house in the Highlands. We cannot know whether the building is cruck-framed (highland couples) but this and the other dwelling may well be. I noted evidence of mural cruck blade slots and even surviving timbers in the hinterland south of Loch Ness during field work in 1984-5.

The left side of the cottage is the *but* or kitchen end and is served by a *hinging lum*⁷ indicated by the position of the *lum* about 45cm (18") along the ridge from the gable apex, and drawing the smoke upwards from the wooden canopy abutting the interior. The square *lum* is a wooden frame with wooden coping, the frame thatched and bound with ropes. It leans away from the ridge and is in need of repair. The *ben* or best room at the right has a hearth served by a mural flue and masonry chimney. A peat stack is built against this gable and possibly another against the kitchen gable but masked by timber.

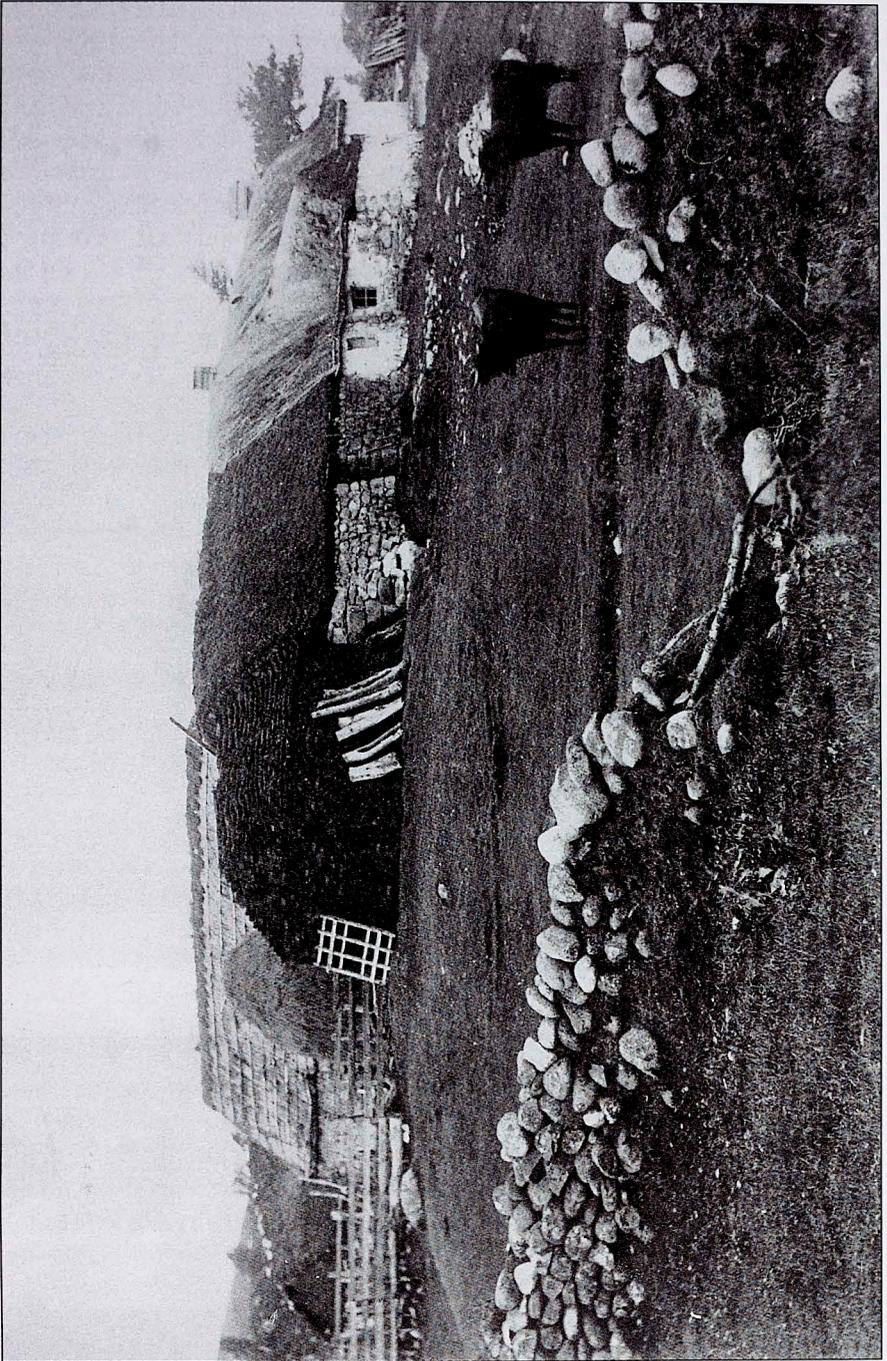
This has a much longer range than cottage A and I surmise it might originally have been a *longhouse*, an interconnecting dwelling and byre under one continuous roof. The dwelling is distinguished from the abutting byre at the left by lime-washed walls and different thatch. The complex stands on a slight rise which would have assisted drainage and, if the site was near the river, protected it from flooding. The dwelling appears longer than cottage B with a deep porch boasting a small window apparently opening into the kitchen end. This porch is probably an addition, again with a turf gable; the roof appears to be also of turf underlay with a wispy thatch too faint to identify the material though again rushes or *bent* are likely, while the eaves are held in place by long rods pegged into the turf as in dwelling A. The ridges are in better shape than the remainder of the roof, pale in colour and

Farm and cottage B

more robust. As before the *lum* is a square wooden frame bound with rope, but in good repair, a neat and upright structure in contrast to its counterpart on Cottage A. The thick walls of the byre are propped by a heavy buttress at the left corner; a low dung heap is gathered between this and the doorway. Here the roof is thatched with regularly coursed, overlapping turf divots, laid with growth on the underside and intended as the roof covering rather than underlay.⁹ A large peat stack abuts the byre gable and blends seamlessly with the range, the colour tones ranging from dark to light, each shade identifying a different accommodation and function.

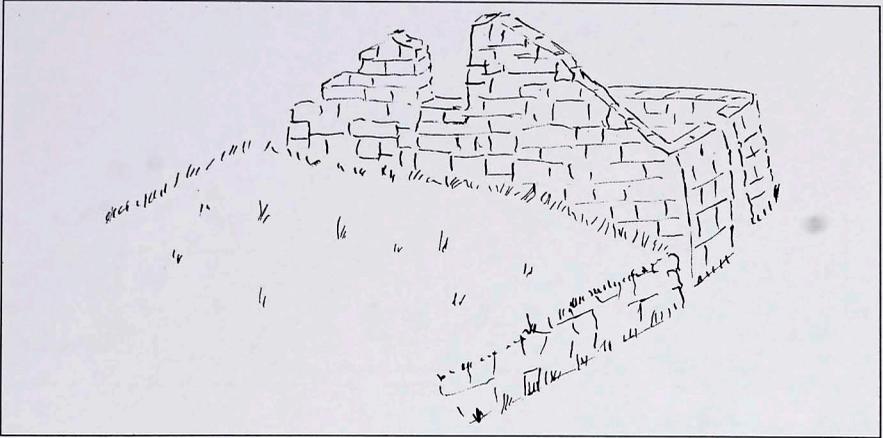
The N end of the barn was gabled and an opening, 0.5m wide at its

Braes of Creich (looking SSE)

base 1.4m from ground level, was probably to give 'crop access' to the barn from the stack-yard. On the inner side of this opening there is no evidence of a loft and this appears confirmed as at the S end of the barn the roof was 'hipped'.

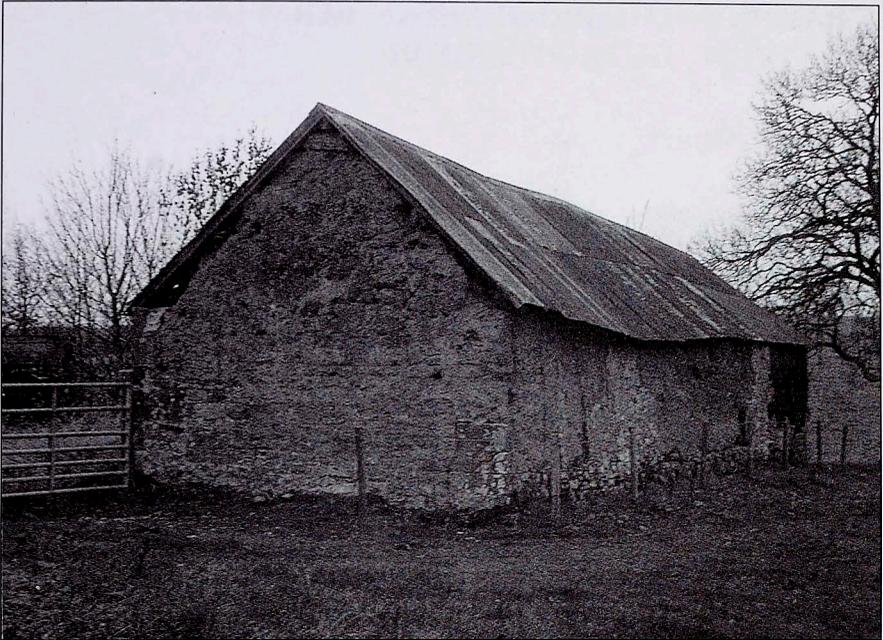
Priorslynn Barn from the north-east

Lack of maintenance has made Priorslynn Barn vulnerable and hastened its decline. If action to repair the building is not taken soon it will not last much longer.

- The earth walls of the west gable and the north-west corner of the building have collapsed.
- The wall is starting to disintegrate around the bottom of a cruck blade in the eastern compartment. Chunks of the wall have begun to fall away.
- A vertical crack has formed at the north-east corner and a large one is also present in the centre of the north elevation.
- The partition between the two compartments is pulling away from the adjacent walls and there are large cracks between them.
- The bond between the timber crucks and the earth wall has been lost in many places and there are cracks between the two materials.
- Much of the stone facing that might have once have been protecting the walls has been lost leaving the wall vulnerable. The bond between some stone and clay walling has been lost.

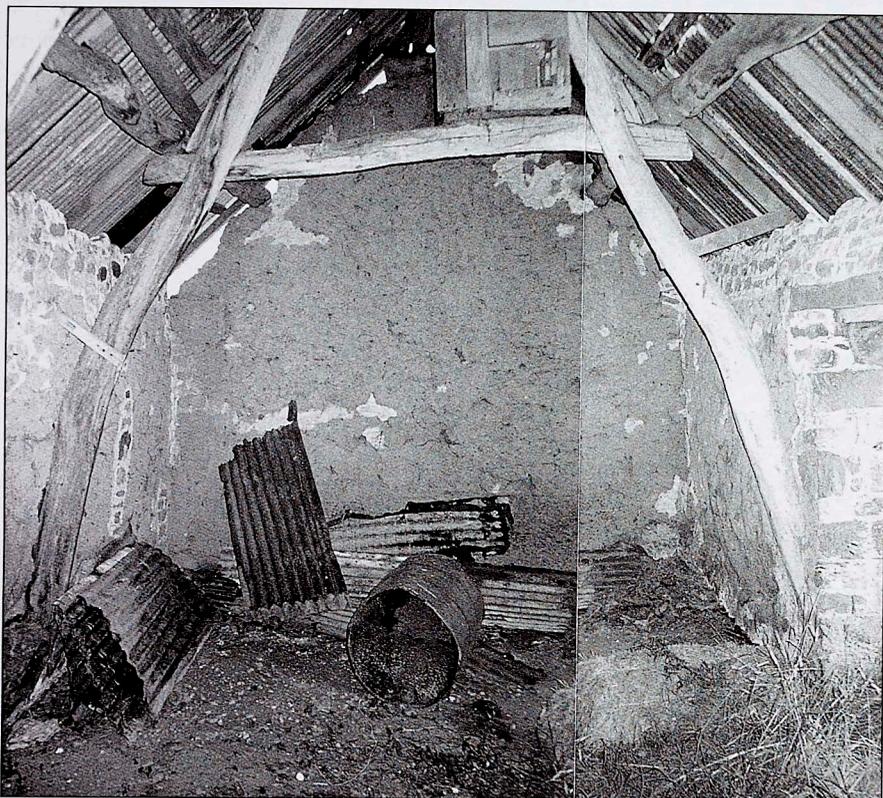
The earth buildings of the Solway Plain were constructed using a timber cruck framing system. After the initial excavation work the crucks were raised and stabilised by the ridge beam, purlins and wall plates. The roof load is carried directly down to the footings via the wooden cruck blades. The quickly built walls did not have to assume any load other than their own self-weight. In other parts of the country earth walls are load bearing but it is quite probable that the rapid method of construction in the Solway Plain meant that the walls could not take any load while they were wet. Because of the framing system, with the ridge beam transferring its load to the crucks, these buildings always have gabled ends instead of hipped

The eastern section of the interior – probably the barn

roofs. In some buildings a cruck frame would be incorporated into a dividing wall. This is the case in Priorslynn Barn where an earthen dividing wall separates a byre from the barn.

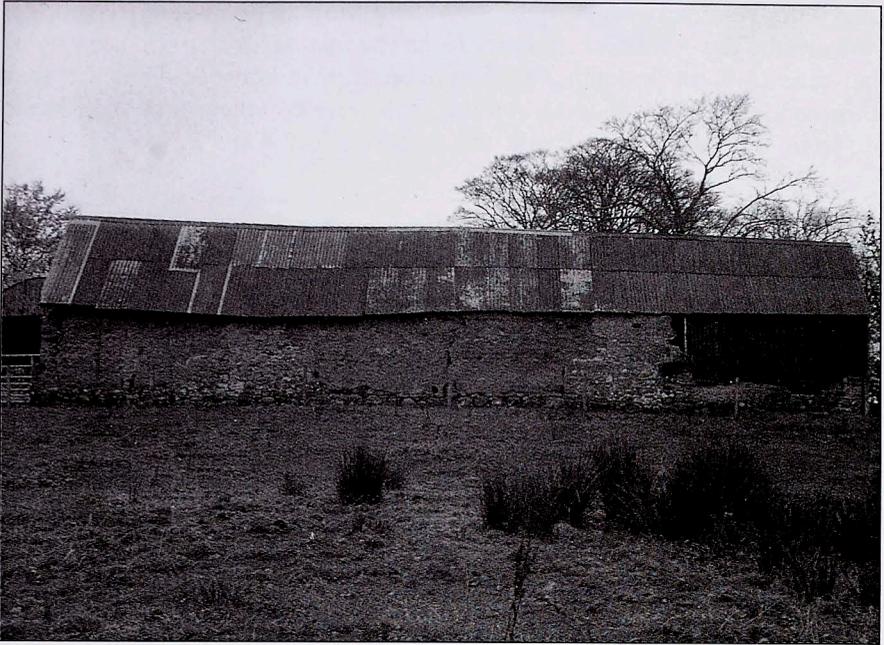
Priorslynn Farm is part of the Buccleugh Estate. The steading is occupied by a tenant and farmers rent the fields. The barn sits on top of a high hill away from the main steading but close to a modern agricultural building. It is small, approximately 7.3m by 4.43m. Five crucks frame the building, the centre one encased in a earth partition wall. The western section of the building has a cobble floor and is thought to have been a byre, while the eastern section has a compacted clay floor and was probably the barn, although there are signs of a plaster finish on the inside. The walls are of earth, approximately 50-60cm thick, and fashioned in the Solway Plain tradition already described. They are constructed on top of a stone plinth

Priorslynn Barn from the south

which varies in height. The western gable and the western section of the north wall have collapsed to a large extent and this area is partially enclosed by a timber and corrugated metal cladding. The building is roofed with badly maintained corrugated metal. There are two openings on the south wall, one for each compartment. The opening for the byre has been made smaller with stone infill and previous openings in the walls opposite have been filled in with stone rubble. Some of the earth walls are erratically faced with stone presumably to protect the earth. If there was ever a protective render on the walls, there is no longer any sign of it. At the door openings dressed stone jambs would have protected the earth at the openings from damage by animals passing through. There are wooden lintels and signs of timber doorframes but no doors now. The wallheads have stone rubble built on top of the earth.. This does not seem to be typical of the technique of building in the area and might reflect later modifications when the building was re-thatched or an attempt to consolidate damaged wallheads. On top of the stone wallheads are the remains of a turf coping. On the southern side of the building quite a few young sycamore saplings grow immediately against the footings. To the north of the building is a shallow dip, shown on the OS maps of the mid-nineteenth century as a pond. Possibly the earth for the walls was found here.

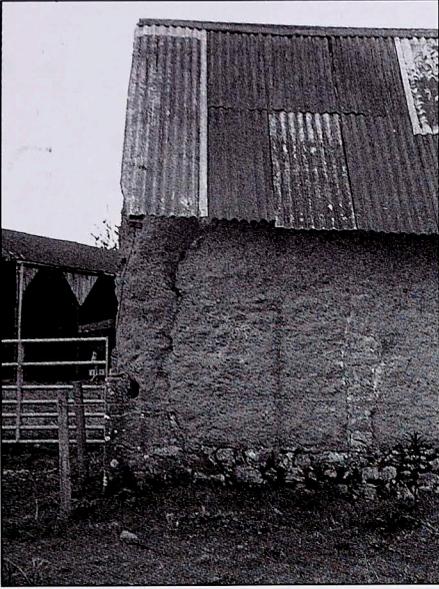
The east end of the north elevation. (Note how the roof does not overhang the east gable.)

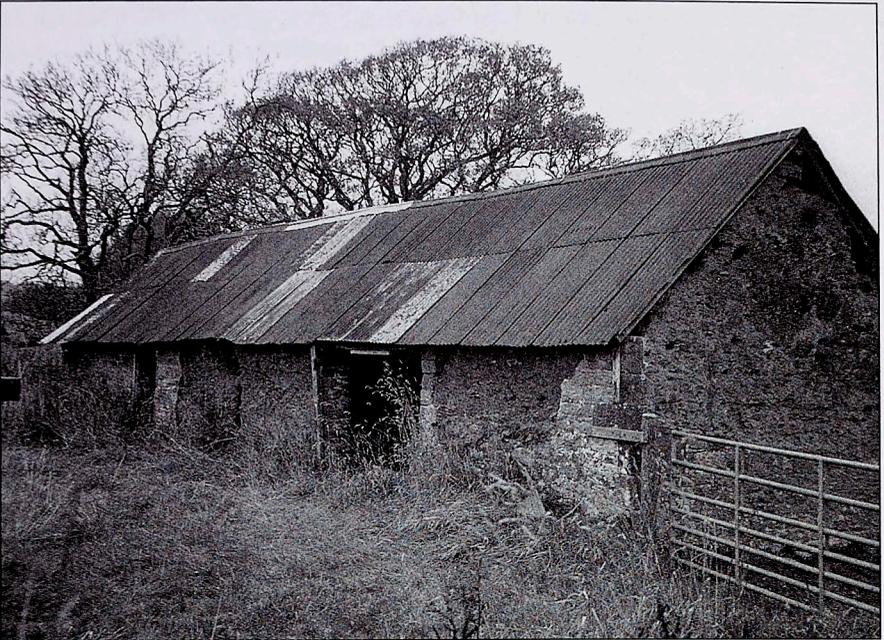
The south-east elevation. The saplings that were growing on the south elevation have been cut back but are showing signs of regrowth.

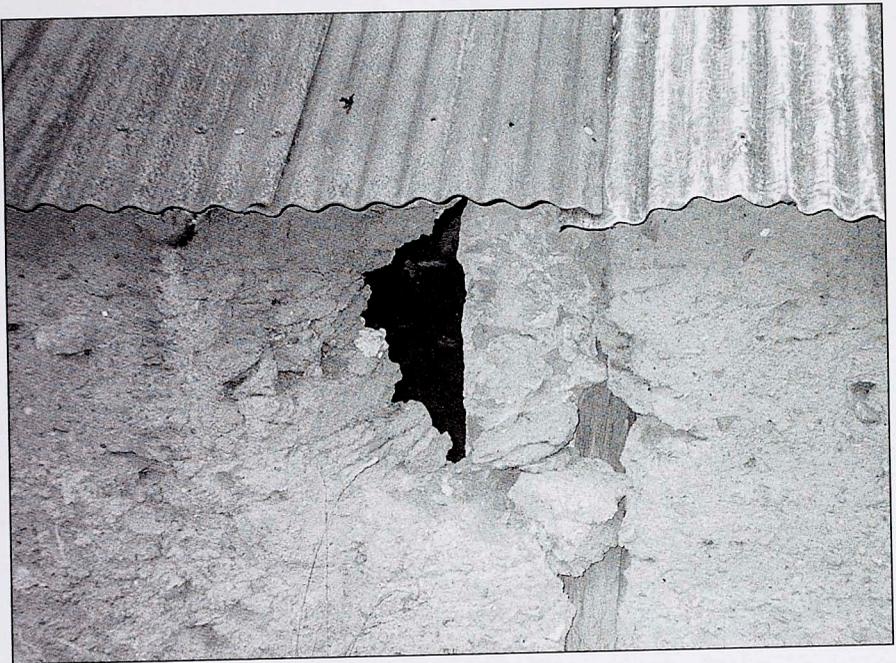
- Because the timber crucks have been allowed to decay (they are showing signs of rot and insect infestation) the framework for the entire building is at risk. As parts of the frame are lost, and as other parts move, the walls themselves are prone to further cracking. The wooden collar in the east gable is losing support from the wall below. Resulting movement of the ridgebeam will cause cracking in other parts of the wall.
- Water getting trapped behind the stone facing has increased the rate of erosion.
- The straw in the earth wall attracts rodents and insects hastening the process of decay.
- Tree growth right up against the building on the southern elevation is probably undermining the footings. Although there are not considerable signs of settlement and cracking it is only a question of time before these start to appear.

New damage (formed since 2001) at the centre crack on the south elevation

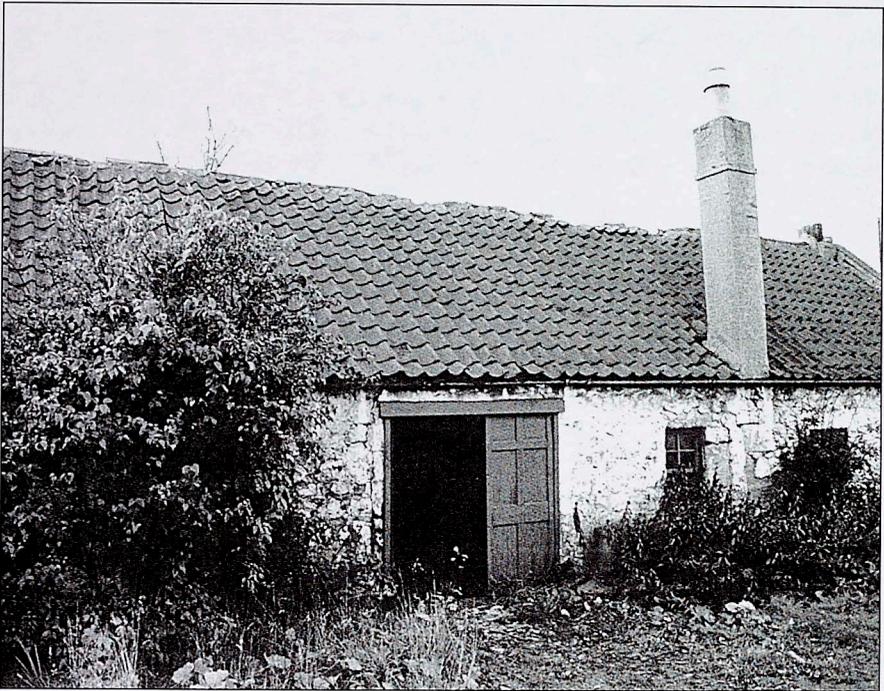
The roof before restoration

The first task in the restoration of the building was to get the tiles off the roof. In the case of the front of the building this had to be accomplished in as short a time as possible, in order to clear the road-side slope. It was done in a morning at the rate of one tile per second, and these were immediately loaded onto a lorry (diverted from Council duties). Miraculously very few tiles were damaged and the rear roof was de-tiled at a more leisurely pace.

Next the tiles required to be cleaned of visible grime and invisible spores of dry rot which infested the roof timbers at that time. Since 2379

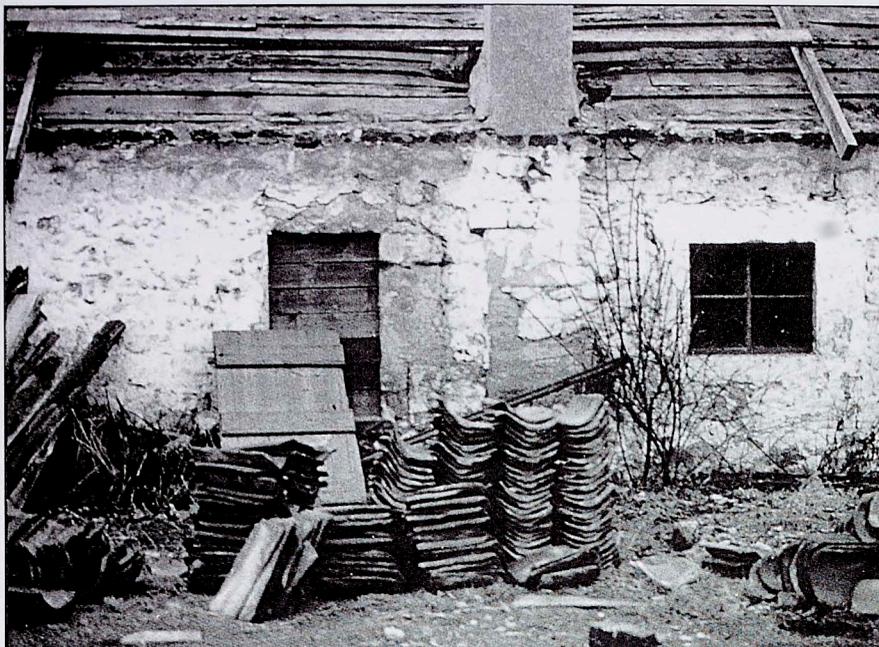
Rear of roof showing part of the structure used to remove the tiles

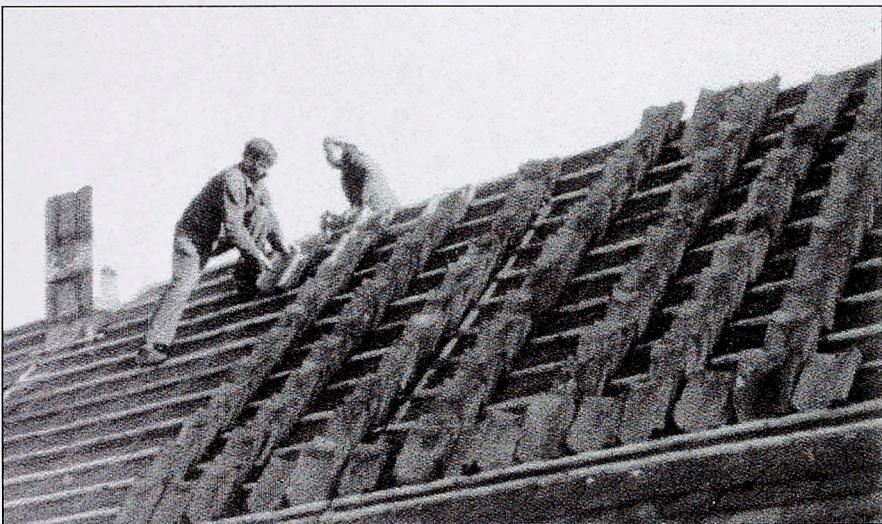
The one job I had failed to persuade anyone to take on was the actual laying of the tiles. It seemed that no-one could lay antique tiles, so I took on the job together with my team of volunteers. First three horizontal rows of relieving slates were laid the full length of the roof, at the bottom. Then the thirteen tiles of the first vertical row were hung on the battens and fitted snugly together from the bottom to the top against the south skew of the west-facing roof. It was when the second vertical row was attempted that problems arose. In the initial row the second tile overlaps the first and so on,

Tiles stacked on the battens ready for laying

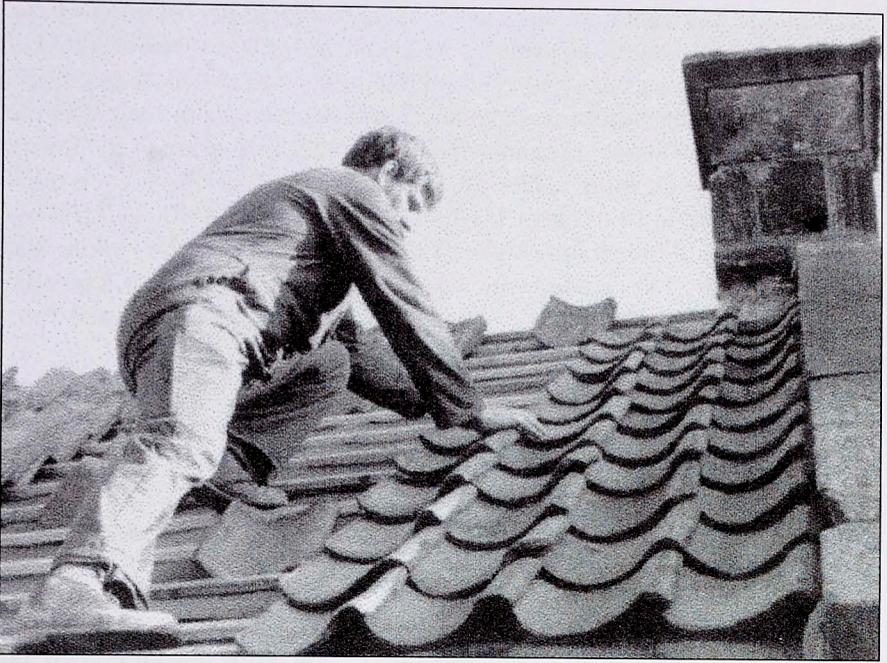
Ian McFall laying tiles with a little difficulty

each hanging from a batten. The second row worked the same way but with an added overlap onto its neighbour in the first row and having also to fit in with the neighbouring one above.

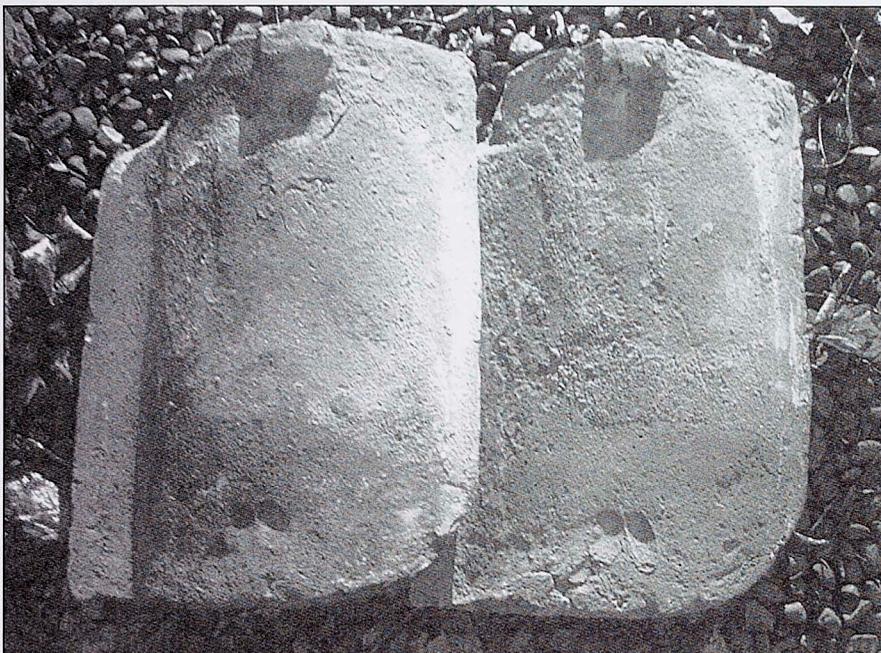
Because the tiles had featured prominently in my perception of the museum I knew them well and had made much of the finger impressions left in them by their makers. I had always indulged the schoolchildren in what I called 'tactile history'. More than just handling an artefact or touching it, with the tiles they could actually put their fingers into the very spot occupied by ancient fingers. From holding children up to inaccessible parts of the museum's north gable so that they could touch field boulders that had not been handled since the day they were laid, I graduated to getting them to put their fingertips into the actual impressions left in the soft unfired tile. I tried

Tiles with fingerprints at the base

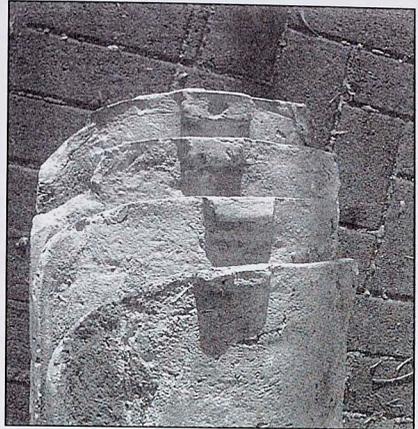
and thickness onto a former shaped with the bevel of a tile. At this point the size and thickness would take into account the fact that clay shrinks about one-ninth from wet to fired state. The tiles exhibit tell-tale scores of grit being dragged in one direction possibly by a slide or sponge drawn across the clay on the former to ensure a smooth upper surface. The tile would be lifted while still impressionable, receiving its signature of fingerprints. At this stage or when the 'green' tile was leather-hard the nib might be added. However it is hard to see any of the joins which

Nib variations

can occur when a separate piece of clay is welded to a clay object in the making with slip (liquid clay). Whatever the case, the variation in nib shape and size suggests that this part of the tile was created by each individual worker or by the persons who made the jigs.

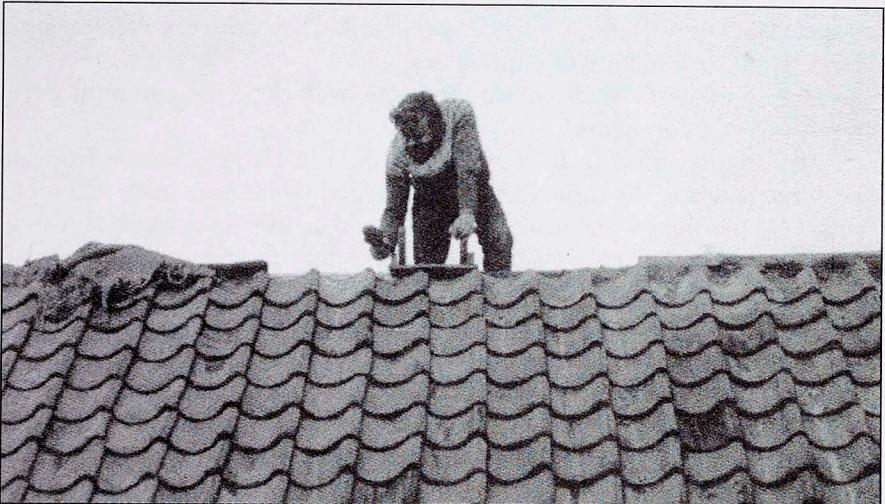
For part of the time when the ridge was being fitted into place the weather was so warm that work could only be carried out in the early morning and in the evening. Throughout the day the job had to be covered with water-soaked pack-sheets.

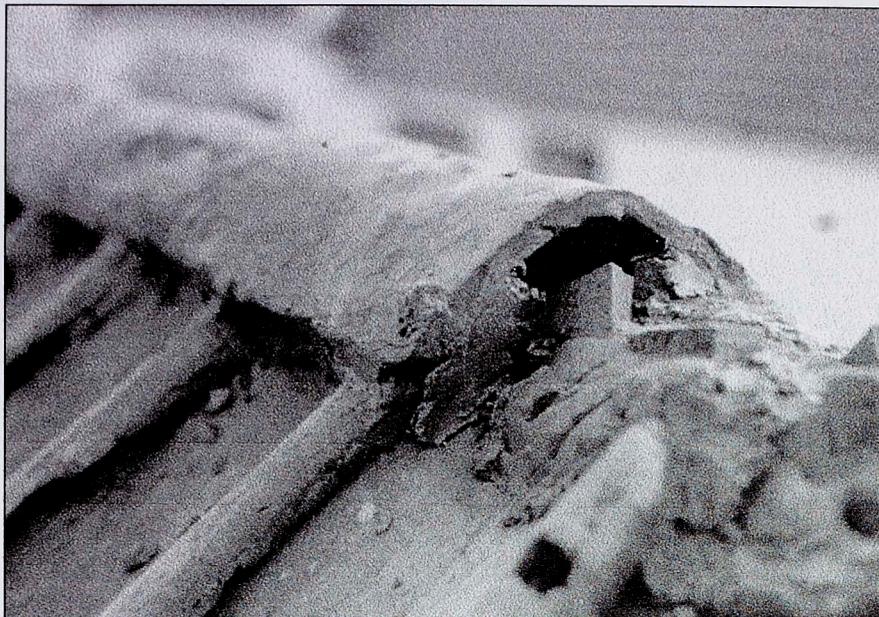
The cat's paw saddle-back

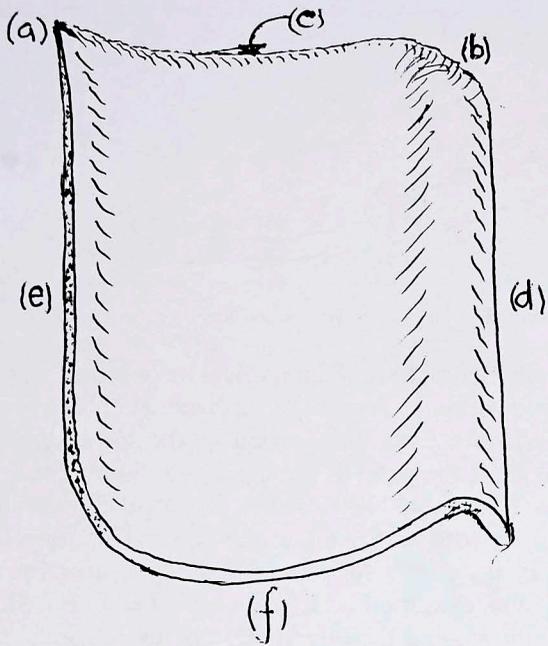
The following analysis is based on my own observations and the names are my own descriptive selection. At the top there is a point (a), a shoulder (b) and a nib (c) at the back. A curved lip runs from the shoulder down the length of the right side (d). A plain tilted edge runs the full length of the left side from the point (e). The S-shaped curved profile which runs the breadth

The geography of a tile

of the tile is clearly defined at the base (f). The 'weather' surface betrays a good deal of handworking. Along the top from shoulder to point there is evidence of a horizontal smoothing action on the soft clay. This is possibly done with a sponge or the palm of the hand and thumb, for long drawn out fingerprint smears are frequently evident in surprising detail. All this is probably to do with work on the nib at the back. The more I have studied the nib, the more it appears to be an integral piece of the original slab. Nevertheless, by whatever method it was established in the tile, the marked variations in the nib suggest the intervention of an individual tile-maker.

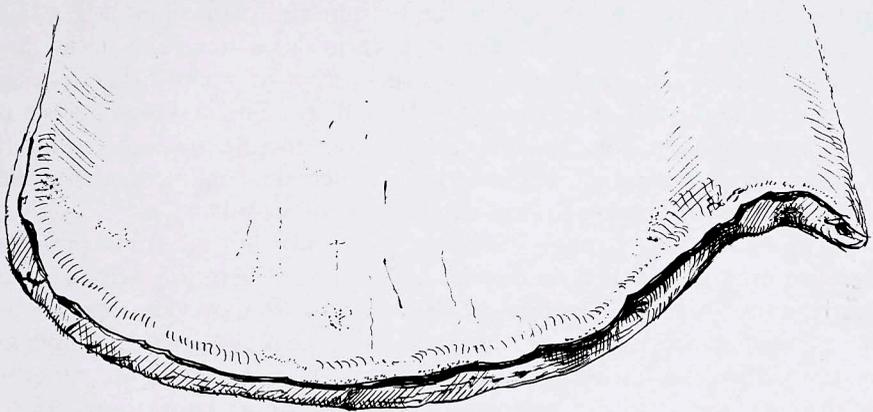
Overlap at 'S'-curved profile created during smoothing work

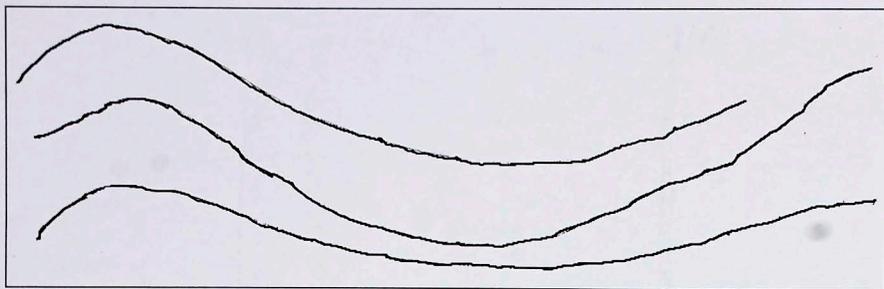
Variations in the 'S'-curved profile – taken from actual tiles

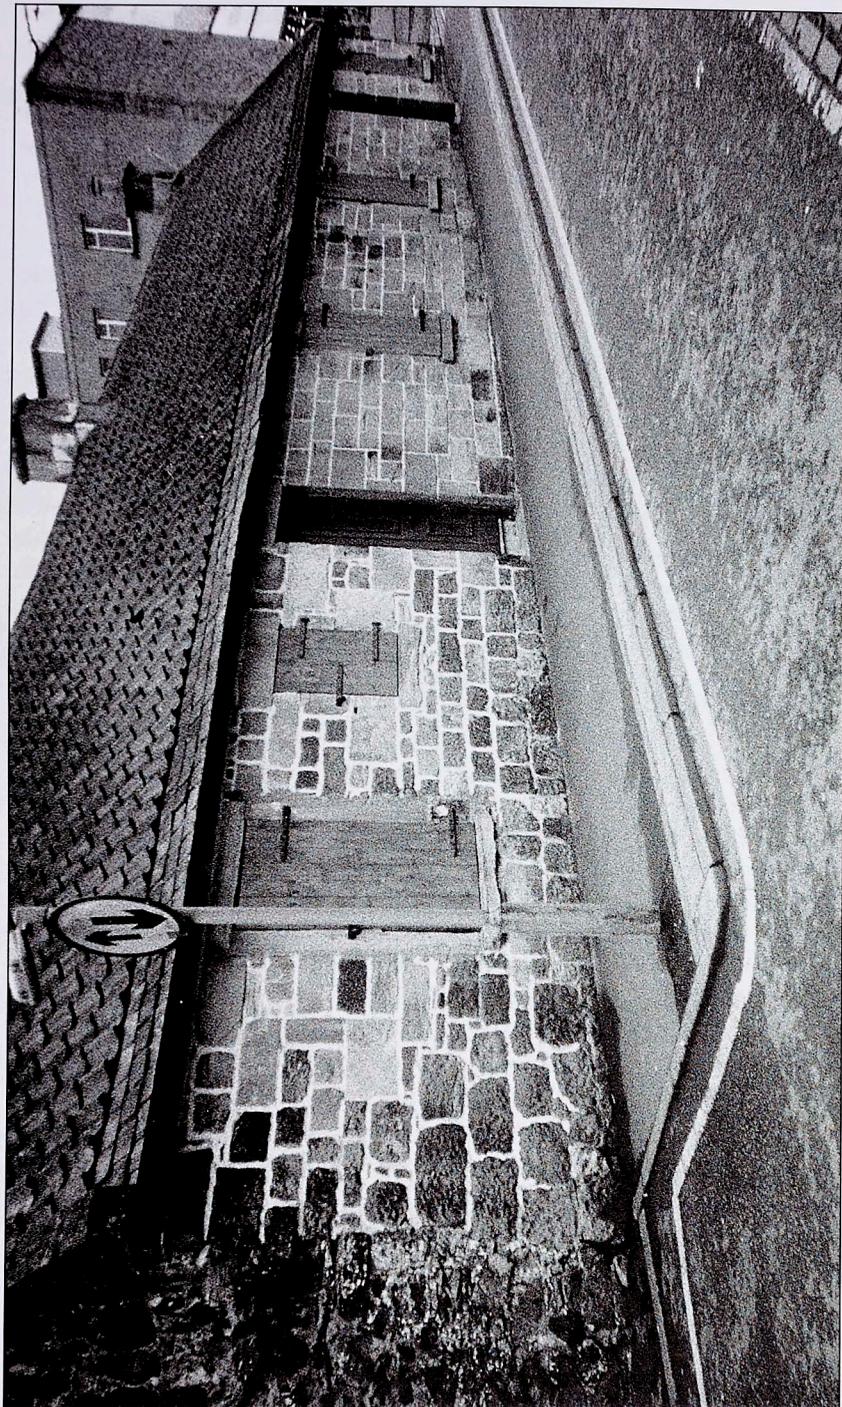
The dimensions of a tile, give or take $\frac{1}{4}$ to $\frac{1}{2}$ inch (6-12mm), are 15 inches by $10\frac{1}{4}$ inches by on average $\frac{1}{2}$ inch thick (380x260x12mm). The tile battens are spaced on the roof to give a tile overlap of about 4 inches (100mm). The right side curved lip overlaps the left plain tilted edge by at least one inch. This overlapping configuration is achieved by laying the tiles from right to left and means that each tile is held down at the top and left

The end result

side in the simplest way possible, obviating the use of nails. (In fact there is no provision of nail holes in a pantile, although there is in the saddleback ridge tile.) The area of each tile thereby open to direct weather is 11 inches vertically by 9 inches horizontally (280x230mm).

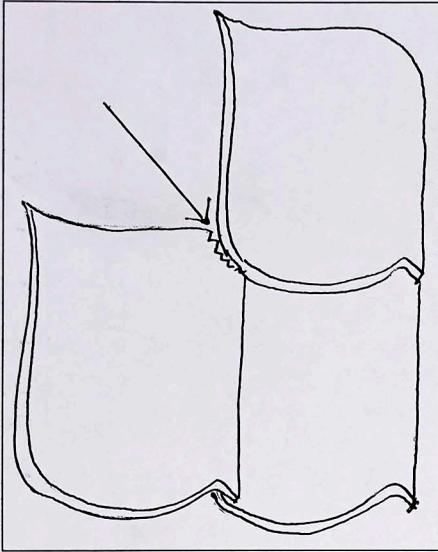
century and a half later. These chippings enabled the tile to fit in with its neighbour.

Chipping at shoulder to aid fitting
