# VERNACULAR BUILDING 10

Scottish Vernacular Buildings  
Working Group

REPORT ON EXCAVATIONS AT WINDGATE HOUSE, NEAR COULTER, LANARK DISTRICT 1981-85

RE-THATCHING AT 12 LOWER ARDELVE, LOCHALSH

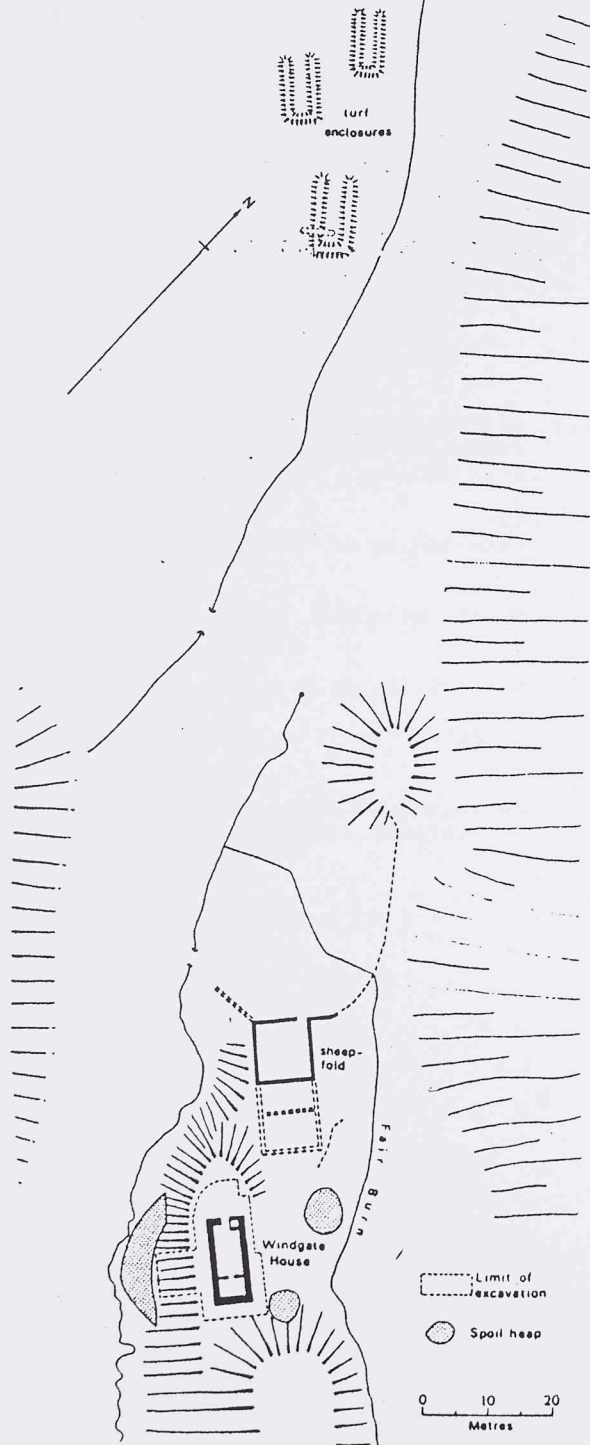
Fig.1: Site Plan

The remains of the building known as Windgate House, with its associated structures, are situated approximately 1/4 mile SW of Cowgill Reservoir in Lanark District of Strathclyde Region, N.G.R. NT 016273. The disposition of the site can best be understood by reference to Fig. 1. The site lies at an elevation of 1225 feet OD and the ruin itself is situated on the N end of a narrow medial ridge at the head of Cowgill Glen just below the pass of Kyegill and flanked by the steep sides of Windgill Bank and Heatherstane Law. A small stream, the Fair Burn, flows north on the NE side of the site and an unnamed tributary flows on the SW side. The ground falls away steeply to the N and W but on the NE the Fair Burn has built up an alluvial fan of debris which causes the ground to slope away only gradually from the site. To the SE the ground rises immediately from the wall of the ruin towards the pass of Kyegill. To the N of the ruin are the drystone footings of a rectangular structure, part of which has been built up into a later sheepfold. Further to the NW are the remains of three rectangular earth bank structures, each having only three sides, the northern ends being open, (see Fig. 1).

The three earth bank structures and the dry stone footings (Fig. 1) are considered to be enclosures contemporary with the house. No apparent cultivation traces are evident in the immediate vicinity of the house, although on the NW bank of the Cowgill Reservoir is a distinct rig-and-furrow field system of uncertain date.

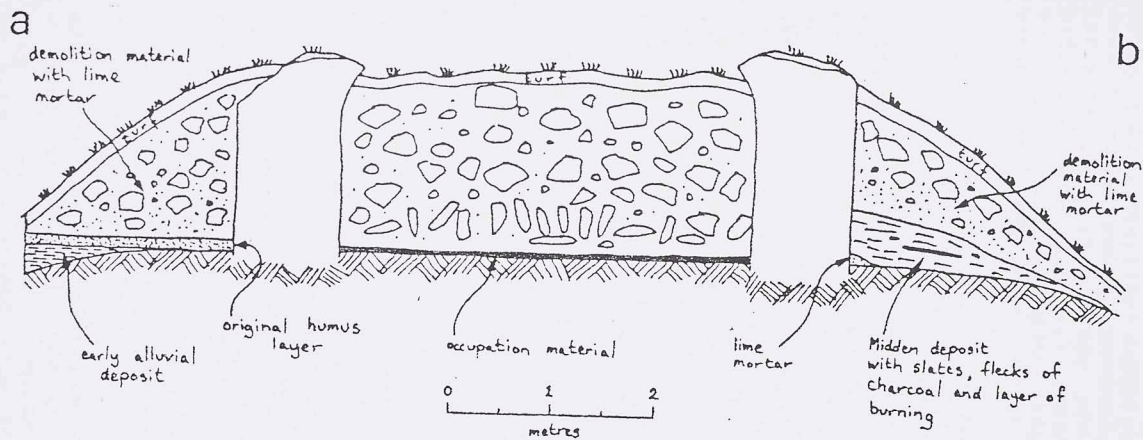
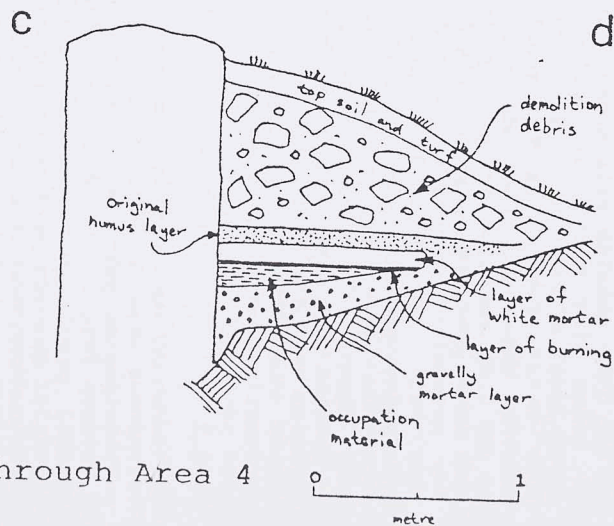
Fig. 3: Section through Area 4

Clearance of this area produced evidence of deliberate demolition as demonstrated in the section Fig. 3 which proved fairly typical of the four outside wall areas. Under the turf lay a varying depth of loose lime mortar intermixed with stones of all sizes. The lower level of this material generally contained little or no stones. This is interpreted as the result of the process of demolition. Beneath the mortar lay an occupational level, varying in depth up to 0.3m and consisting of a dark soil containing bone, pottery and some complete examples of slate (some of which lay beneath the occupation deposit). A midden deposit was located against this wall (see Fig. 3). This consisted of the typical dark occupation material 0.45m at its deepest point against the wall and containing layers of slate. A layer of burning was noted and also divots of carbonised peat. The midden material contained a greater concentration of artefacts, especially bone, and this deposit extended down the slope from the wall. Immediately on top of the midden material lay several pieces of dressed sandstone, apparently from a window above.

The material was similar to that in Area 3, though not quite so voluminous due to the lower height of the extant walls. The substratum in parts was overlain with an alluvial deposit up to 0.3m deep (Fig.3). Within this alluvium and on top of the substratum several pieces of worked chert of a local bluegrey variety and pieces of pre-historic pottery were found. Some blocks of sandstone were stacked near the corner of the building which do not appear to have been used in the construction. Pieces of dressed sandstone from a window opening were also found.

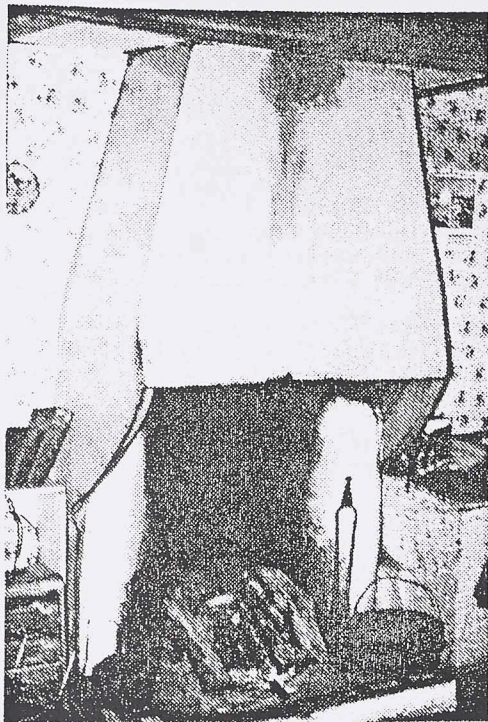
"Hanging lum"

This house is the last remaining intact example of the type that was universal in this part of the Western Highlands (perhaps from Torridon south to Ardnamurchan) one hundred years ago. It is at Lower Ardelve, Lochalsh, Ross-shire (N.G.R., NG 873267). The rough, mortared stone walls stand fairly vertical, rounded at the corners, and are topped with a high, hipped, thatched roof, overhanging at the eaves. Two small windows are symmetrically placed on either side of the front door, while at the back a tiny central window is the only opening. In this house, a small corrugated iron porch has been added. At the eastern end of the house, a stone chimney stack rises flush with the wall but at the western end there is only a thatched wooden "box" chimney, jutting out at the angle of the hipped roof.

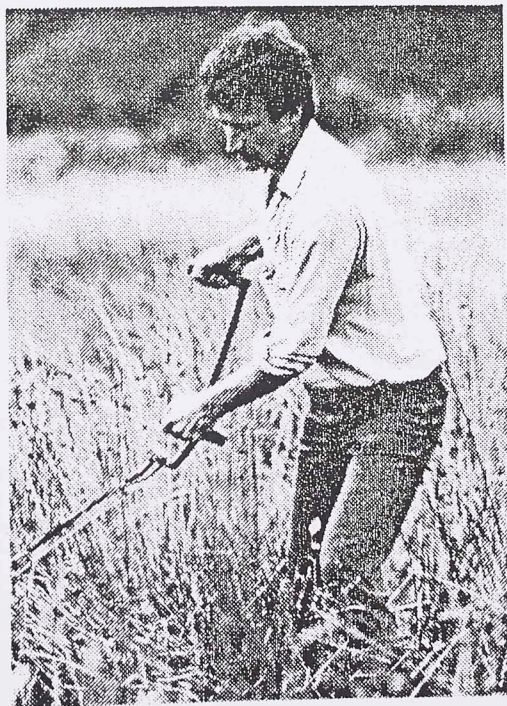
Cutting rushes  
for thatch

The material used was the Common Rush (Latin - Juncus effusus; Gaelic - lauchair). Rushes used for thatch should be as thickly growing and as long as possible (3-4 ft)<sup>1</sup>, qualities which are rarer than the ubiquitous nature of the rush would suggest. The rushes are cut low with a scythe, lifted in handfuls, shaken then combed of grass, moss etc. with the fingers, laid in sheaves, tied and carried from the field. One scytheman should easily keep three or more gatherers occupied in thick rushes. One man working alone - cutting, gathering, tying and carrying - might average five sheaves per hour.

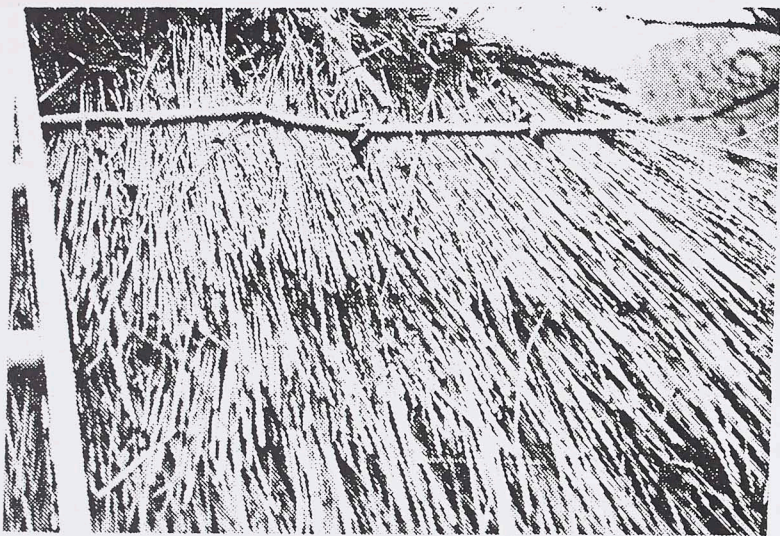
Lath and pegs securing course of thatch

The pegs should be made quickly after the rods are cut, and certainly no later than a week after, so that the rods remain sappy. The rod is heated at its centre over a narrow fire (or gas burner) till it becomes black and slightly burnt on one side. It is twisted firmly with the hands (the heating enables this), bent double and secured in this position for a while (e.g. by tying or sticking in the ground). It will thus achieve the desired "springiness" which holds it firmly in the thatch. The ends of the peg can be sharpened before or after making. Hazel pegs should last for many years.

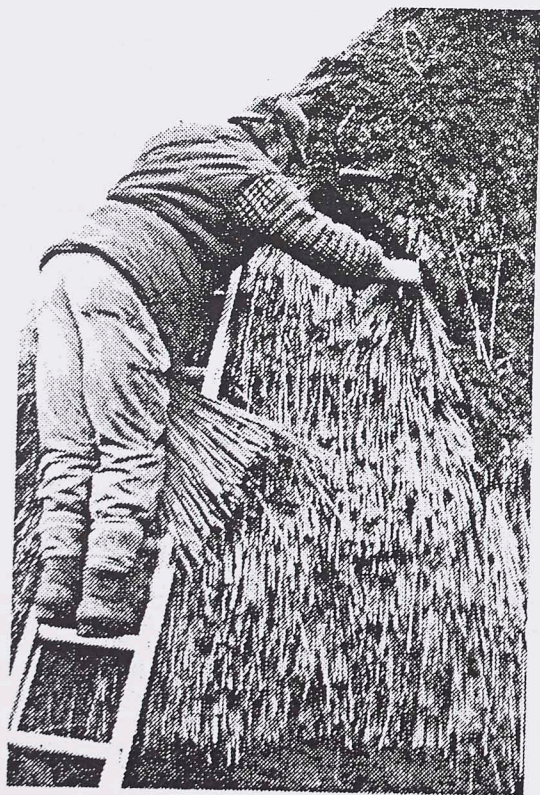
Thatching

The cutting and thatching was carried out by Duncan Matheson ("The Stalker") of Camas Luinie, assisted to varying degrees by his sons Duncan and John, and by James Souness. The work was done particularly meticulously and skillfully, to a standard of thatching probably not executed by any Scotsman for many years. The ingenuity displayed was particularly fortunate as it soon became clear that this was far from an ordinary thatching job, but rather a last minute rescue operation!

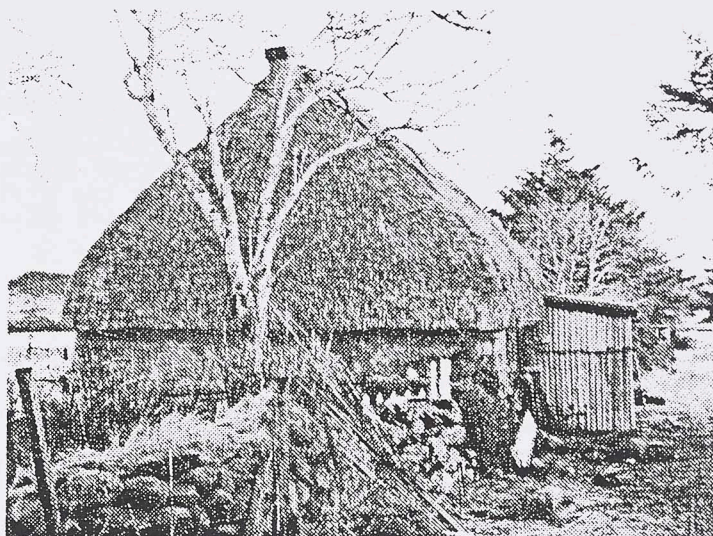
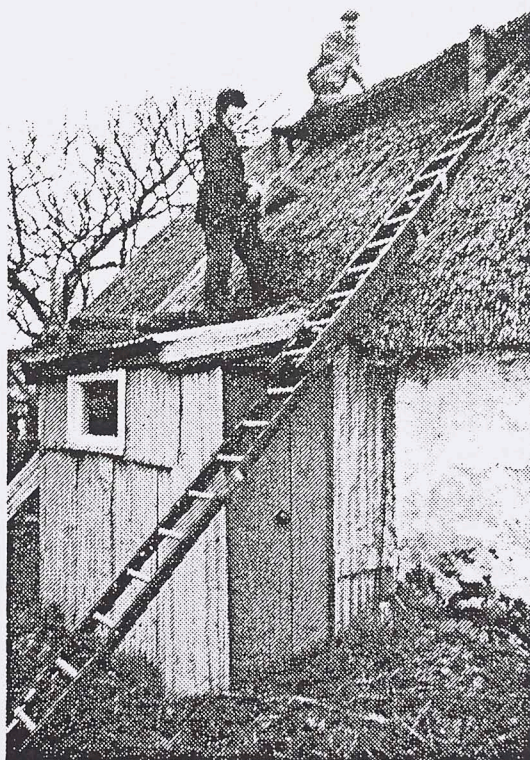
Fig. 8:  
12, Lower Ardelve

Thatching completed

Thatching from  
platform

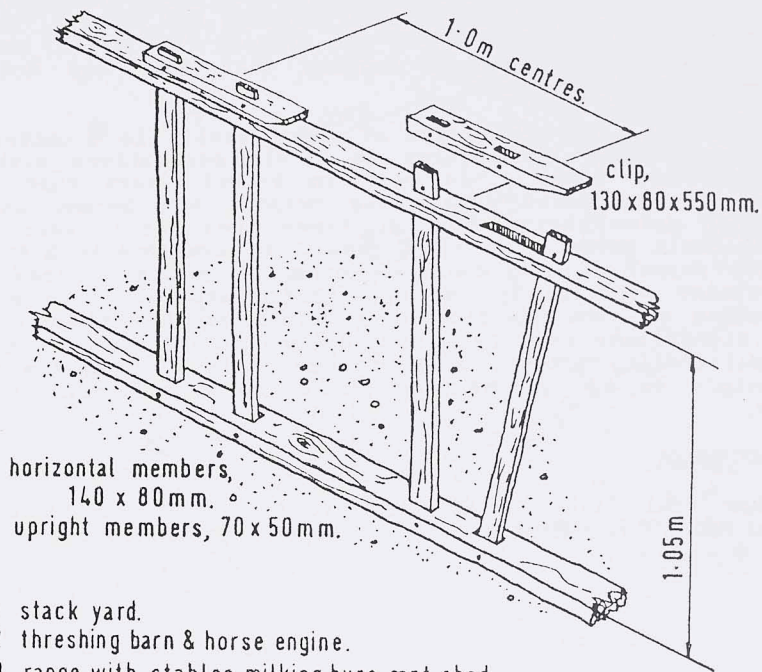
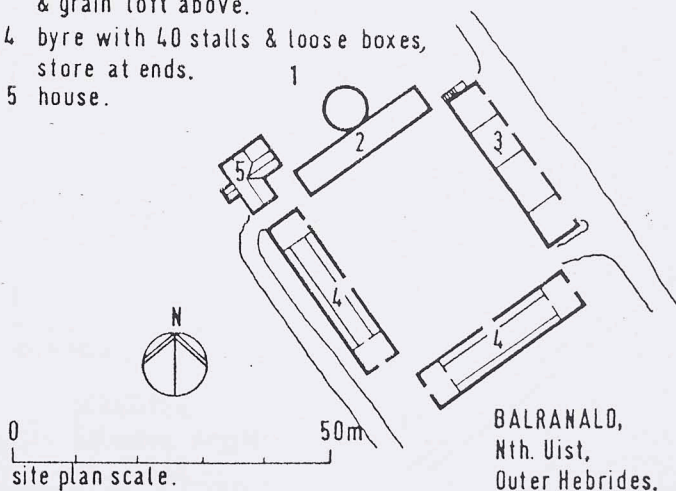
Fig. 10

- 1 stack yard.
- 2 threshing barn & horse engine.
- 3 range with stables, milking byre, cart shed,  
& grain loft above.
- 4 byre with 40 stalls & loose boxes,  
store at ends.
- 5 house.

BALRANALD,  
Nth. Uist,  
Outer Hebrides.  
NF718698.

Balranald Farm on North Uist (Outer Hebrides, N.G.R., NF 718698, see Fig. 10) is a very large planned farm said to be noted for its Highland cattle. This may be a clue to the design of its stalls, although it is not certain that such cattle are brought inside during winter. Two of the buildings which form part of the farm square are used as byres, and in all have 80 open-framed stalls.

The wooden framework for the stalls comprises principal horizontal members positioned 1.50m from the walls, the lower member being fixed to the floor, and the upper member being set at a height of 1.40m. There are two uprights for each stall, one fixed and the other movable. The latter pivots in its socket in the lower horizontal member, and its top end passes through a slot 0.35m long in the upper horizontal member. In the closed vertical position, the movable upright is 0.18m away from, and parallel to, the fixed upright. Its top end projects 0.08m and is secured by a rectangular wrought-iron clip which is made of 7mm square-bar, one end of which is fixed to the upper horizontal member by a heavyweight staple. The feeding passage between the walls and the stalls incorporates a secondary wooden frame (not shown in the drawing) which contains the feedstuff and supports the main frame.

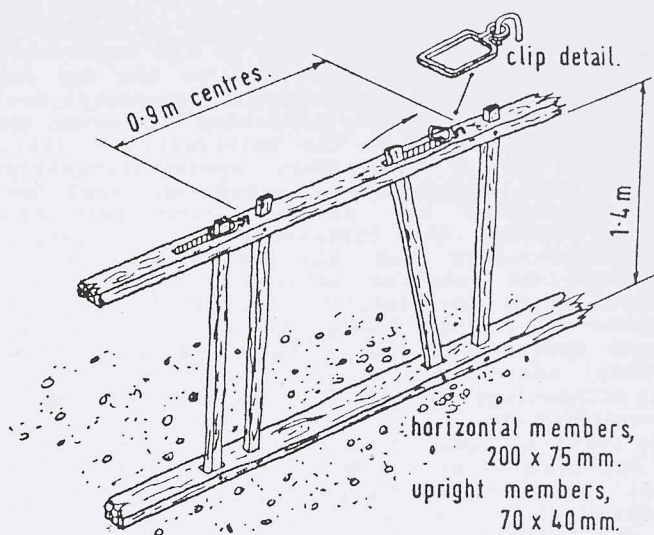
Fig. 11

- 1 stack yard.
- 2 loose byre.
- 3 main byre with 11 stalls.
- 4 stable with 3 stalls.
- 5 threshing barn.
- 6 horse engine.
- 7 implement shed.
- 8 house.

SCRUITTEN,  
Colonsay, Argyll.  
NR 375957.

A second similar example has been noted at Scrutton on Colonsay, Argyll, Inner Hebrides (NR 375957, Fig. 11). This small steading contains a well fitted three-stall stable, a horse-powered threshing machine (driven by one horse), an implement shed, a loose byre, and a larger byre with eleven open-framed stalls. Five of the eleven stalls are arranged along one cross wall, and the remaining six along the other. Unlike the North Uist example, there are passages on either side of the byre providing direct access to the feeding space. In addition to the doorways to these passages, there is a central mucking-out passage with a door at each end. The OS 6-inch map of 1900 does not show the south projection or the horse-walk, so these probably represent later changes and additions.
