VERNACULAR BUILDING 16

Scottish Vernacular Buildings

Working Group

1992

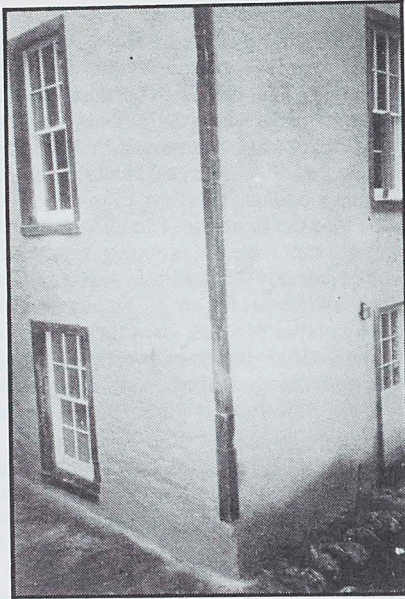
*West and South Elevation : Completed Harl
The West elevation finished with lime wash*

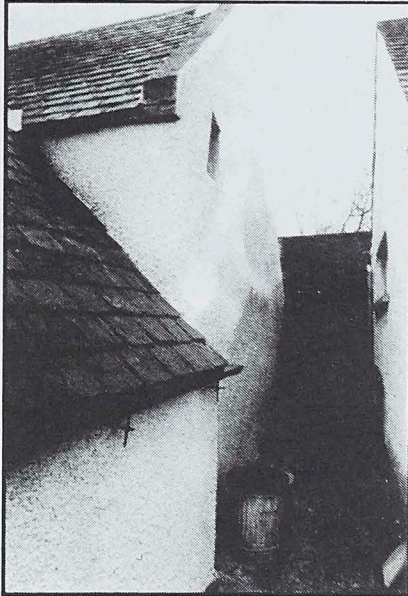
West Elevation : The completed harl which in this case respects rather than hides the sequence

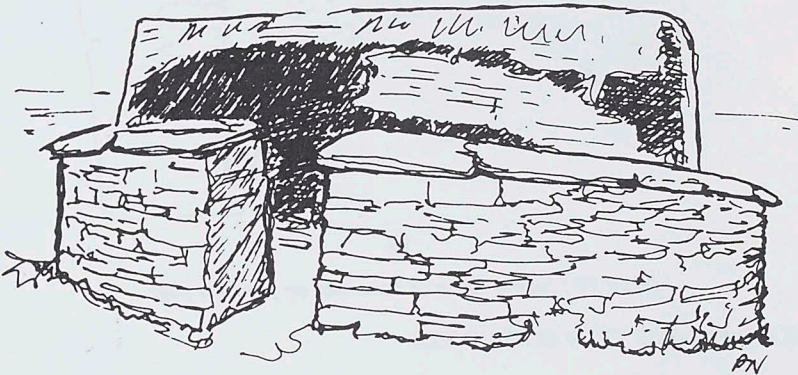
figure 16: Boat roof on North Ronaldsay May 1991

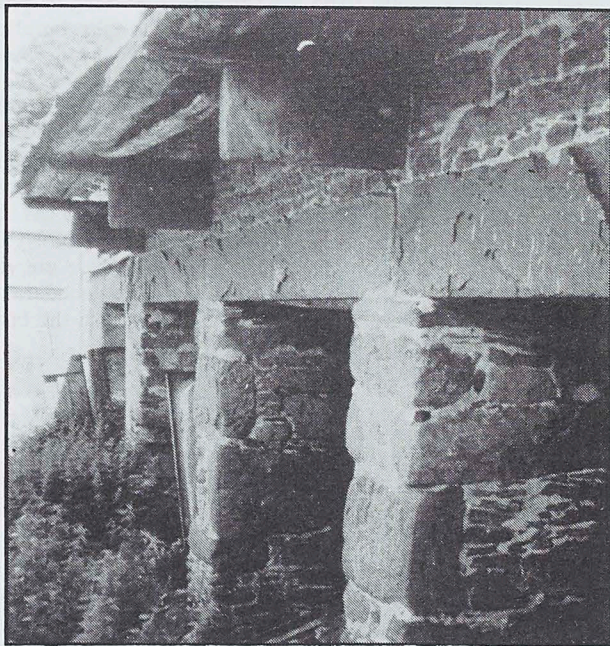
The swept roof over the granary openings, supported on long projecting corbels

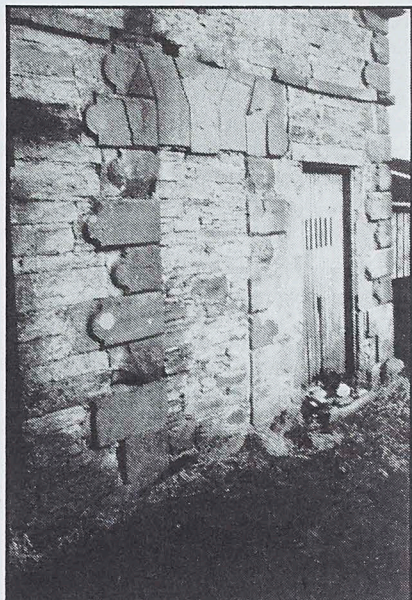
Buckle-type quoins in the former threshing barn

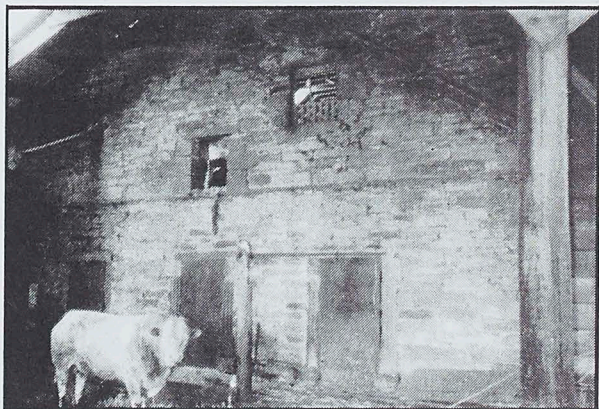
Entrances to the vaults, with fluted jambs

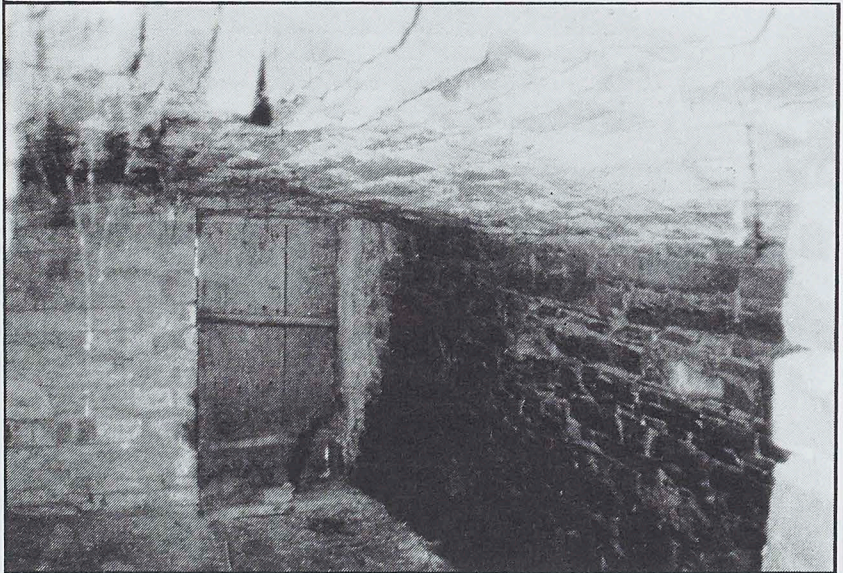
The threshing barn, showing the segmental vaulted chamber with battered walls
