VERNACULAR BUILDING 31

**Scottish Vernacular Buildings
Working Group**

2007–2008

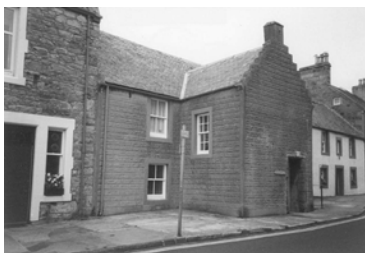
*Figure 2. Wynd Lodge in 2003:
view from south-east.*

This description by John Gifford in his book *The Buildings of Scotland: Fife* (1992) sums up exactly what I found when I bought Wynd Lodge in 2003. I knew it was one of Elie's earliest houses by virtue of its doorpiece and crawstanes (crow-stepped gables), but it was smothered in cement rendering at the time (see figs 2

and 3). I wanted to chip this off immediately, but my lack of funds meant that that this would not be possible until the summer of 2006. Nevertheless, the delay allowed me time to research the history and restore the interior of the house – although, as a rule, the roof and exterior of a building should be made sound before starting on the interior. Time and effort would have been saved if I had abided by this guideline. This paper will firstly look at Wynd Lodge’s history before discussing in detail its restoration.

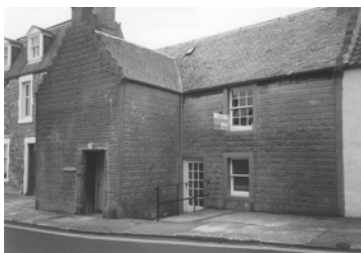
*Figure 3. Wynd Lodge in 2003:
view from north-east.*

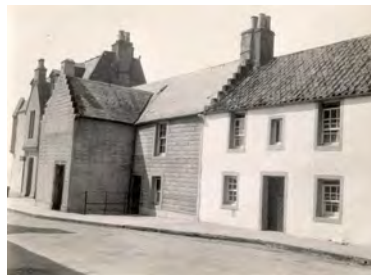
Figure 5. Photograph of Wynd Lodge c.1937, by Ian Lindsay. (RCAHMS (Ian G Lindsay Collection); © RCAHMS)

David Garland & Sons, and ask them to look into inserting a new first-floor window on the west (rear) elevation. David Thomson of the Elie Historical Society saved the drawing for this work (fig.4), along with many other Elie drawings from the Dean of Guild. However this window was not inserted on the first floor but on the ground floor, perhaps because the former would have overlooked a neighbouring property. The McCallum family, prior to 1945, owned the house for 15 years after purchasing it in 1930. The McCallums were probably responsible for the cement cladding as it is shown as very clean on the architect Ian Lindsay's photograph of c.1937 (fig.5).

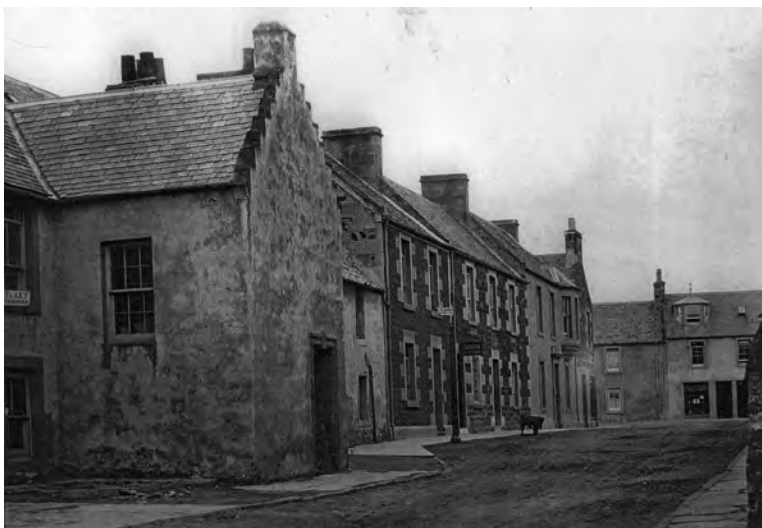
Figure 6. Wynd Lodge c.1900. (Source: Elie Historical Society)

home. Ann lived with her parents, was unmarried, and died of heart disease at the age of 38 on 7 February 1900 in Wynd Lodge. The Turners did not own the house, which means they rented it, and a photograph of Wynd Lodge c.1900 shows a 'To Let' sign in the upstairs window (see fig.6). I suspect the reason why my mother's house has this deed is due to the fact that at the time people were borrowing money from each other, and this was recorded with house deeds. However it is nice to think that the connection between the two houses has been re-established 100 years later.

I was fairly sure that the building would originally have been covered in lime as many early houses were. Remains of lime were found under the cement and a photograph of the house c.1900 (see fig.6) shows the harling before the cement rendering. The stone is beginning to show where the harling has worn away, which is a feature of lime-covered buildings. Lime harling also allows the building to breathe as water that penetrates the surface is released back out, whereas with cement harling the water would be trapped on the inside. Mr Anderson was against using lime as he felt it would not last and it would be more time-consuming and expensive to apply than cement. He felt the house should be pointed to show the stone. I contacted Mr Craig Frew at the Scottish Lime Centre and he reassured me that I was correct. Armed with this knowledge, I persuaded Mr Anderson to use lime. Without his expertise and hard work, the job would never have been done. Masons Mortar supplied the sand (Broomhead Coarse Sand) and lime (Natural Hydraulic Lime 3.5) for the next stage.

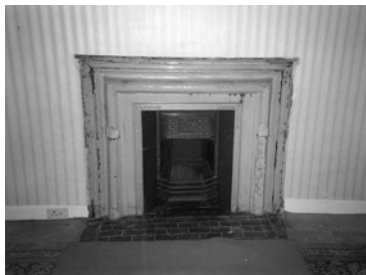
Figure 8. The first-floor chimneypiece, stripped down but unrestored.

The chimneypiece of the first-floor room, for example, had been blocked up, although with an attractive wallpaper covering, and had a 1970s mantelpiece (see fig.7). The paper was carefully peeled off, archived, and the boarding removed to expose a beautiful fireplace (see fig.8). The grate had most likely been put in by Alexander

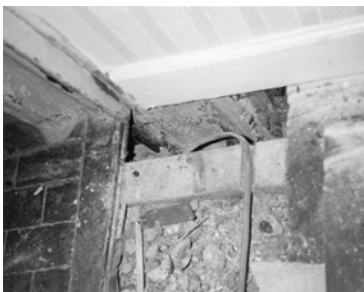
Figure 9. Detail of the first-floor room, showing part of a stone chimneypiece and wallpaper beneath floor level.

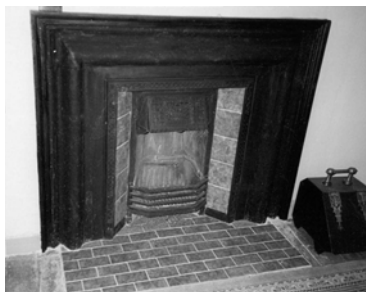
Figure 10. The first-floor chimney-piece after restoration.

Wood, because an 1895 sixpence and 1896 halfpenny were found in a crevice when the 1970s mantelpiece was removed. The coins were probably meant as good luck charms, placed there by workmen who installed the fireplace. Coins have been found in many houses in the East Neuk during renovation work. The Victorian grate had been set into an early-seventeenth-century stone fireplace with a small wooden surround. The stone fireplace continues for about a foot (30cm) under the floor, which means the ceiling on the ground floor has been raised (see fig.9). Old wallpaper is also evident, and the colour found on the plaster was copied and used as the décor for the whole room. The fireplace was stripped of its paint, and a cement mix was used to repair the damage caused by the wooden batons. A stonemason would have been employed to restore the fireplace if money had been no object; this could still happen in the future. The fireplace was black-leaded for use (see fig.10).

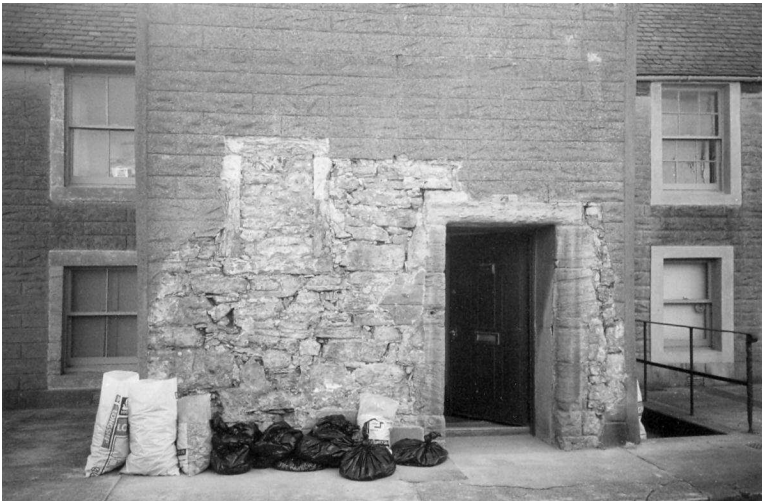
Figure 11. Removing the cladding, 2006.

I obtained planning permission and listed building consent to remove the cladding by the summer of 2006. The quickest way to remove the cement rendering would have been with a machine, but I felt that this might damage the building. I started on the projecting jamb with a hammer and chisel and was quickly rewarded by finding a blocked-up window (see fig.11). This window had been hiding under harling for well over 100 years, as it is not shown on any nineteenth-century photographs of the house. This find caused me great excitement; but the work had caused pinning stones to fall, and earth was pouring out from behind the lime pointing. It was time to call in the professionals. I later found out that many old buildings in Fife were built of earth and stone, with lime only being used to point

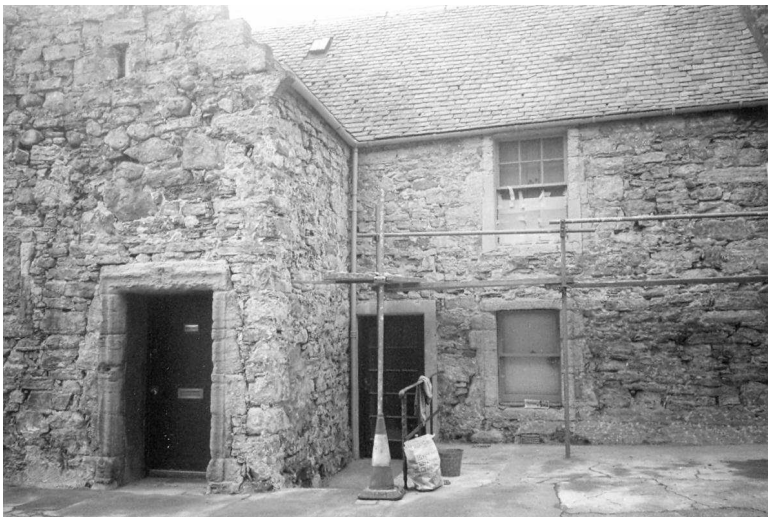
Figure 12. The house without cladding.

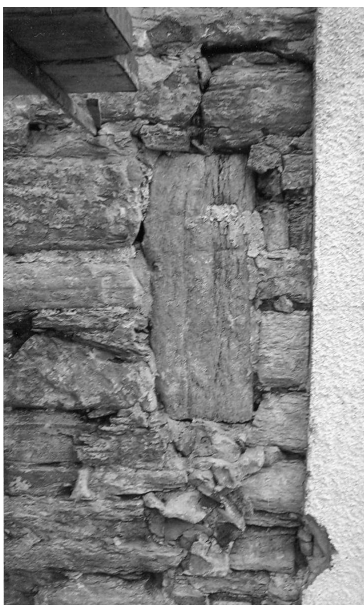
Figure 13: An unusual vertically aligned stone.

The exercise uncovered some excellent architectural features: a small opening was found in the attic of the projecting jamb, and stone window sills and margins were found around two of the windows. One of the most curious finds was a stone turned on its end with a small hole from which something was attached (see fig.13). Perhaps this was where an inn sign or a ring to tie a horse pulling a cart laden with beer barrels hung? A stone margin from a smaller,

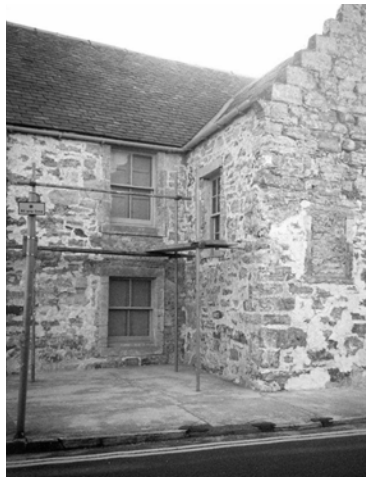
Figure 14. Dubbing and pointing: left side.

The house was pointed and 'dubbed' with a mixture of lime, sand and water. Dubbing is an important stage where broken pantiles are used to build out areas on the façade which are holey or uneven (see figs 14 and 15). Three coats of lime harling were hand thrown by Mr Anderson onto the house – the undercoat on a ratio of 2 parts sand to 1 part lime and thereafter 2 ½ parts sand to 1 part lime. There was a week's gap between each coat, and the final coat was protected from

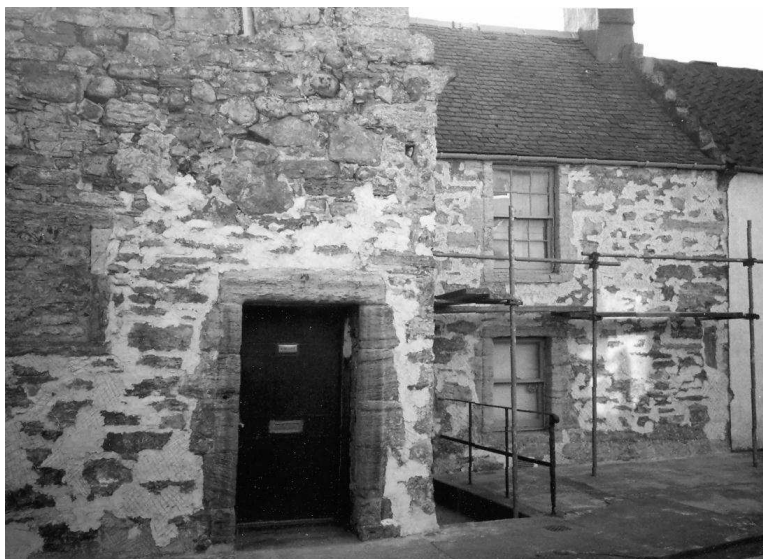
Figures 15. Dubbing and pointing: right side.

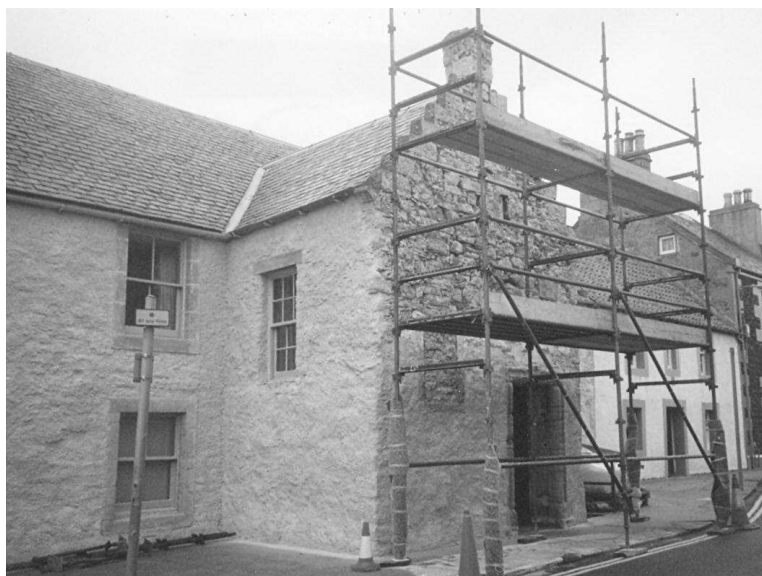
Figure 16. Applying the lime.

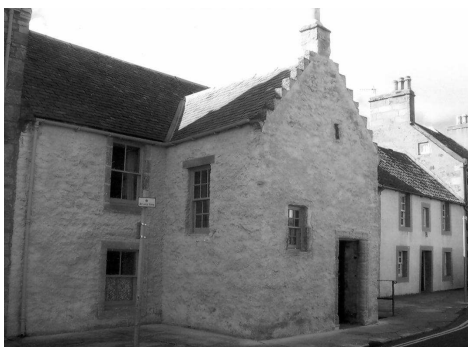
Figures 18 and 19. The finished look, with re-instated window.

Planning permission and listed building consent had to be sought to reinstate the blocked-in hall window (see fig.17). The window frame was made in Musselburgh and the local joiner, Frazer Thomson, fitted the window (see fig.18). The Musselburgh firm also supplied astragals which I cut and fitted over the plate-glass window on the ground floor. This restored the missing astragals without having to replace the glass or window frame. The final job for the façade was to replace the glass front door with a Georgian door found in a salvage yard in Wooler.

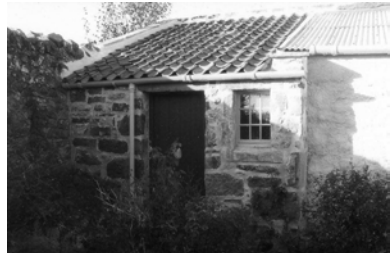
Figures 20 and 21. Partition wall and collapsed wall of outhouse.

At the rear of the house were the remains of an old outhouse which had a very unusual ‘partition wall’. This wall consisted of a wood frame in which stones were laid on their ends, producing a much thinner wall than usual (see fig.20). The wall was beginning to deteriorate (see fig.21), so the decision was made to rebuild the front wall and re-roof the structure. Mr Anderson sourced a stone window frame, and the façade was built up in lime, with a pantiled roof being fitted in 2007. The partition wall has been saved and the cottage looks as though it has always been there (see fig.22).

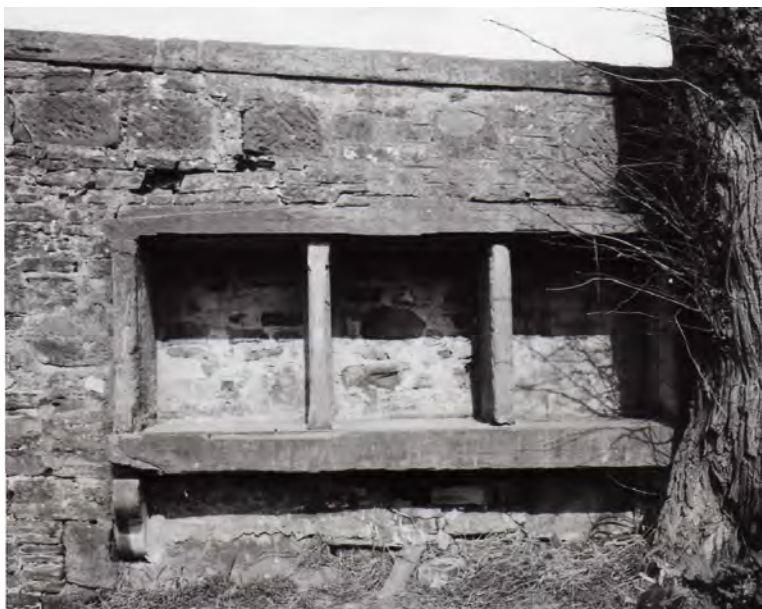
Figure 1. Typical row of three bee boles, Clifftown Hotel, Arbroath, Angus (IBRA Register No.0384). (Photo: E C Willscher, 1980)

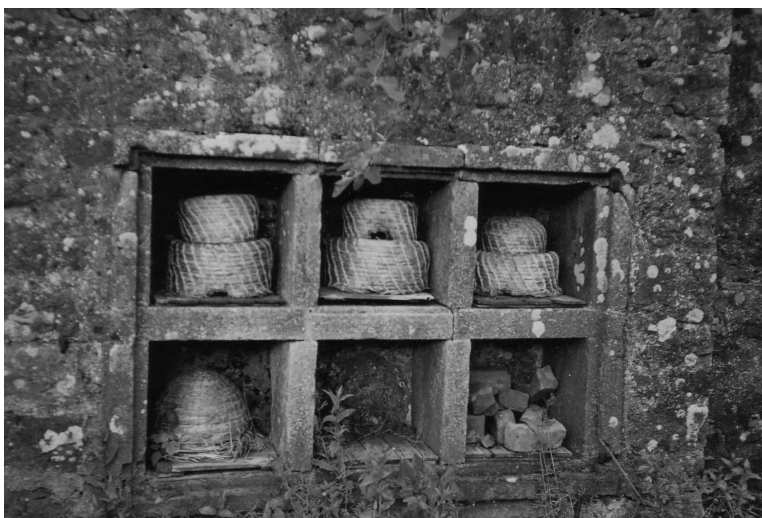
Figure 2. Two tiers of bee boles, Edenshead, Gateside, Cupar, Fife (IBRA Register No.0297); note that three skeps have 'caps', i.e. coiled-straw extensions, on top. (Photo: P Walker, 2006)

Table 2. Winter bee houses recorded in Scotland (all at private properties – before visiting, the owner’s prior permission must be obtained).
[†] The taller recesses were probably for skeps with caps, as shown in the upper bee boles in fig. 2.

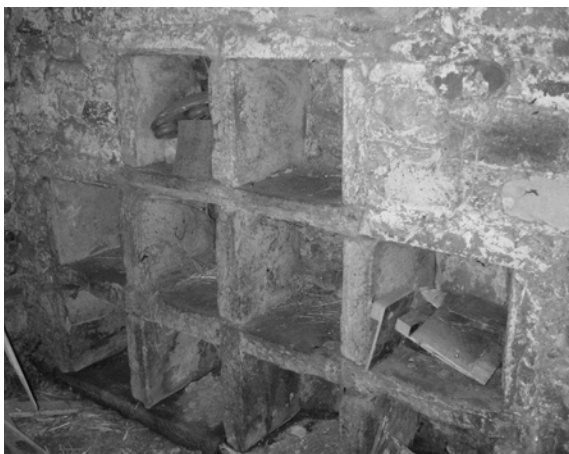
Figure 3. Winter bee house, Old Dairsie Manse, near Cupar, Fife (IBRA Register No.1364). (Photo: P Walker, 2004)

However, some windowless buildings have been found which contain roughly cuboid internal recesses (see fig. 3), like bee boles, and for some of these there is evidence that they were used for skeps. This implies that other similar internal recesses were built for the same purpose.⁶ The Register now contains records for 54 of these windowless buildings with recesses on the inside

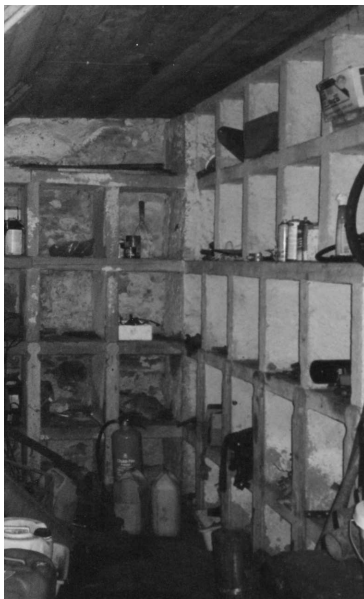
Figure 4. Many winter recesses in an outbuilding now used for general storage at Burnturk Farm, Kingskettle, Fife (IBRA Register No.1248). (Photo: P Walker, 2004)

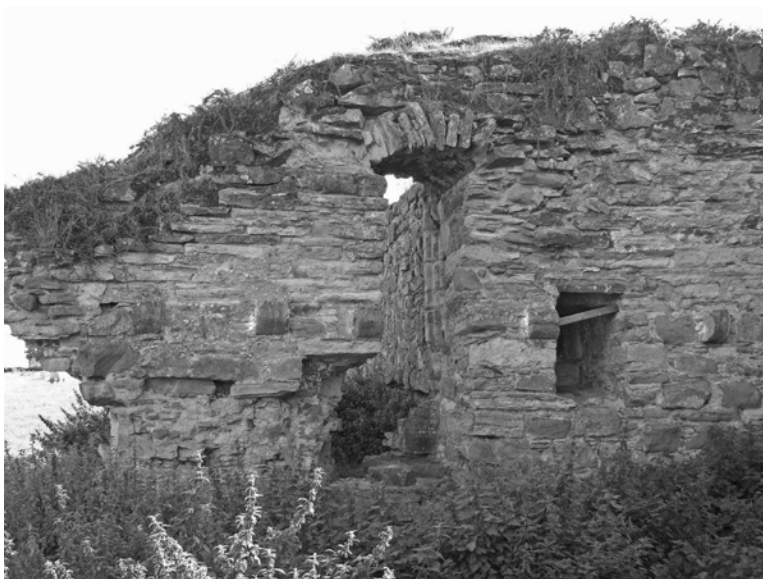
Figure 1. Doorway in the south wall of the 'castle', with the corbels clearly 'cutting through' the opening.

The lower room was a vaulted kitchen area, with a large fireplace in the north wall and an inlet for fresh water to the right. The door into this area is in the south, and, unusually, the drop from sill to floor is considerable, which suggests either steps down, or entry from above. However, there are two features which sit clumsily together and do not seem to make sense (see fig.1).

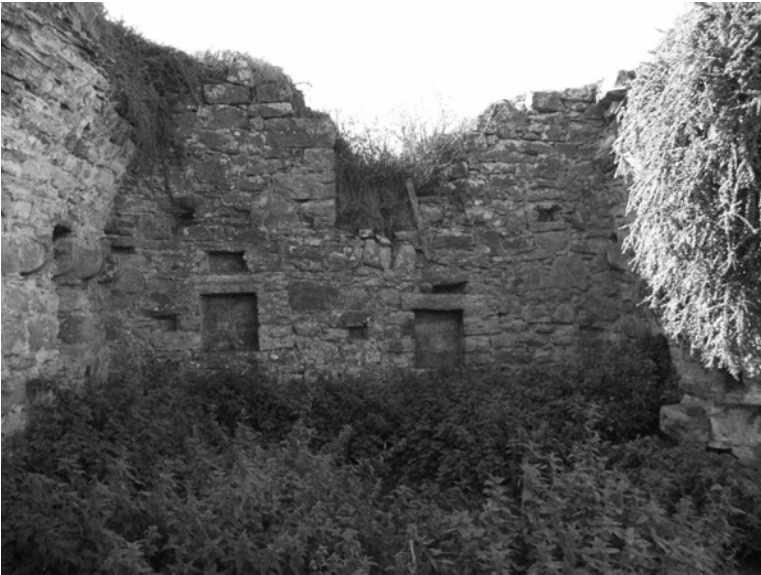
Figure 2. Interior of the 'castle', showing the barrel vault; the fireplace is to the right.

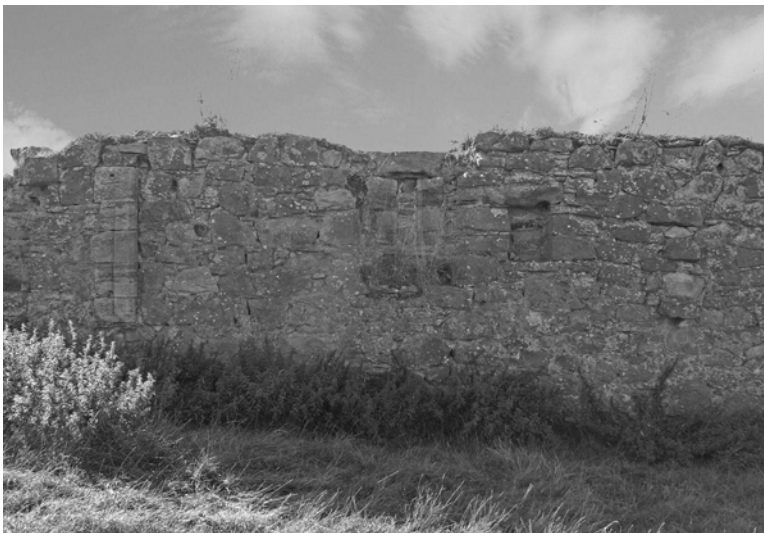
Figure 3. Blocked window, cupboard and jamb of seventeenth-century structure.

The destruction of the castle in 1547 does not preclude a rebuild. However, a look at the wall that runs from the south wall shows an extension that can be recognised from features such as a blocked window, an aumbry and a door jamb (see fig.3). It is clear that this now missing structure would have formed a courtyard with the ruined castle to the north. This is not unusual: comparable examples exist elsewhere in the Lothians, such as East Garleton Castle, which sits ruined beside a later seventeenth-century house. Chronologically the house must sit between the sixteenth century (the end of the castle) and the construction of the next phase (the eighteenth-century walled garden); only further geophysical investigations will confirm dates.

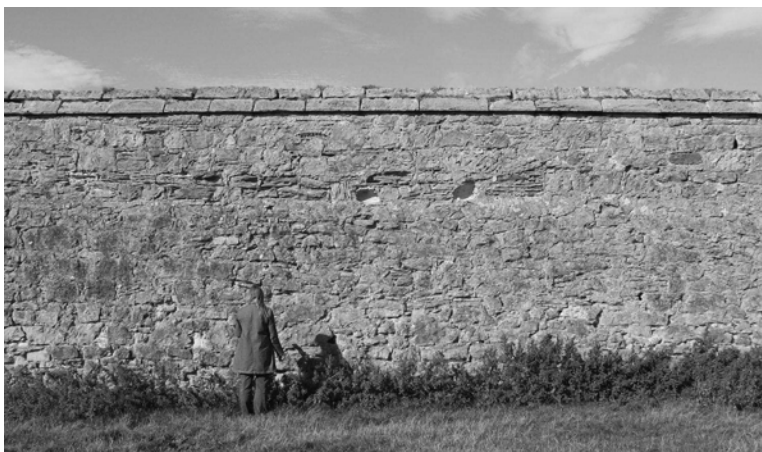
Figure 4. The walled garden: note the raising of the wall, and the pitched copes.

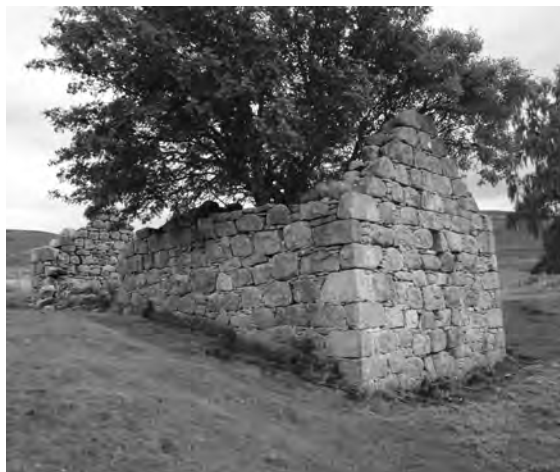
Figure 2. View of the kilnbarn at Sliabhclachd, NJ02SE 29, taken from the north-west. (RCAHMS, DP 019126; Crown Copyright: RCAHMS)

been a kilnbarn (see fig.2). This earlier building had a cruck-framed roof and opposed doorways, which were retained in the latest phase of use. The later building, which probably dates to the late eighteenth or early nineteenth century, had a kiln in its west end that has an arched opening to its flue. Commonly, flues in kilnbarns are relatively low and narrow, and are roofed with flat slabs or lintels; the provision of an arch here could be an indication that the building was better constructed than most similar structures.

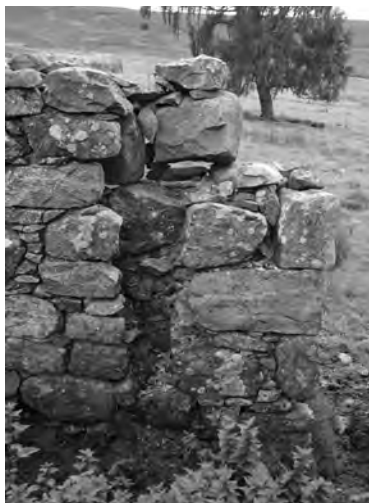
Figure 3. One of the cruck-slots is visible just east of the doorway on the south side of the kilnbarn at Sliabhclachd, NJ02SE 29. (RCAHMS, DP 019125; Crown Copyright: RCAHMS)

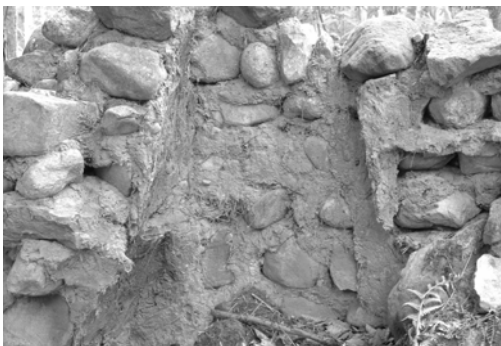
Figure 6. Building 3c, detail of flue.

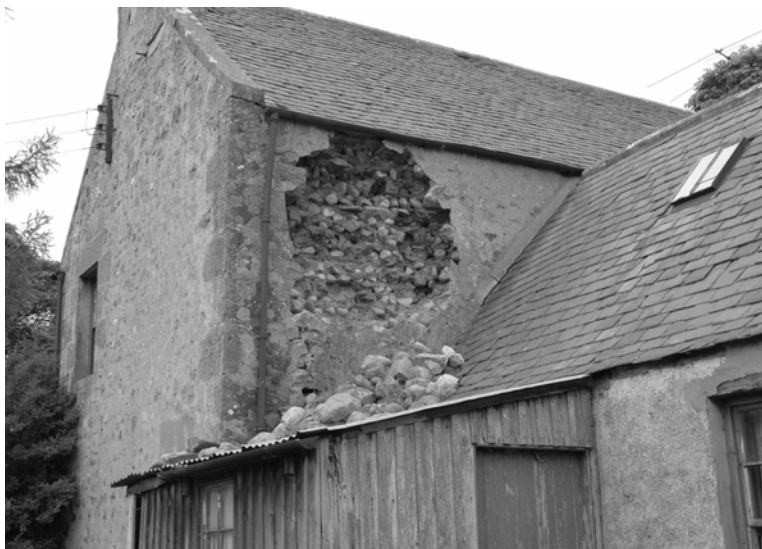
Figure 9. Lower Maverston farmhouse from back.

The farmhouse at Lower Maverston was not part of the survey, but was nevertheless recorded, since it is adjacent to the settlements that were the focus of the study and is an example of a far larger building built using the same clay and bool construction. It was derelict at the time of survey but had originally been a fine two-storey-and-attic building with dressed sandstone around the chimney, windows and doors. The wall construction could be clearly seen where the outer face of the upper part of the back wall had eroded.

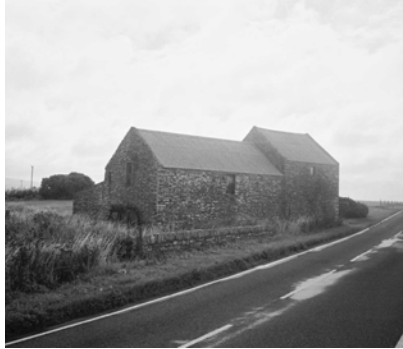
Figure 3. Mill of Rango, Sandwick. Like many of the mills surviving in Orkney, the Mill of Rango has been converted to living accommodation. What marks this building out architecturally is the square kiln with hipped roof.

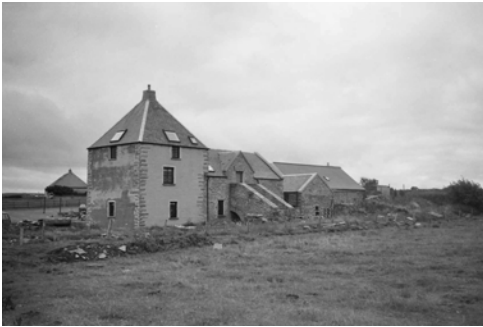
Figure 4. Kirkhouse Mill, South Ronaldsay. The horizontal slot in the wall suggests an internal wheel. Given the remoteness of the site, it is unlikely that this was to reduce noise. The wheel was enclosed more probably because of the site's exposed position – to protect it from windage, to prevent water being blown from the bucket, or to guard against ice damage.

The majority of later vertical water mills were found to be linear in plan, two storeys high, and to feature an overshot wheel, integral kiln and two pairs of stones (see table 1 and fig.1). There are, however, a few notable exceptions. Sabiston Mill (see fig.2) was latterly modified to provide an engine house; Mill of Rango features a square kiln (see fig.3); Kirkhouse has a water wheel hidden from view set within the main building (see fig.4); Skaill featured an unusual rotary kiln vent (see

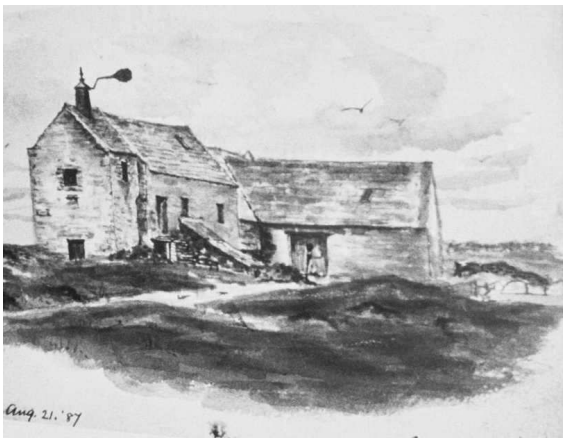
Figure 5. Mill of Skaill. This mill has now been lost to the sea; however, this watercolour, painted in 1887, shows a rotating kiln vent on the roof. Although common in Scotland, this was unusual in Orkney.

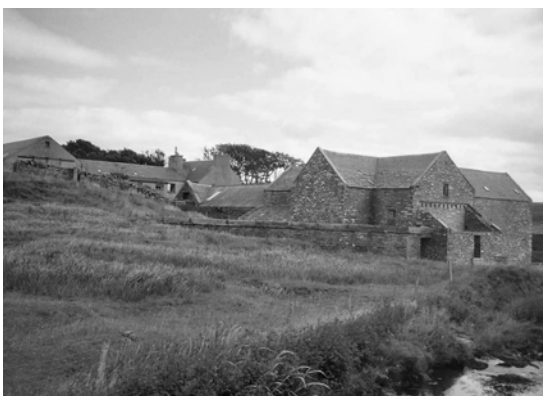
Figure 7. Kirbister Mill, Chinegar, Orphir. The most complex of Orkney's mills, Kirbister combines a grinding mill, threshing mill and kiln all on one site. Both water wheels are enclosed, and the lade allows water to be diverted to either threshing or grinding mills as required.

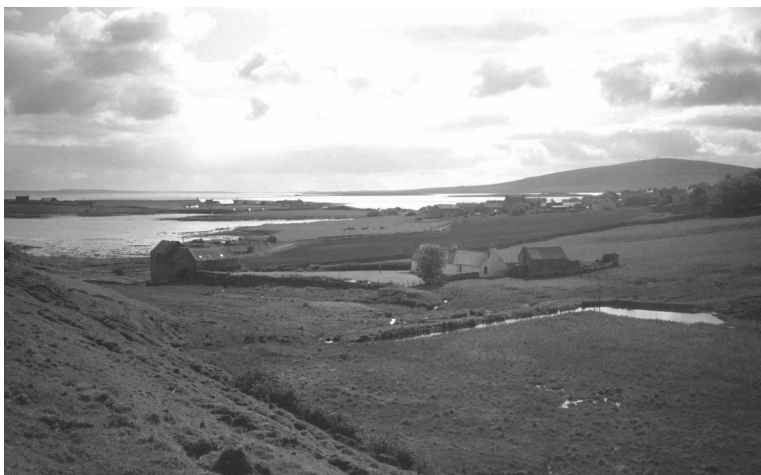
Figure 8. Firth Meal Mill. The general landscape around Firth Meal Mill showing the mill pond, mill dam, lade, bypass burn, mill cottages with threshing barn and, in the background, the L-plan three-storey mill building.

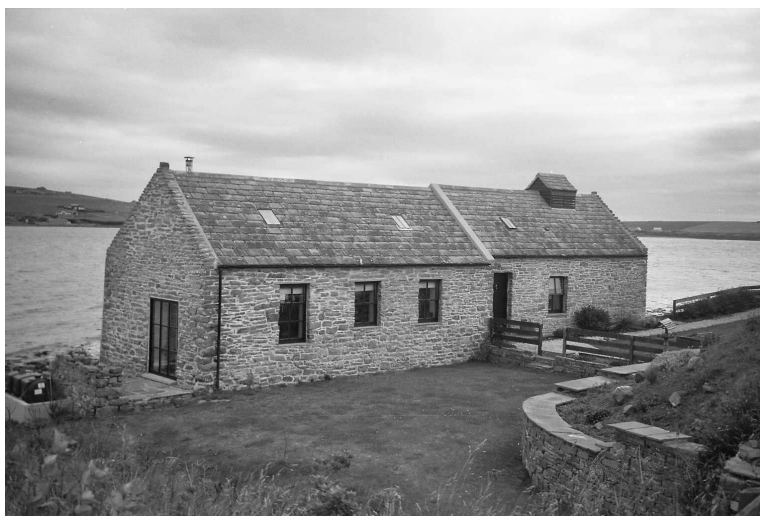
Figure 11. Cara Corn Mill, South Ronaldsay. Cara is a small, linear corn mill which originally featured a breastshot wheel (now absent). The kiln block, to the right, is a later addition to the original building.

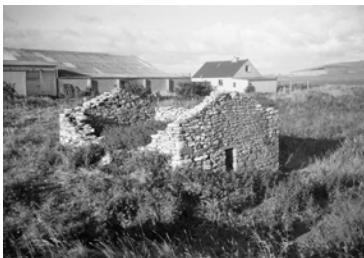
Figure 12. Kirbuster Mill, Birsay. Upstream wall and gable, the latter showing the aperture for the shaft.

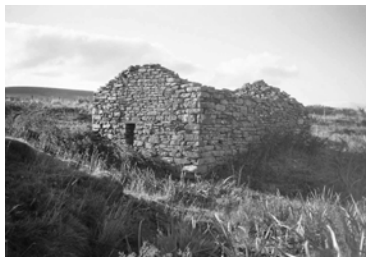
Figure 13. Kirbuster Mill, Birsay. Downstream wall and gable.

Kirbuster Corn Mill, Birsay, is a small, 21 foot 3 inch by 16 foot 2 inch (6.47m x 4.92m), rectangular building featuring an aperture of 19 by 35 inches (48cm x 89cm) in the gable wall (see figs 12

and 13). The position of the shaft aperture and the geometry of the gable suggest a midbreast wheel with a diameter of around 8 feet (2.5m), much less than is generally found in later mills. Interestingly the building displayed no signs of having a door aperture; this suggests that there may have been stairs to a door to an upper level, reminiscent of the mill of Rango (see fig.3). Complex earthworks (see fig.14) suggest that the mill was fed by a substantial mill pond and sophisticated system of sluices and burns.

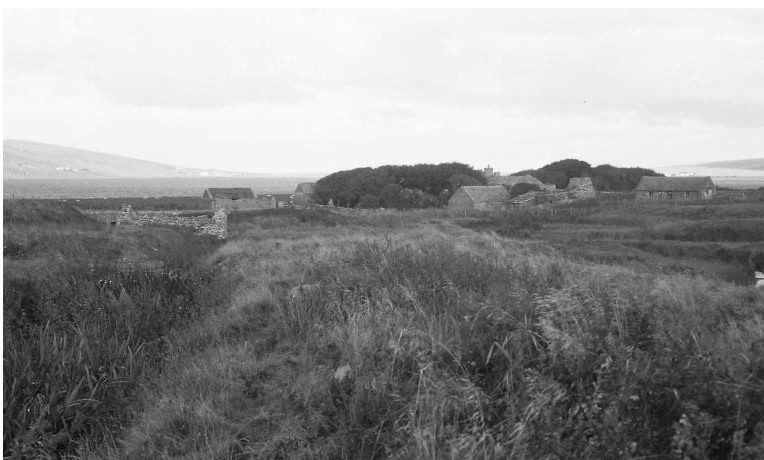
Figure 14. Kirbuster Mill, Birsay. The earthworks upstream of the mill suggest that the lade was not carried on stone piers, as was the case in the later mills, but took the form of a specially cut watercourse travelling in a straight line from the substantial dam to the mill. The bypass burn can be seen on the right side of the picture, and the farmstead associated with the mill is visible in the background.

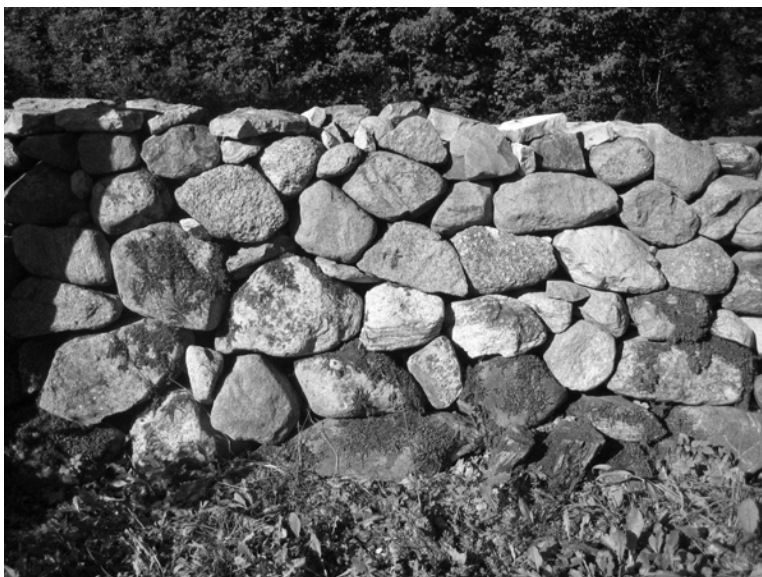
Figure 1. A recently repaired section of wall at St Catherine's Church, Muhu.

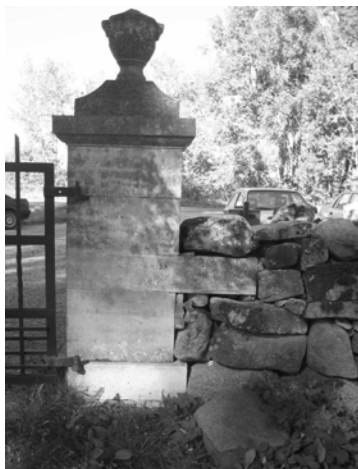
Figure 3. The entrance to Kaarma Church, with its gateway and wall 'married' in a union which has lasted 200 years.

In the village of Kaarma on Saaremaa, the church grounds are surrounded by an impressive dry limestone dyke, which has a couple of sections that have recently partially collapsed. These collapsed sections afford an interesting insight into the construction methods employed. The limestone dykes of Saaremaa have little in common with Scottish dykes. However, they can be compared in many ways to the stone walls of Kentucky, USA and the Cotswold area of England, both of which use limestone. It should be stressed that both the walls of Kentucky and those of the Cotswolds (to a lesser degree) employ the use of batter, which is absent in Saaremaa dykes. Kaarma church dyke, following the local style, has no batter on the dyke; and trace stones are commonly used, as in Cotswold walls. The dyke measures approximately 4 feet (1.2m) at the base – double the width of Cotswold walls – with an average height of 3 feet (1m). There is no evidence of through stones, and the hearting had been loosely packed – both of which factors probably contributed to the partial collapse. The dyke has a flat, tightly bonded finish and is in decent condition. In comparison to granite dykes – where the principle of one stone over two, two over one results in strong bonding – running joints are often found in limestone dykes. Considering the use of trace stones, lack of batter and running joints, all frowned upon by dykers, one wonders how this particular dyke has stood for some 200 years without any major collapse and looks as though it could last for a few more years. Interestingly, it is in this particular dyke that we find a fine example of the marriage of vernacular dry stone and dressed mortar wall styles, two distinct types of stonework that are rarely combined. Two dressed stone gateposts (see fig.3), specifically designed to accommodate the

surrounding limestone dyke, impressively flank the entrance to Kaarma Church. This implies that dry stonework in this particular area, and at the particular time of construction, seems to have been appreciated from both an aesthetic and a practical viewpoint, resulting in it being taken into consideration during the planning process.

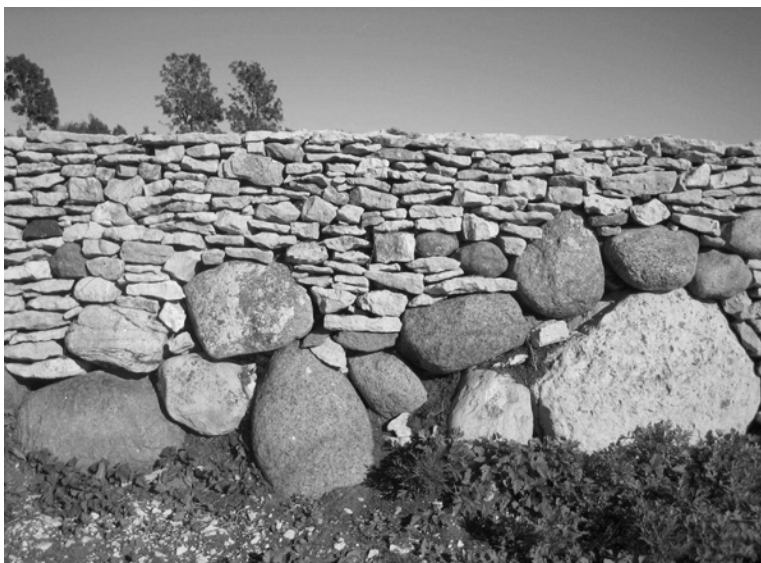
Figure 4. The contrast between granite fieldstones and limestone is dramatically revealed in this section of repaired wall by Kaja Juulik.

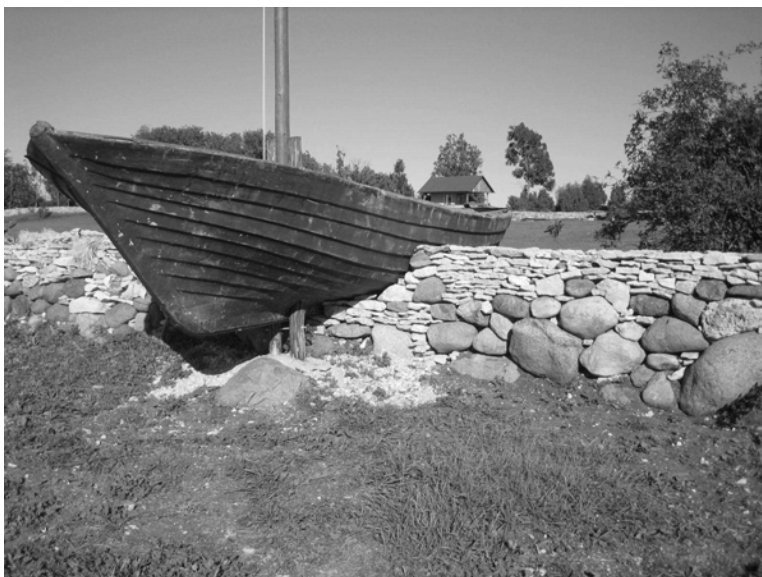
Figure 5. An interesting example of Kaja Juulik's renovated walls at Karala. Kaja has added a new twist to the island's relationship with walls and boats.

lies tantalisingly only a few feet away (see fig.5). This image of renewal, motion and vitality is a perfect symbol of the upswing in the dyking regeneration in this beautiful area of the Baltic Sea. The contrast between the old moss-covered walls of Koguva village with their upturned boats, and Kaja's renewed walls brought dramatically to life by the emerging boat heading towards the open sea, gives hope for the continual redevelopment of this little-known area of the Baltic entering a new dawn in its often turbulent history.
