VERNACULAR BUILDING 34

Scottish Vernacular Buildings Working Group

2010–2011

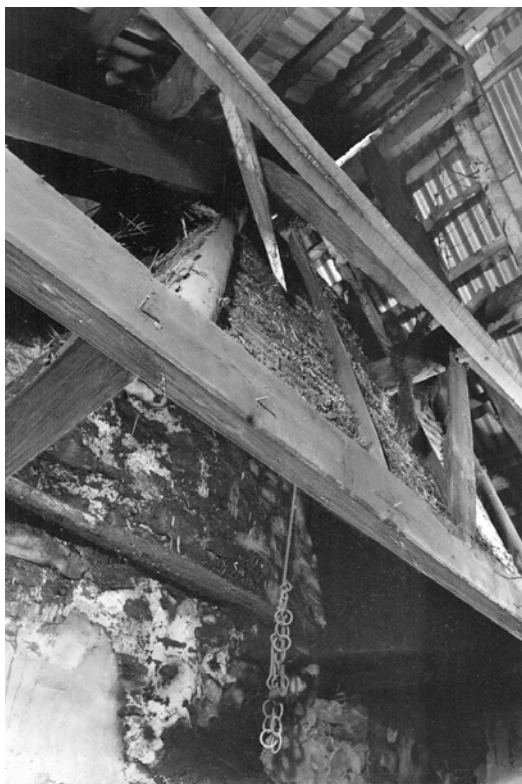
*Figure 6. Camserney
Longhouse, Perthshire
(mid-18th century):
hanging chimney.
(© Crown Copyright:
RCAHMS. Licensor
www.rcahms.gov.uk)*

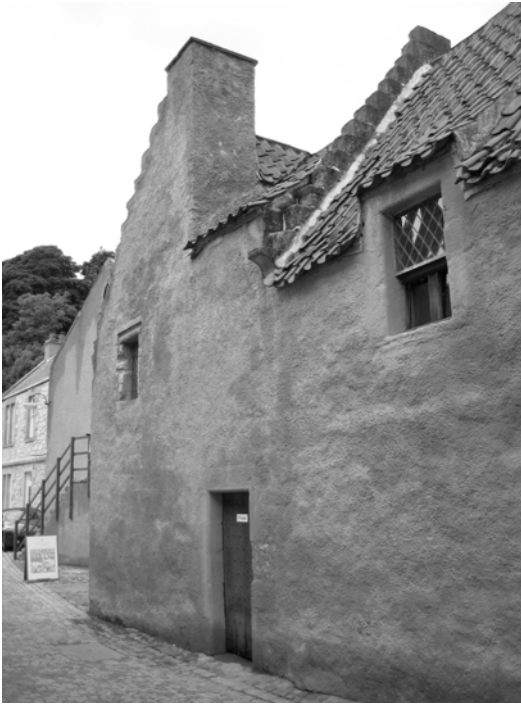
Figure 7. Culross Palace, Fife (1597–1611) – mural chimney and crow-stepped gable.

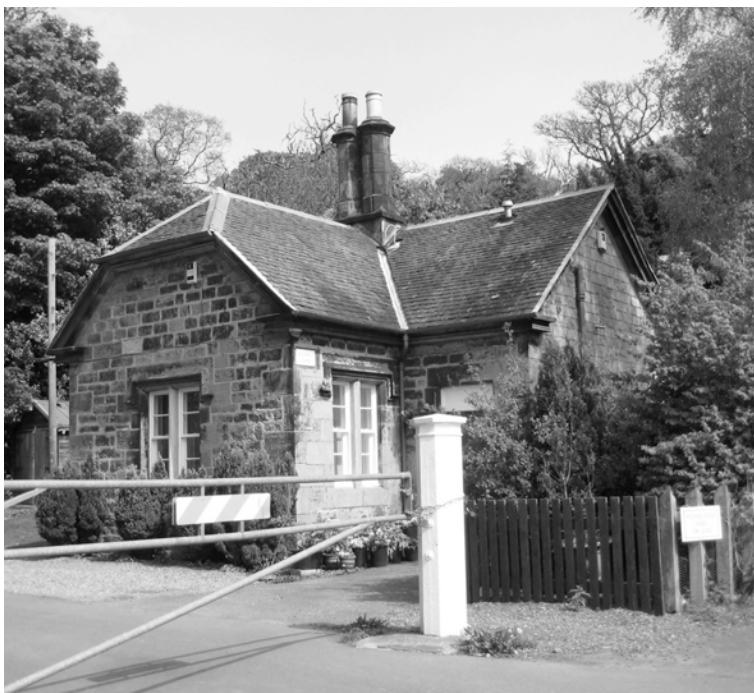
Figure 8. Dalmeny Estate, Leuchold Gate (19th century): view from the south-west – central chimney.

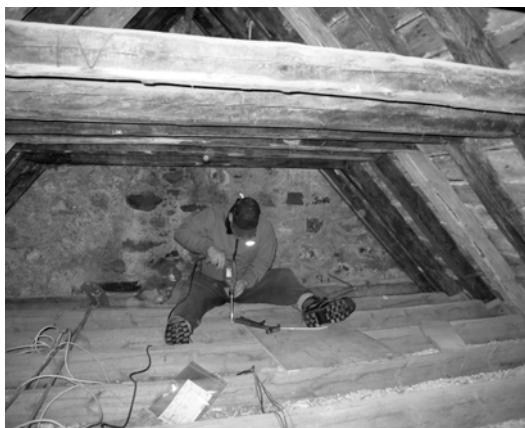
Figure 1. Working in the roof of Allargue House, Strathdon.

As dendrochronologists we have spent much time over the past few decades crawling around roof spaces throughout Scotland to assess and subsequently sample the timbers (see fig.1). Assessing their dendrochronological potential means observing and recording a number of variables. Species, length of ring-pattern and presence/absence of outermost rings are essential factors in determining whether the timber is datable or not, and how precise a date we can obtain. Equally important are other details, such as the evidence

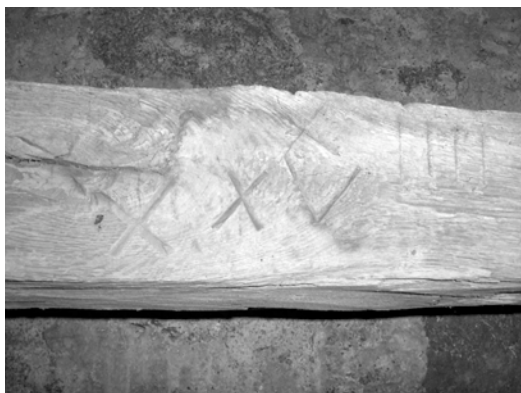
Figure 2. Duplicate carpenters' marks on oak in the roof of the Mansion House, Drum Castle.

for reuse of timbers (i.e. redundant joints and duplicate carpenters' marks – see fig.2), whether wooden trenails or iron spikes have been used to secure the joints, how the timber has been converted from the tree and what sort of tools have been used to dress and shape the timber. This paper is therefore concerned as much with the subsidiary knowledge that we have acquired over the years about the type of timber and how it has been used in Scottish buildings as with their dendro-dating. In view of Bruce Walker's recent appeal for a greater understanding in the world of architectural conservation of that physical evidence – of the building materials themselves – this paper seems timely.⁸

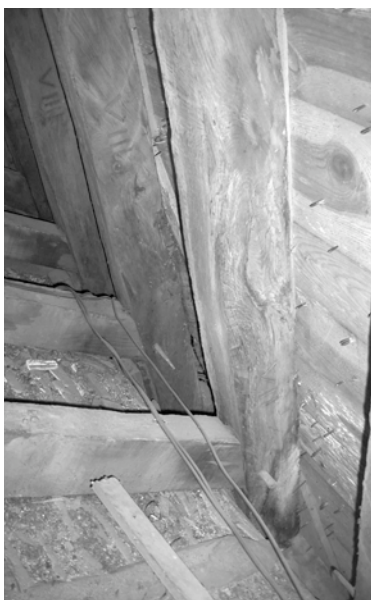
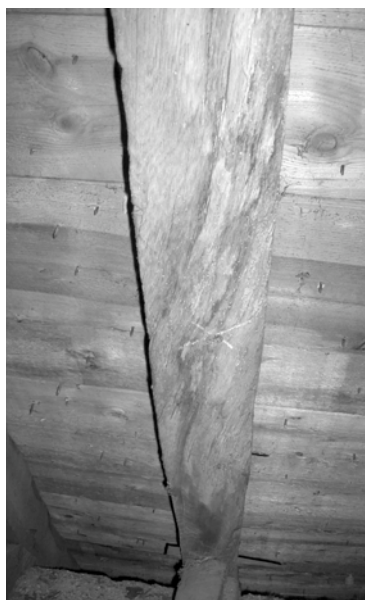
Figures 3a and 3b. Bastard-grained oak timbers in the roof of the Mansion House, Drum Castle.

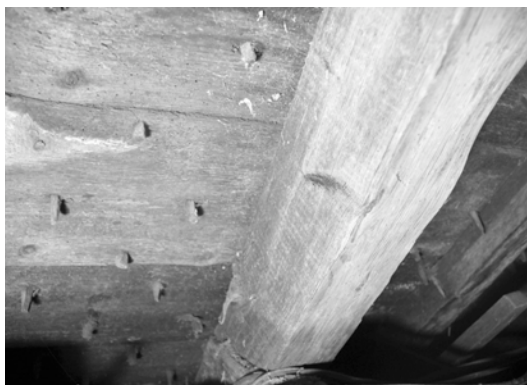
Figure 4. Sawn and hewn pine baulks in the roof of the Old Courthouse, Campbeltown. Note the wooden pegs in the sarking.

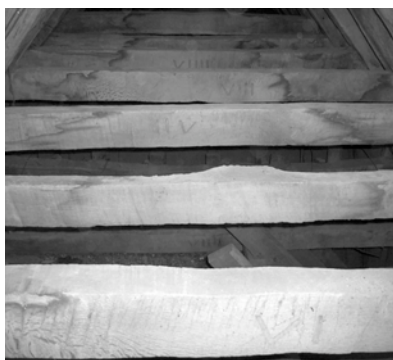
Figure 5. Hand-sawn oak collars in the roof of the Mansion House, Drum Castle.

Apart from the mill-sawn rectangular baulks seen in some of the nineteenth-century buildings in our sample, the sawn timber in the buildings listed in Table 2 and mentioned above was almost invariably hand-sawn. The sawmarks were usually quite coarse and irregular, and lay at roughly right-angles to the edge of the baulk (see figs 5 and 6).

The earliest examples of hand-sawn baulks in our sample were found in Crathes Castle, the Mansion House at Drum (fig.5) and Castle Fraser in Aberdeenshire, in roofs of late sixteenth- and early seventeenth-century date, but hand-sawing as a means of converting timber into baulks does not appear to have come into common use in Scotland until the eighteenth century. Elsewhere in Europe, rip-sawing was undertaken by professional sawyers who moved from job to job, taking their equipment with them, so it may have been too costly a means of conversion for most in the Scottish countryside.³¹ It is perhaps unsurprising that it appears earliest in prestigious buildings whose wealthy owners could afford to hire a sawyer.

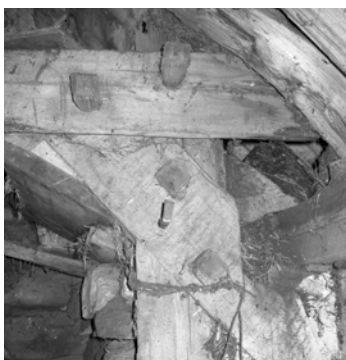
Figure 6. Hand-sawn pine in a composite cruck in the Inverey byre.

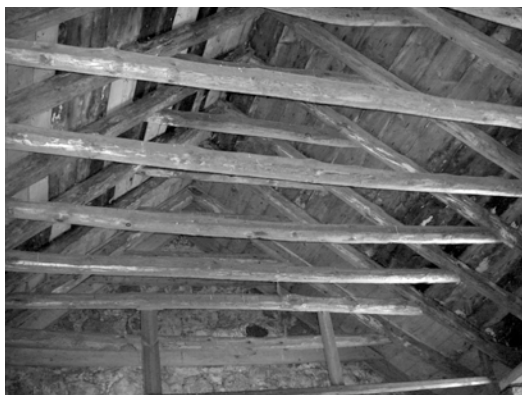
Figure 7. Small, fast-grown hewn pine timbers in the roof over the Old Laundry, Drum Castle (c.1800).

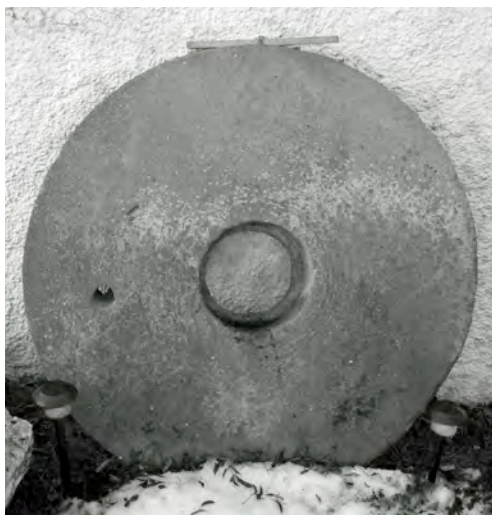
Figure 2. Baldernock Mill runner stone viewed from the underside. Note the cross section of the eye and the circular grooves around it. The ruler on top of the stone is 457 mm (18 in) long.

surfaces, whereas the runner stone is commonly thicker at the eye than at the rim (see figs 2–3). In some instances the upper surface of the nether stone may be convex-up, in which case it is matched by a concave-down lower surface of the runner stone; the curved surfaces help the grain to migrate outwards as it is ground. Table 1 (see previous pages) sets out measured and reported dimensions of some millstones in Scotland and elsewhere.

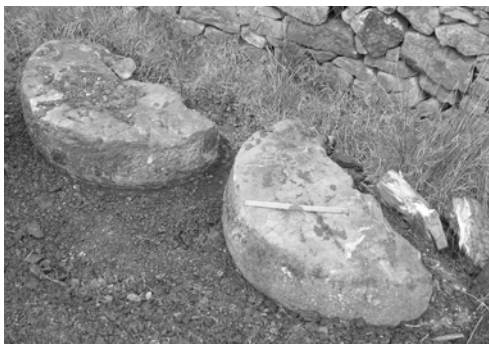
Figure 4. Broken monolithic millstone, Muirhouse Farm yard. Ruler is 457 mm (18 in) long.

Craigmaddie Muir, about 1.5 kilometres (just under a mile) north-north-east of Baldernock Mill, is underlain by sedimentary rocks (sandstones and conglomerates) of the Carboniferous Lawmuir Formation. Sandstones along the southern edge (the Baldernock side) of the muir crop out as disconnected ragged cliff sections over about half a kilometre. These sandstones have been worked for millstones and the overall site is known by RCAHMS as the Craigmaddie Muir Millstone Quarries.¹⁷ Evidence of the millstone working ranges from circular pecked outlines of (presumably) millstones, to *in situ* but unlifted millstones, to circular depressions in the rock where millstones have been lifted, to complete monolithic millstones that have been recovered from the muir (see figs 4–8).

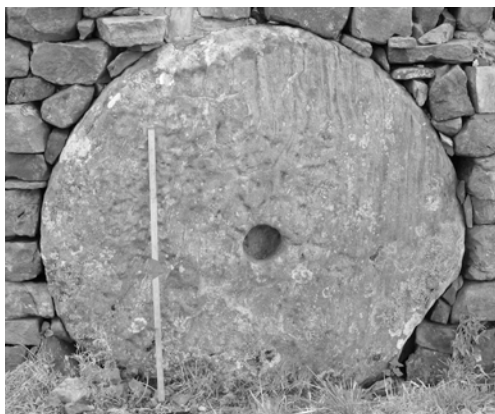
Figure 5. Millstone set in stone wall at Muirhouse Farm gate. Ruler is 914 mm (36 in) long.

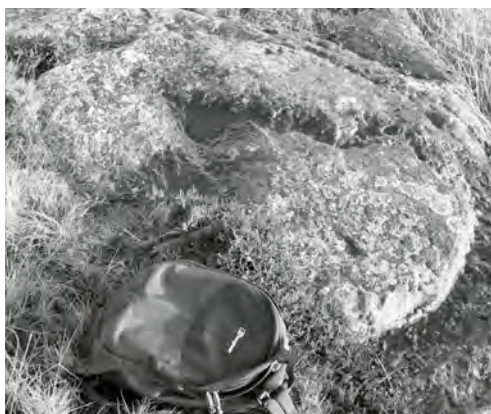
Figure 6. Unlifted millstone north-east of Muirhouse Farm.

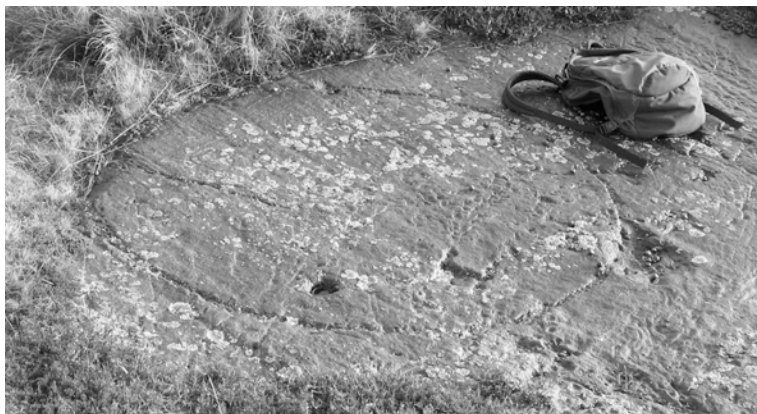
Figure 7. Pecked millstone outline north-east of Muirhouse Farm.

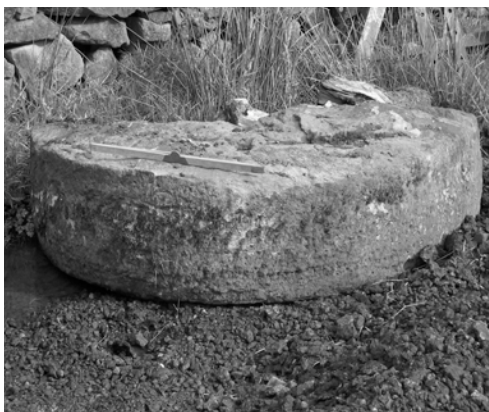
Figure 8. Detail of broken monolithic millstone in Muirhouse Farm yard, highlighting the millstone edge's worked (pecked), slightly convex-out surface. Scale is 457 mm (18 in) long.

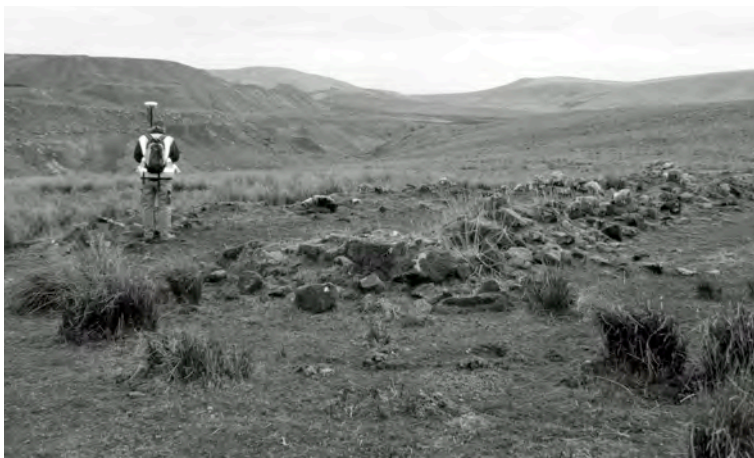
Figure 2. View of Cairniebottom during initial survey, looking south-west.

The survey of Cairniebottom revealed the remains of a low turf-covered building that measured 22.5 by 6.8 metres (74 x 23 ft) externally, with walls roughly 0.7 metre (2 ft 3 in) wide and up to 1 metre (3 ft 3 in) high in places (see fig.2). The building was aligned north-west to south-east, falling to the south-east. Around it was a spread of collapsed stone and turf superstructure. There was an entrance towards the north-west end of the more northerly long wall, and there was a marked change in level in the south-east half of the building, representing a step down. There were also traces here of a central drain. Initial field observations interpreted this south-east half as a possible byre, with the higher north-west part of the building being a small farmhouse.

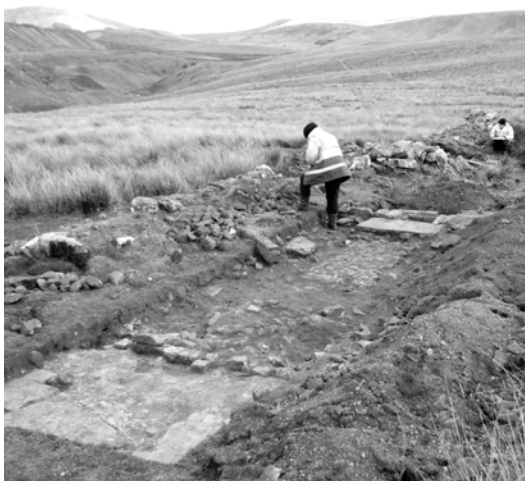
*Figure 4.
View of the house end
of Carniebottom,
looking south-west.*

farmhouse in order to locate the hearth (if present) and to investigate the drop in level within the building noted during the initial survey. The north-west end of the trench revealed a floor surface, comprising a mixture of large flagstones, lime mortar and cement mortar, which was present to the north of a narrow internal wall. To the south-east of this was a spread of stone rubble likely to be collapse from the adjacent wall (see fig.4).

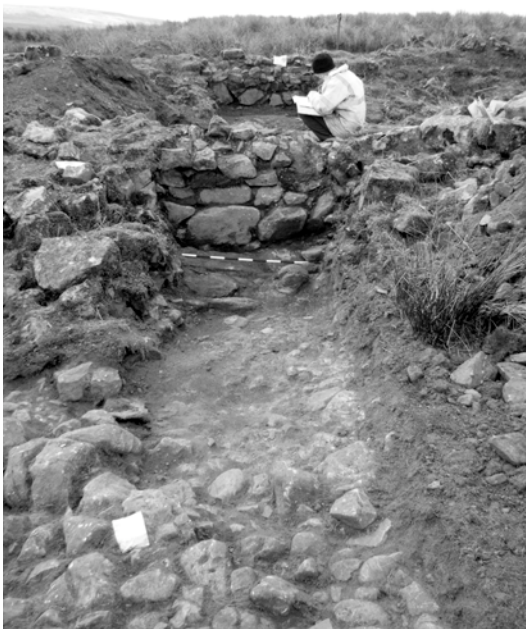
*Figure 6.
View of stone drain
in the centre of the byre.*

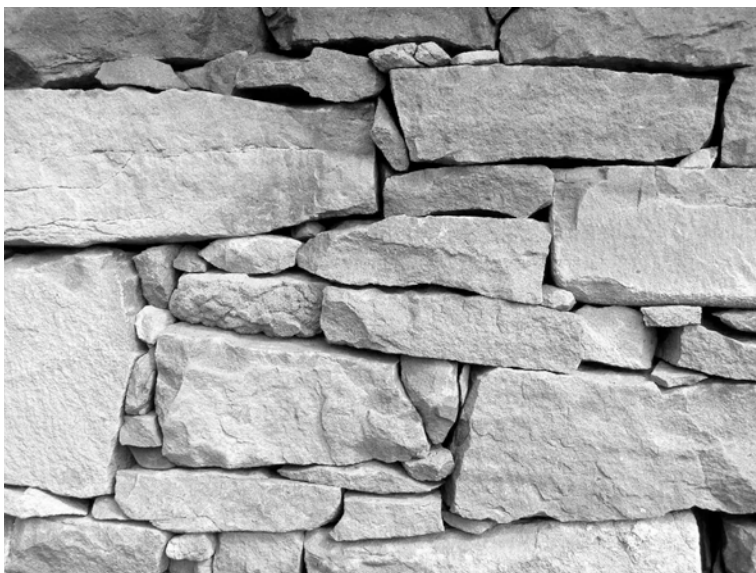
Figure 5. Finely executed masonry to the front wall of the house, shaped from Torridonian sandstone.

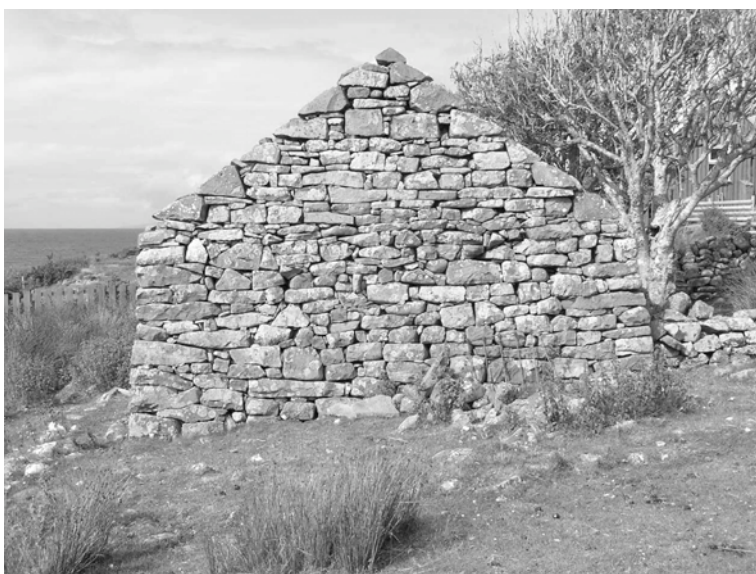
Figure 6. The south gable of the barn to the front of the house.

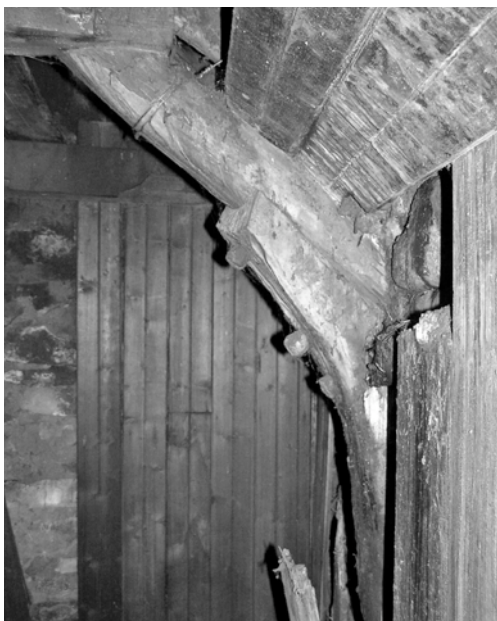
Figure 9. Detail of the pegged joint between the cruck blade and stub post (crup).

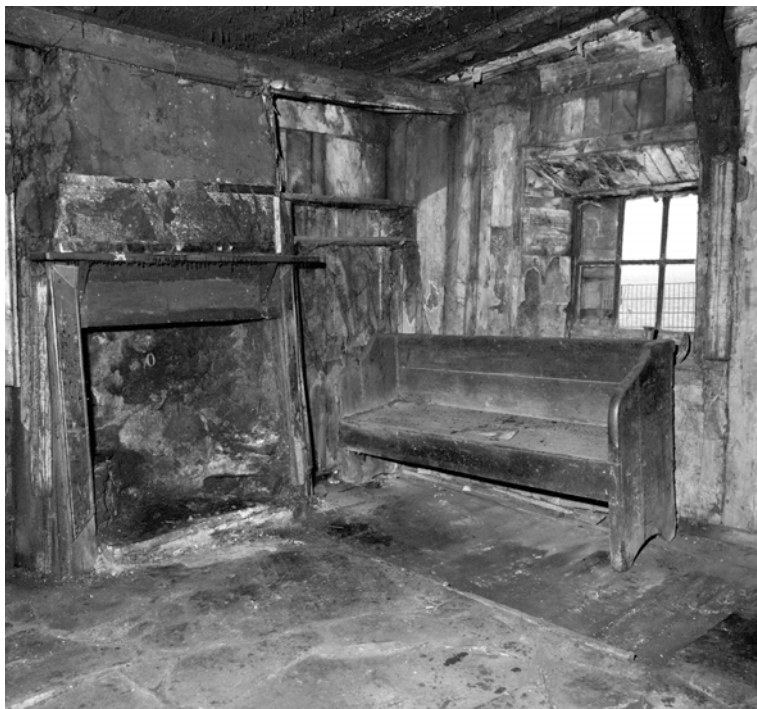
*Figure 10. Photograph of the south room of the house taken in 1991.
(© Crown Copyright: RCAHMS. Licensor www.rcahms.gov.uk)*

Sadly, many of Dunacan Mackenzie's few possessions were dispersed after his departure from the house, and some damage was inflicted upon the interior of the property before it came into the possession of the National Trust for Scotland. However, it is fortunate that two pieces of important Highland vernacular furniture have survived, and will be conserved. One is a three-legged stick-back chair with five 'comb-back' stays (fig.11), found typically in the coastal areas from Wester Ross to Kintyre, and the other a plain bench, or settle, of solid planks with gently curved endboards (see fig.10).¹⁰ There had been a wooden bed in the house which must have been destroyed.

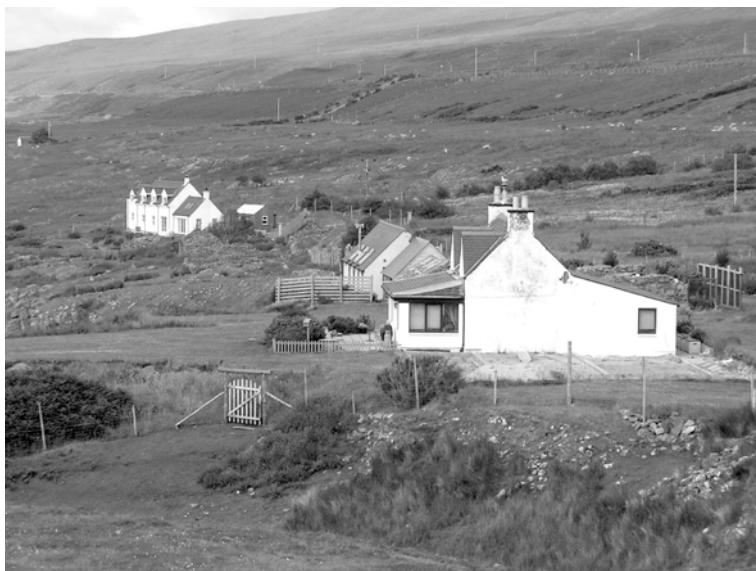
Figure 12. The linear character of the township structures, built from materials of the land, has been compromised by the erection of new buildings and from extensions where the buildings have continued in use.

The iconic image of the linear township, with the shells of the old houses running out across the landscape in an unbroken straight line, has been violated in recent years, perhaps not so much by structures which have been erected out of alignment with the original plan, but by the new houses built upon the original plots which are of a different scale and of contrasting materials. There has also been the visual damage from the incremental growth of sheds, conservatories and polytunnels which have sprung up around them. Damaging as this might appear, in truth the desecration of the site only began when the shells of the old houses adjacent to Dunacan's house were turned into a filmset for Bill Bryden's portrayal of the last days of the community on St Kilda, *Ill Fares the Land*, released in 1982 for Channel 4 and starring Fulton Mackay. Makeshift thatched roofs were erected to create the illusion of the filmset, for which the wallheads and gables of the houses were rebuilt indiscriminately with an internal concrete block skin applied. In the majority of cases these have

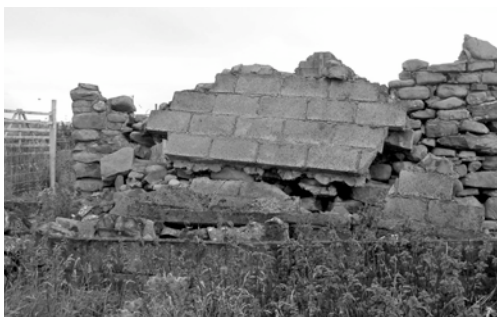
Figure 13. A collapsed gable showing the damage from rebuilding the walls of the shells of the old houses with concrete blockwork as part of a filmset in the early 1980s.

collapsed during the worst of the gales, leaving blocks strewn around the interiors of the shells, and as a consequence permanent damage has been caused to the archaeology of the site. It is hard to conceive how the last remaining tenant at the end of the row coped with the assault on his secluded privacy from the film crew and actors. It is hard also not to form the view that the special character of this unique place should have been protected by an appropriate designation under historic environment legislation.

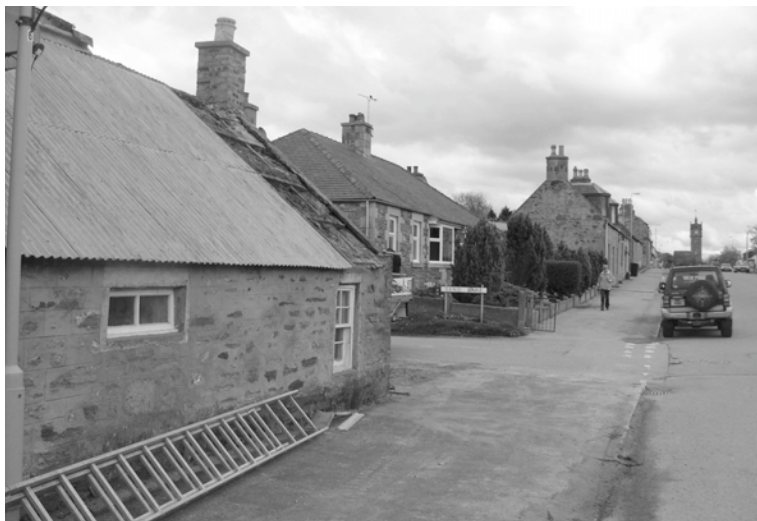
Figure 4. The former smiddy building from the west, at the moment when the tin roof was removed and the thatch roof exposed for the first time in decades. Also visible is the curiously small window in the front wall, which appears to have been formed by blocking up a larger opening.

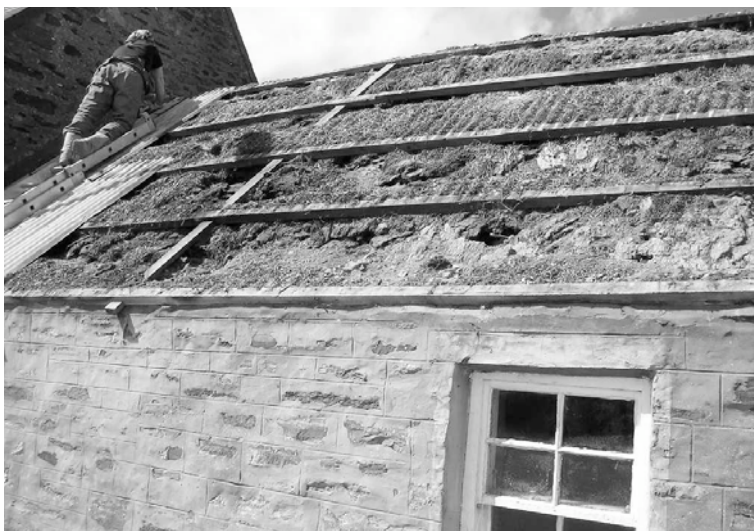
Figure 5. The tin roof in the course of removal. The previous straw thatch finish is visible, although now pressed down into a corrugated pattern. The turf divots below are most clearly seen between the tin roof battens along the lower section of roof. The substantial front stone wall has been extensively pointed using a cement-based mortar and then lined out. Note the slightly unusual 8-pane sash-and-case arrangement of the eastern window.

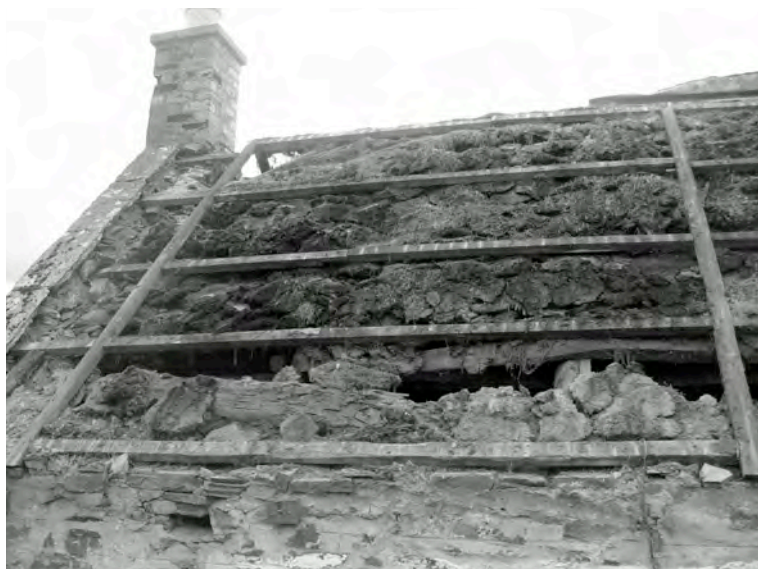
Figure 6. The rear roof shows few remnants of the straw thatch finish, although the turf divots are clearer to view. The partial collapse of the sarking battens and their sods provides glimpses of the varying thicknesses of sarking. Also recorded here are the later brick chimneyhead and the rather fine stone skews.

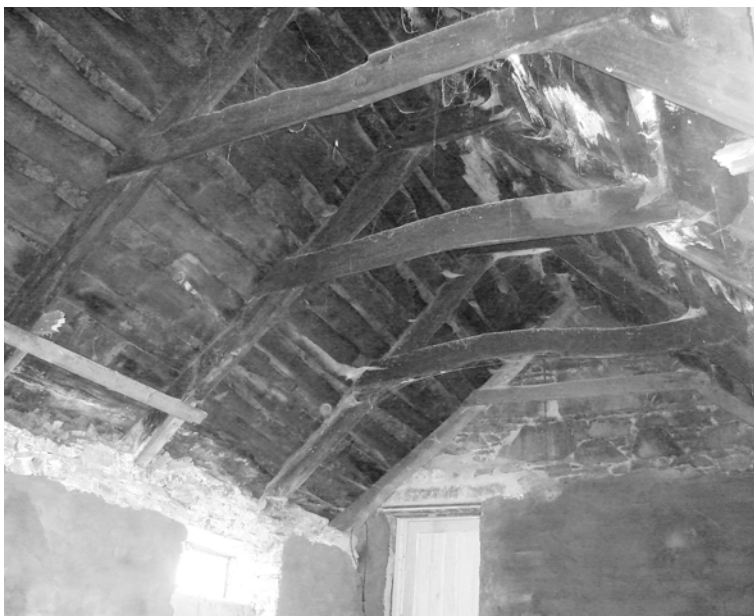
Figure 7. Interior view looking south-west (after clearing out and the creation of a new door opening to link to main house). The substantial main roof trusses at wide centres are constructed using irregular timbers, which is most clearly seen in the lack of straightness in some of the tie beams. Several of the trusses have small tie beams near their apex, and all are beam-filled at their wallhead ends. The irregular sarking battens are clearly visible, as well as the base of earth and clay material which was applied from above between their spacings.

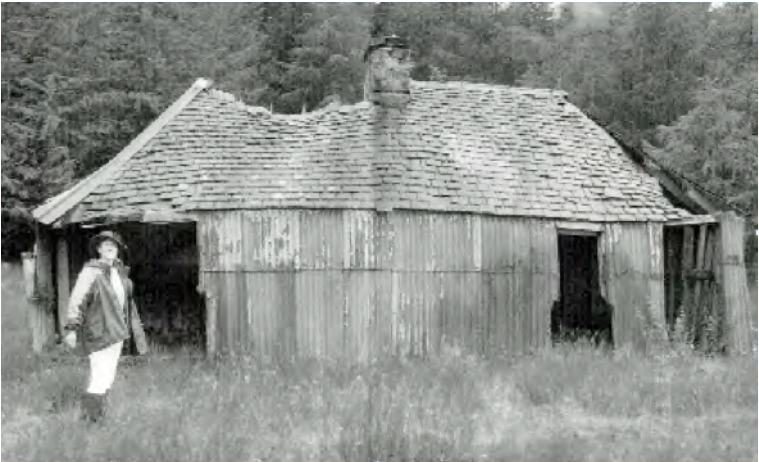
Figure 1. Corrugated-iron building at Gaodhail, Glen Forsa, Mull, in a state of disrepair.

In 1995 I measured a corrugated-iron building in Gaodhail, Glen Forsa, Mull (NM 6100 3855) and my report was published the same year in *Vernacular Building* 19 (pp 50–53). The structure, possibly an estate school, lies near the boundary of two properties. Sadly, in spite of local efforts to save this interesting structure, it is now ruinous (see fig.1). This shows all too clearly how soon and how completely a structure deteriorates once the roof starts to ‘go’.

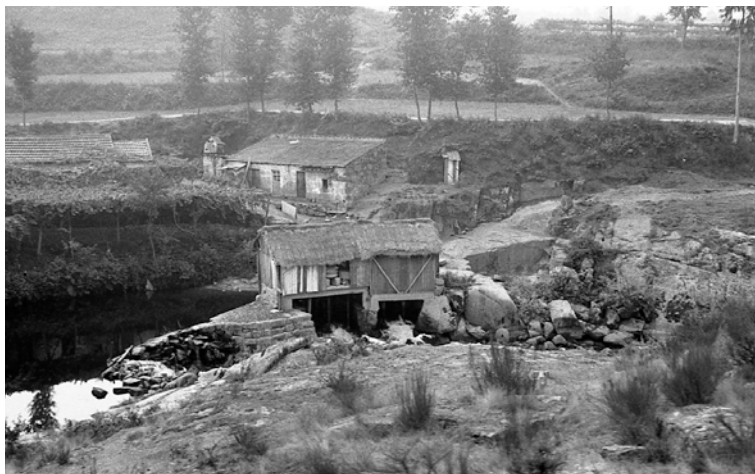
Figure 3. A Portuguese horizontal mill (photo taken 1970).
